Consulting Arborist Services Level I & II Tree Risk Assessment

**EAST CARRIAGE CONDOMINIUM ASSOCIATION, INC.
P.O. Box 207, South Glastonbury, CT 06073**

MONTAUK WAY, GLASTONBURY, CT, 06033

6/1/22

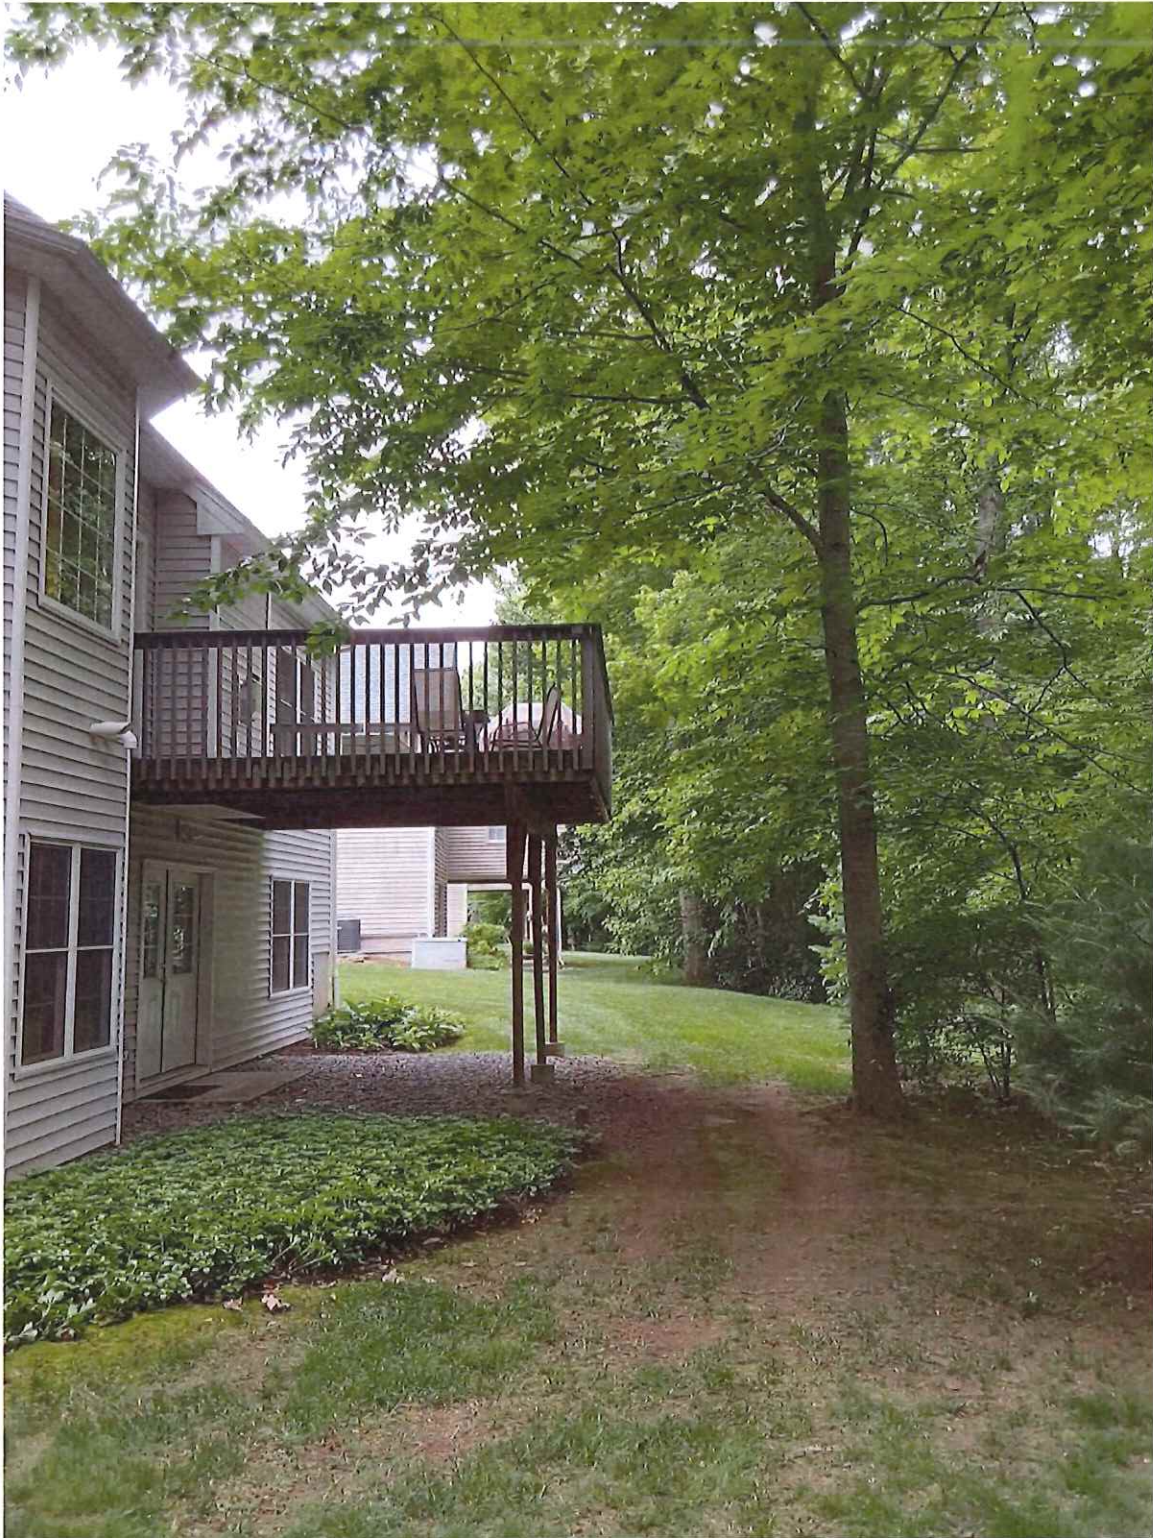
Trees growing along the edge between the conservation area and the ECCA property have limbs extending over the boundary that in some cases come in contact with existing structures, (Photograph 1, 2 & 3). Defects noted on boundary trees are consistent with mechanical injuries that may have occurred likely during original construction, (Photographs 4 - 8). The multi-stem structure in 3 mature hardwoods shows evidence of internal decay or poor connection, (Photographs 9, 11 & 12). The grade elevation where the forested area is lower than the existing structures positions the live crown of boundary trees closer to and in direct view or contact with first level.

Photograph 1: Tree # 1 shown with limbs extending over structure. Reduction or removal of first limb over structure will reduce this condition and lower risk. The tree health is sufficient to sustain the pruning impact. Warning: Over pruning of the tree can cause a wound response that generates multiple sprouts. Limit pruning in this tree to this limb or 10% or less.

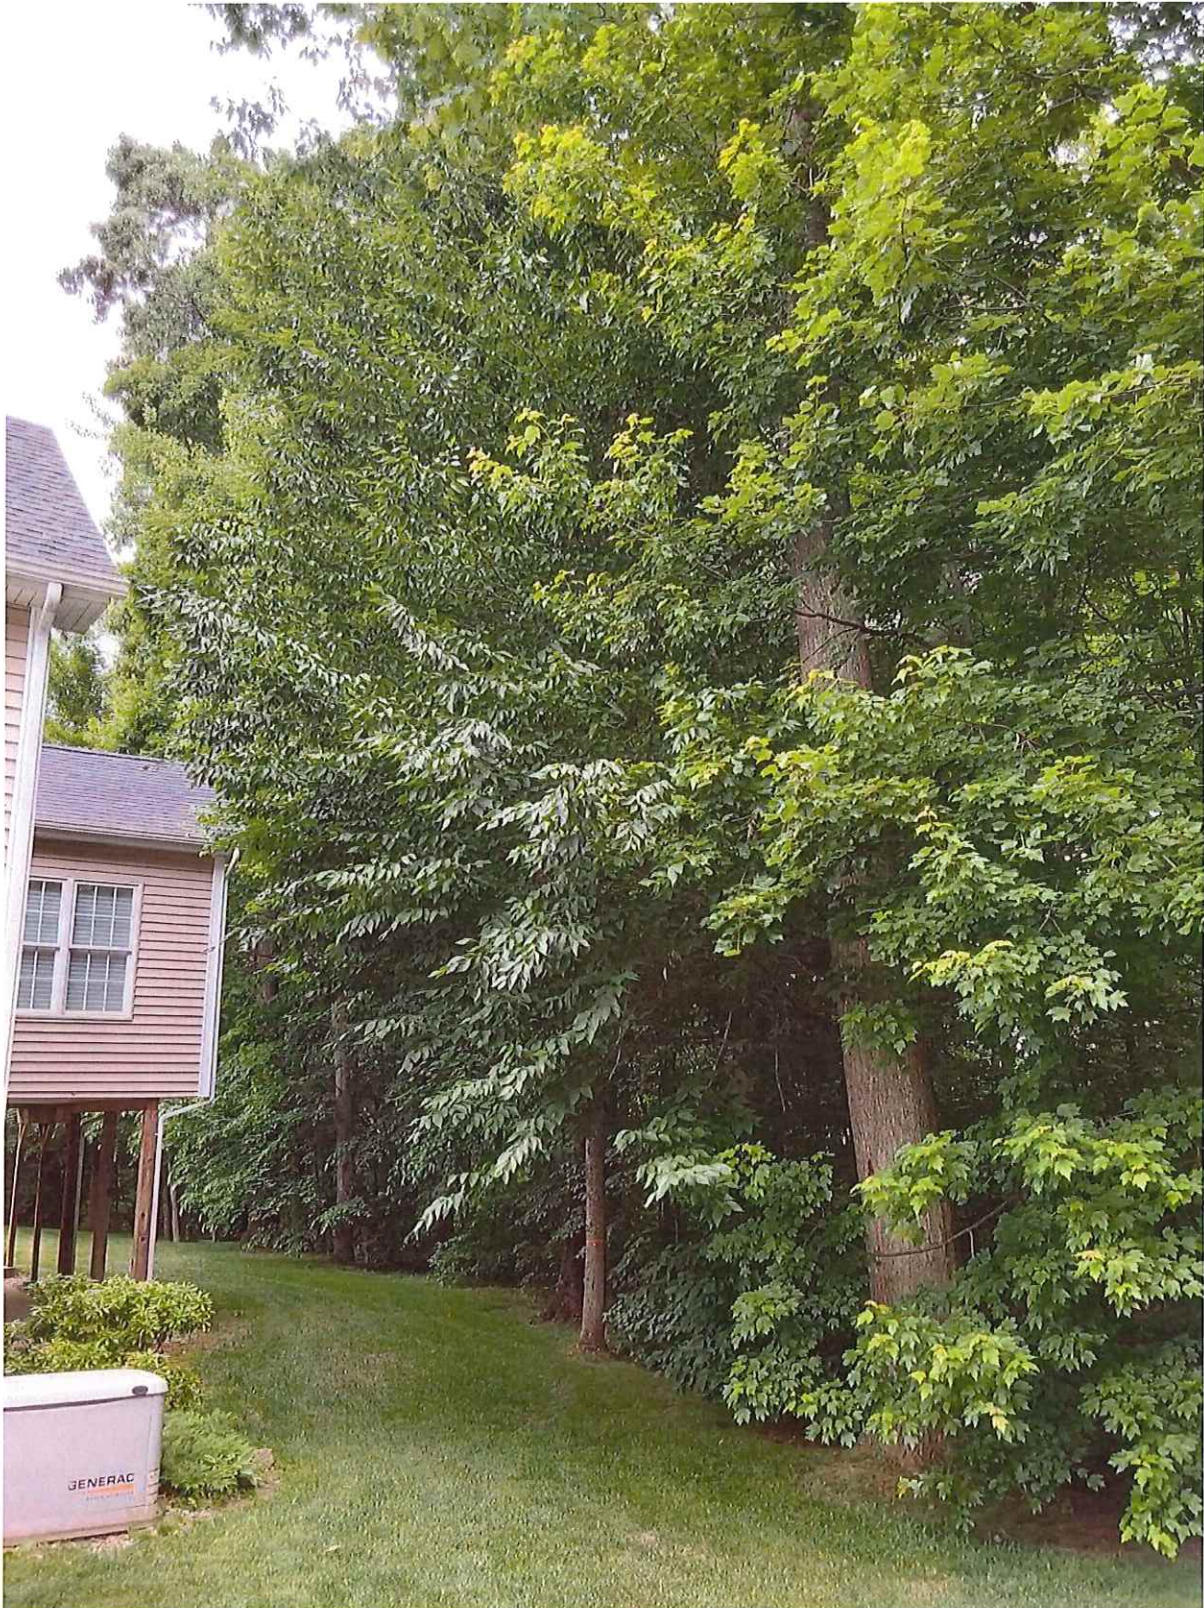
Photograph 2: Another area where reduction pruning is recommended. Note: Pruning of only limbs that are within 6 to 8 feet of structure should be considered. Over pruning will result in stimulated growth and possible structural imbalance.

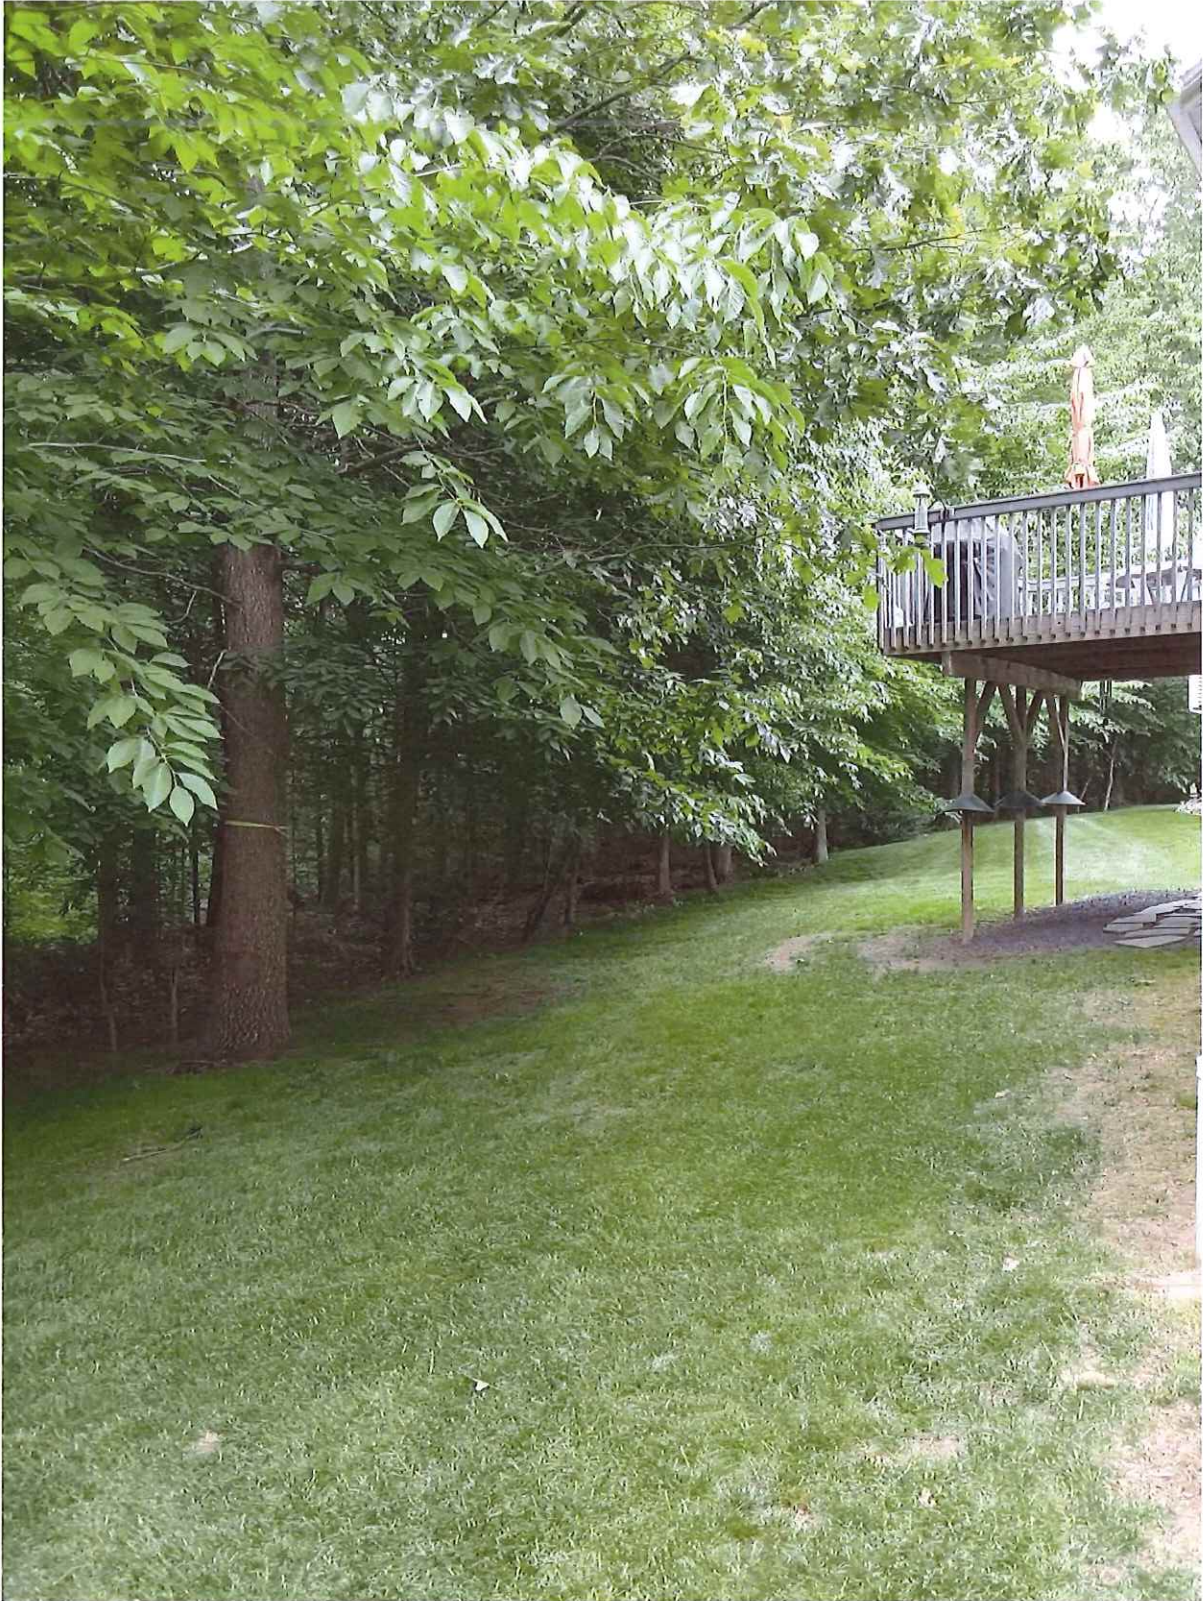
Photograph 3: As the slope or ground level decreases toward the wooded area, trees that were elevated to provide clearance for lawn area produce additional foliage toward the structure.

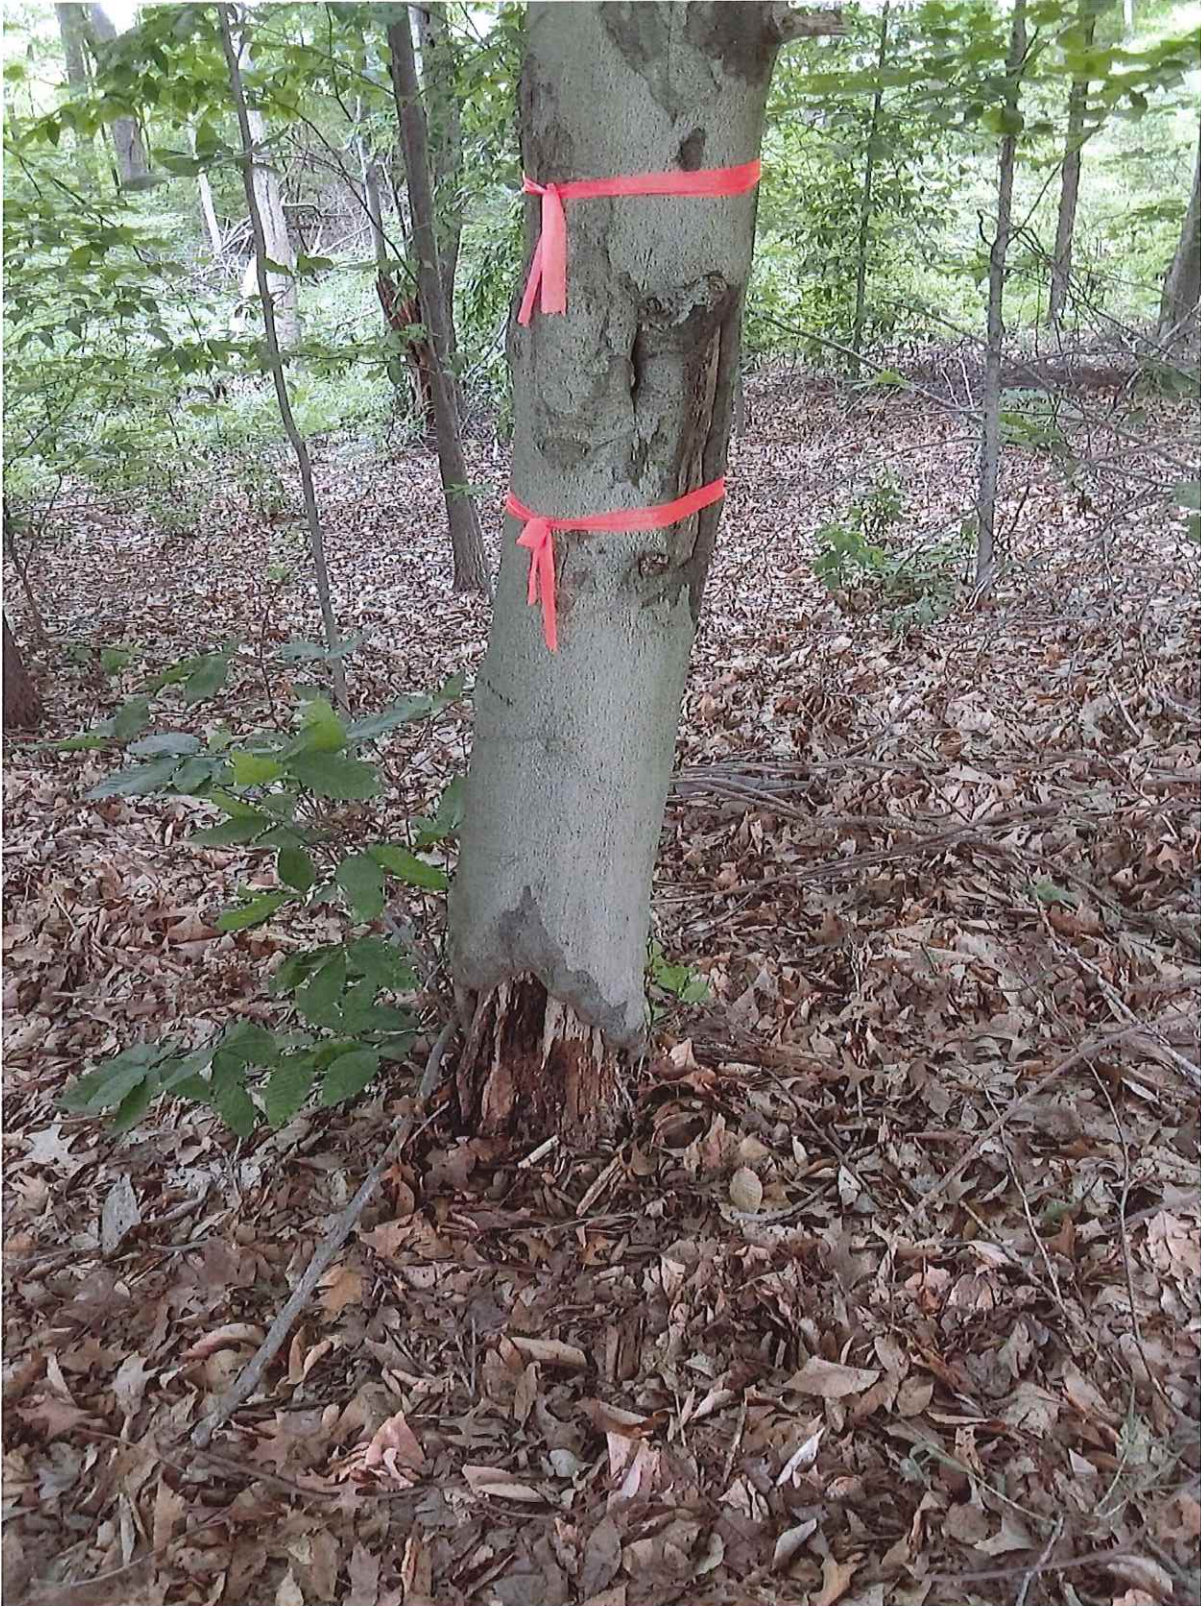
Photograph 4: Tree #5 with mechanical damage defect showing extensive decay at base. Failure is imminent. This tree is recommended for removal.

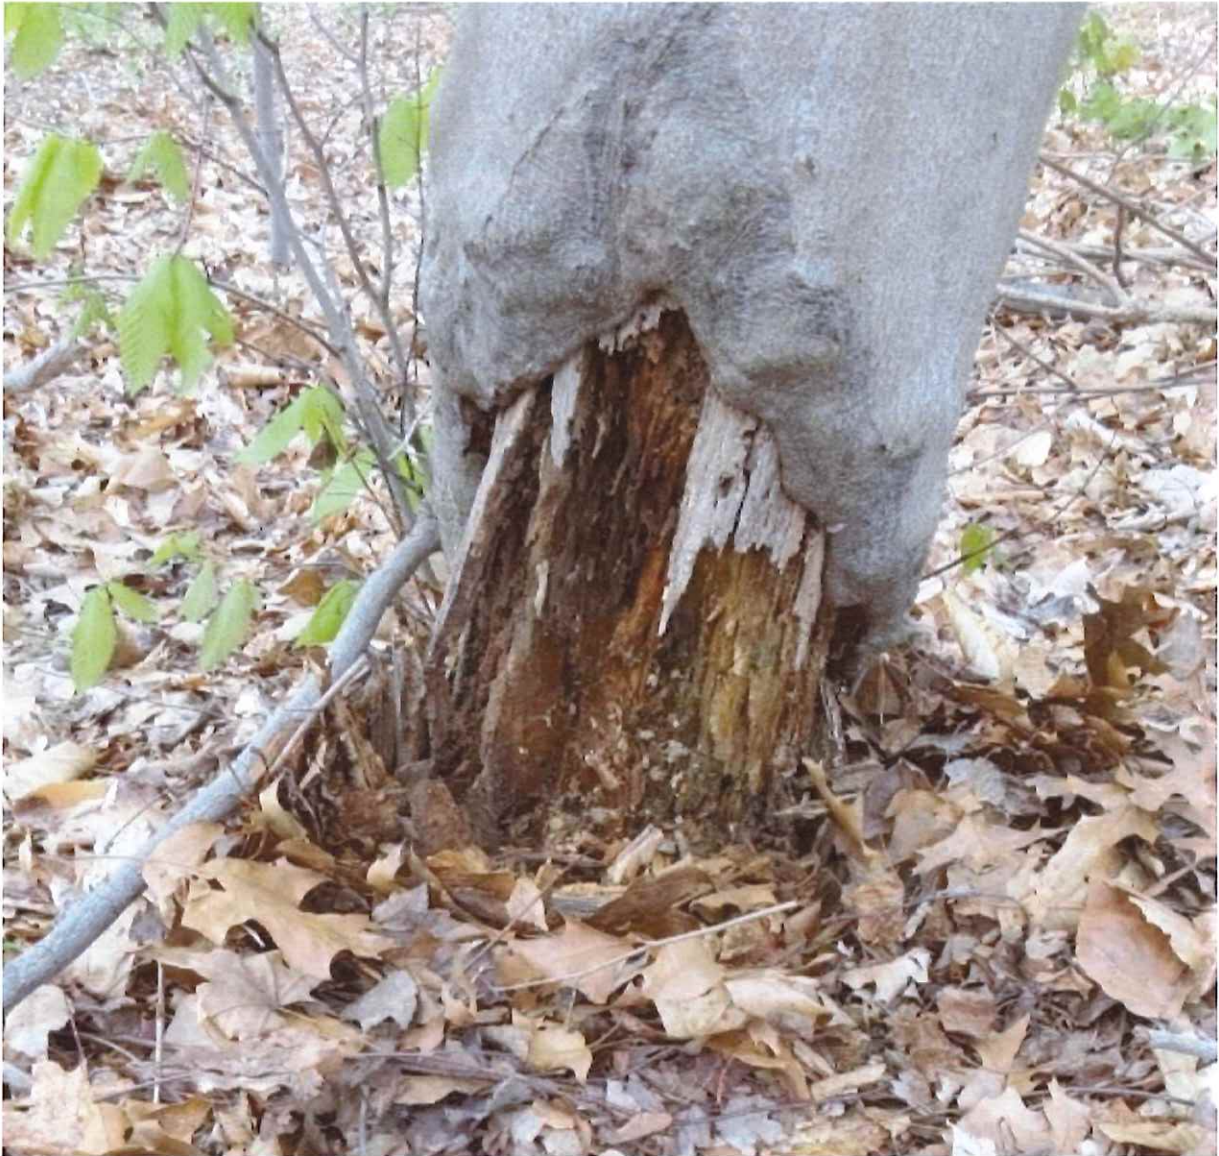
Photograph 5: Closer view of the root flare of Tree #5. The tree is attempting to compartmentalize the area. Failure is likely in the short term. Remove as soon as possible.

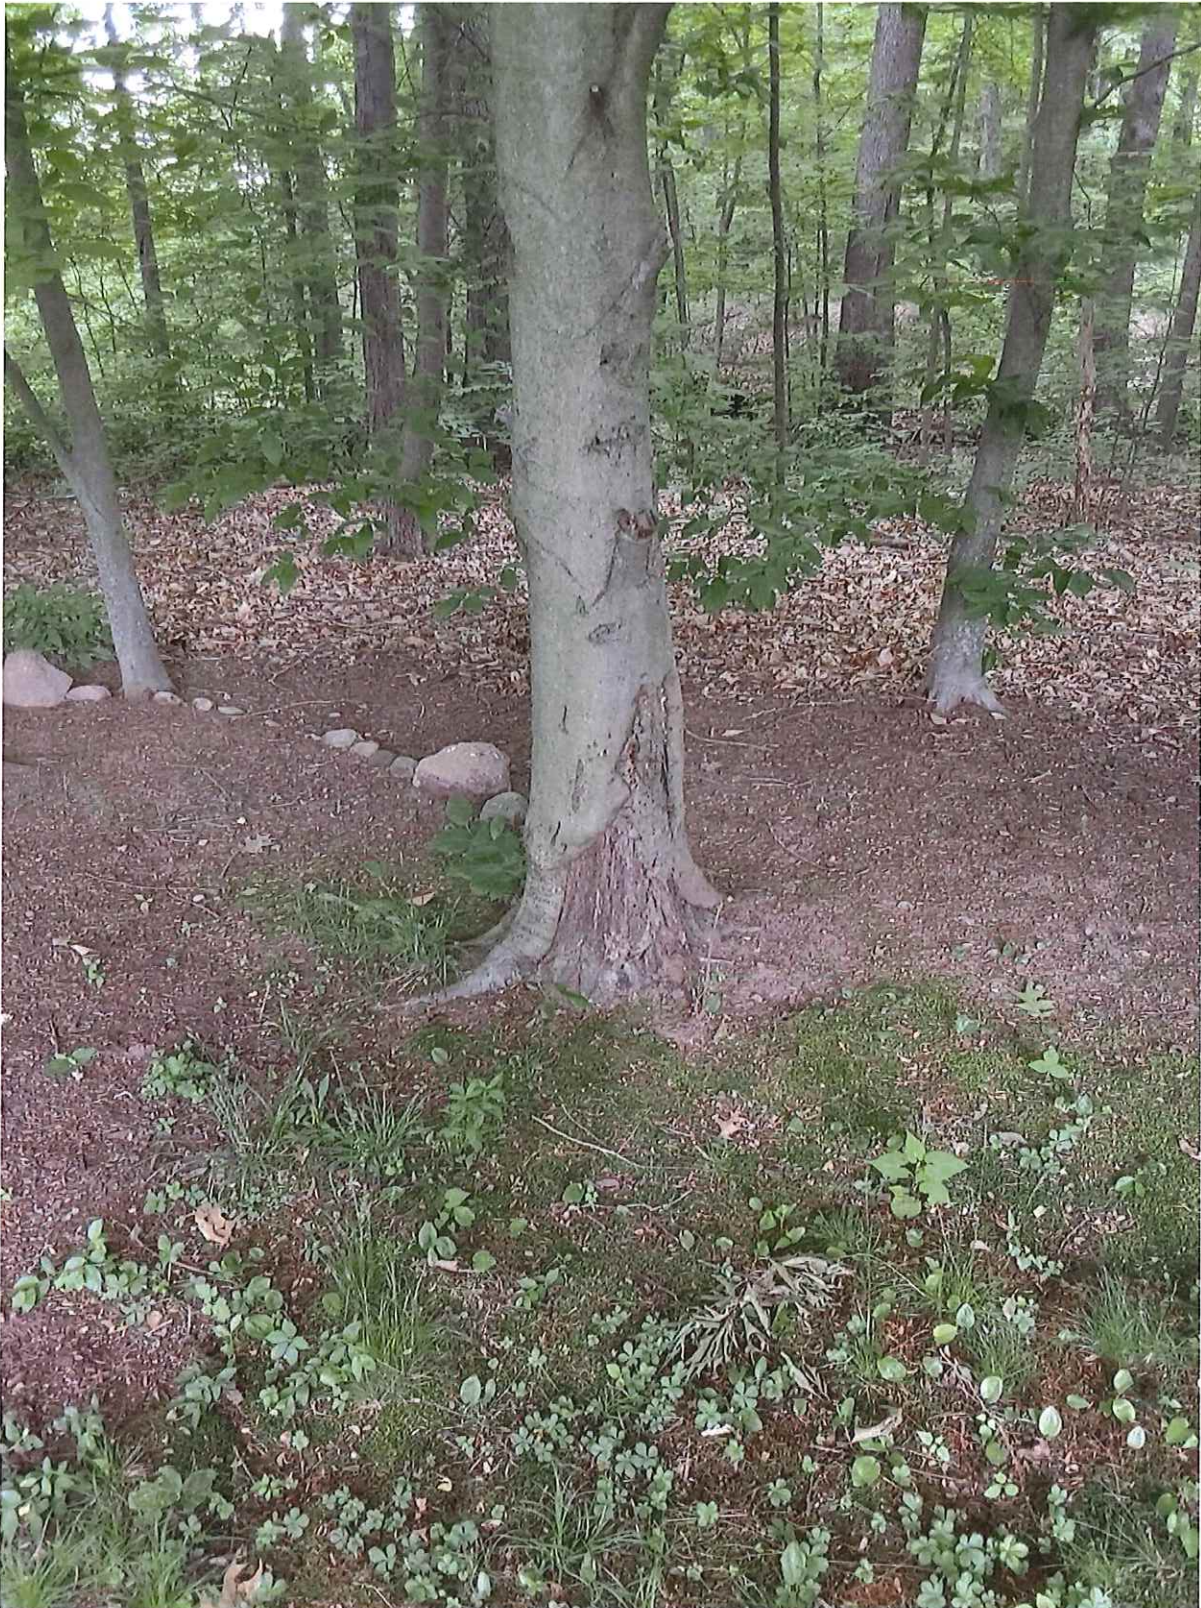
Photograph 6: Tree #4 showing mechanical damage to the root flare. This tree has a high likelihood of failure due to the defect and assigned a Moderate risk rating due to the distance from a target. Mitigation would include Monitoring and health care treatment. If Moderate risk is acceptable, retain and treat or perform removal to eliminate the risk.

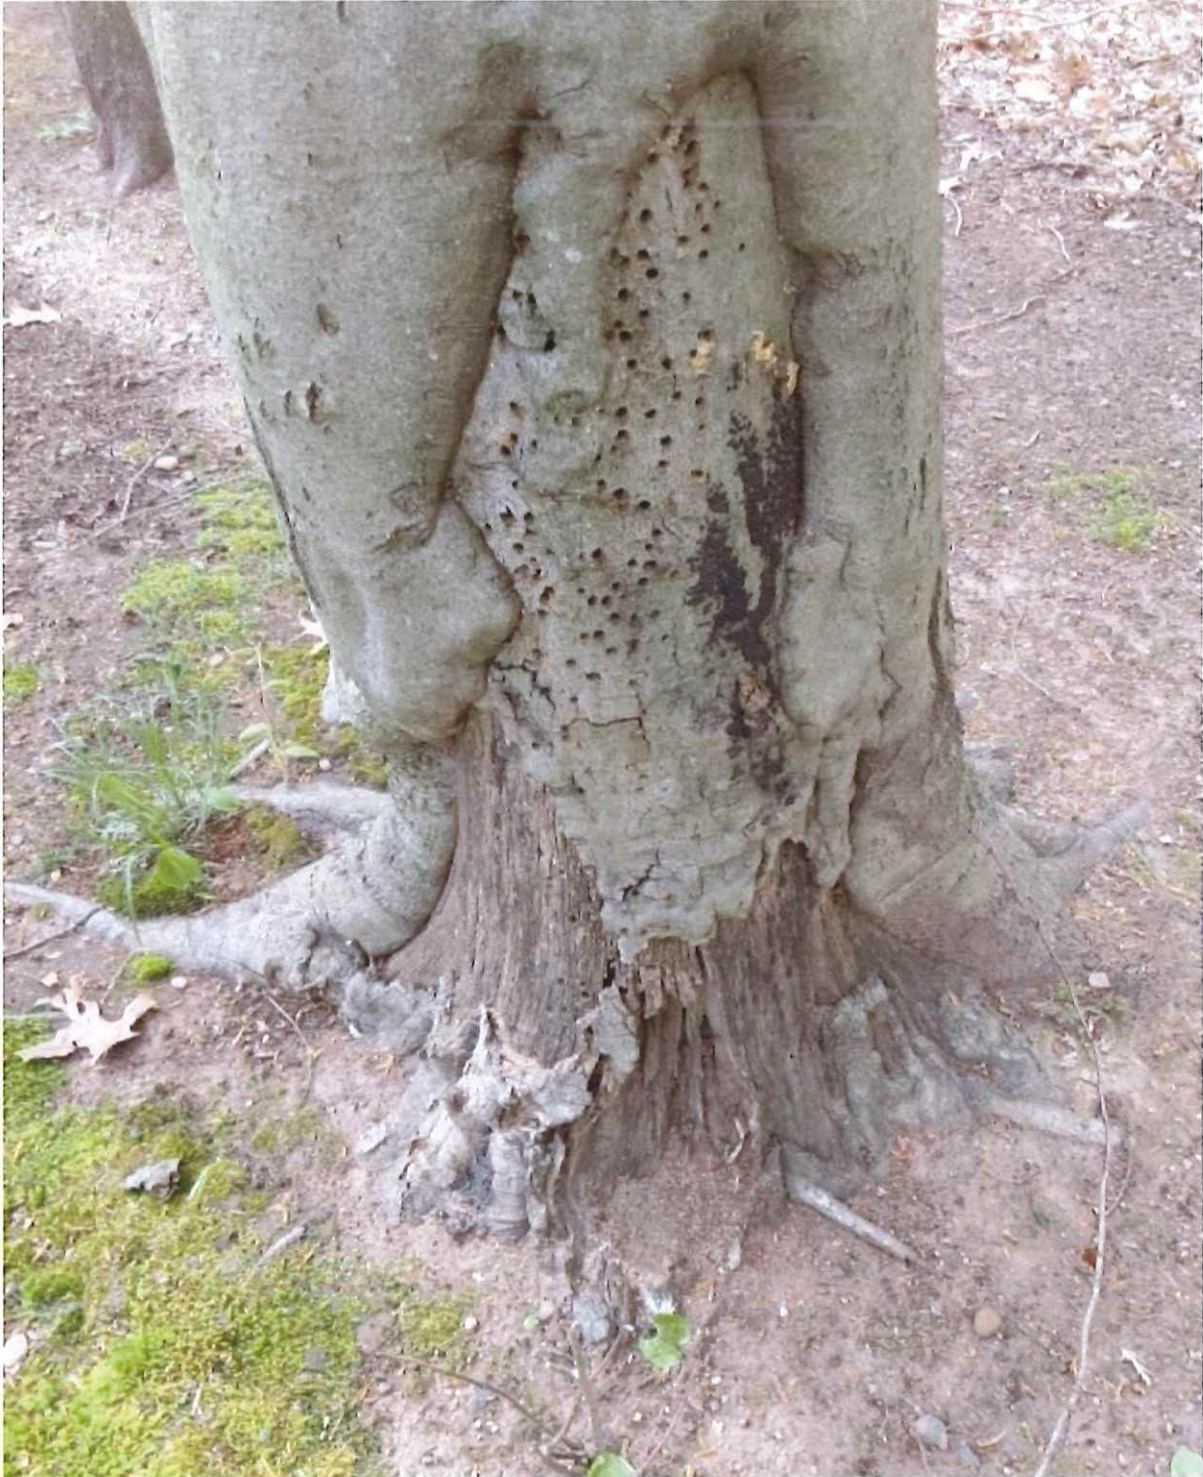
Photograph 7: Close up view of Tree #4 showing the trees effort to compartmentalize the weakened area with new tissue.

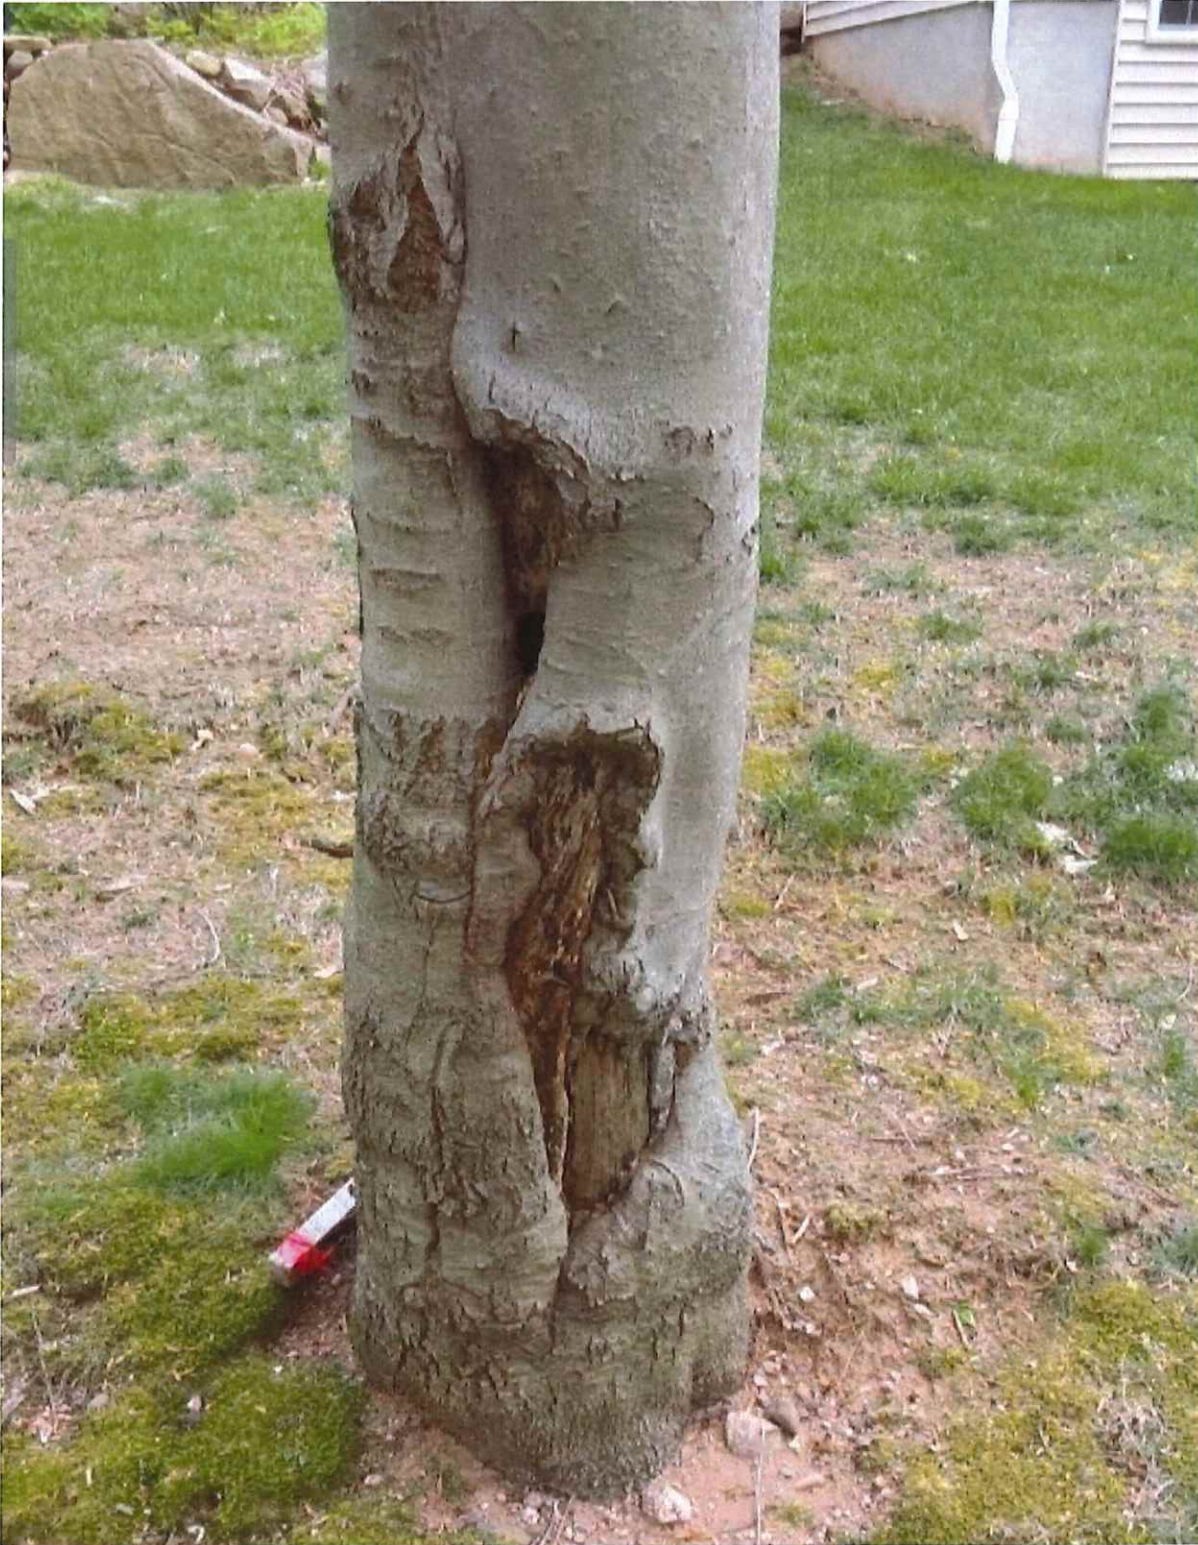
Photograph 8: Tree # 7 is showing a partially compartmentalized mechanical wound. Wound response in trees involves two processes, Compartmentalization and the formation of Barrier Zones.²

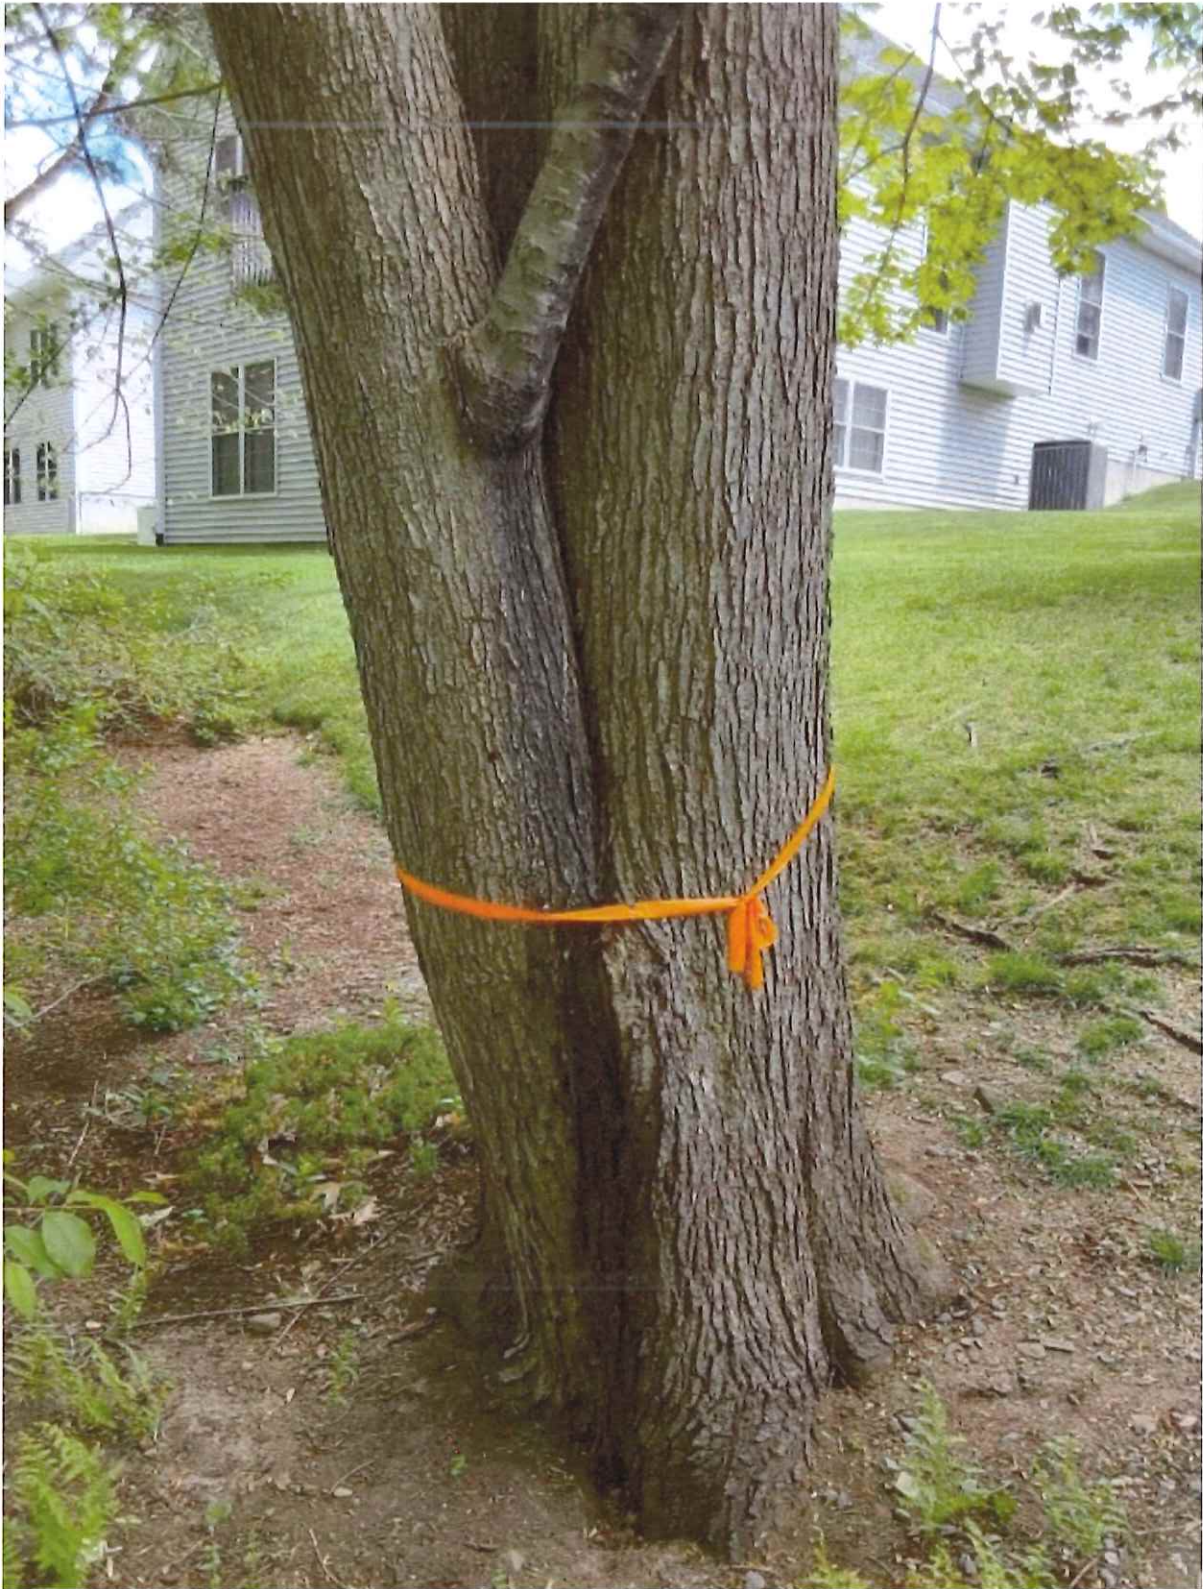
Photograph 9: Tree # 13, codominant stem with included bark and possible internal decay and considered a weak connection. Mitigation could include supplemental rod bracing, steel cable installation, monitoring or removal. Assigned High Risk rating.

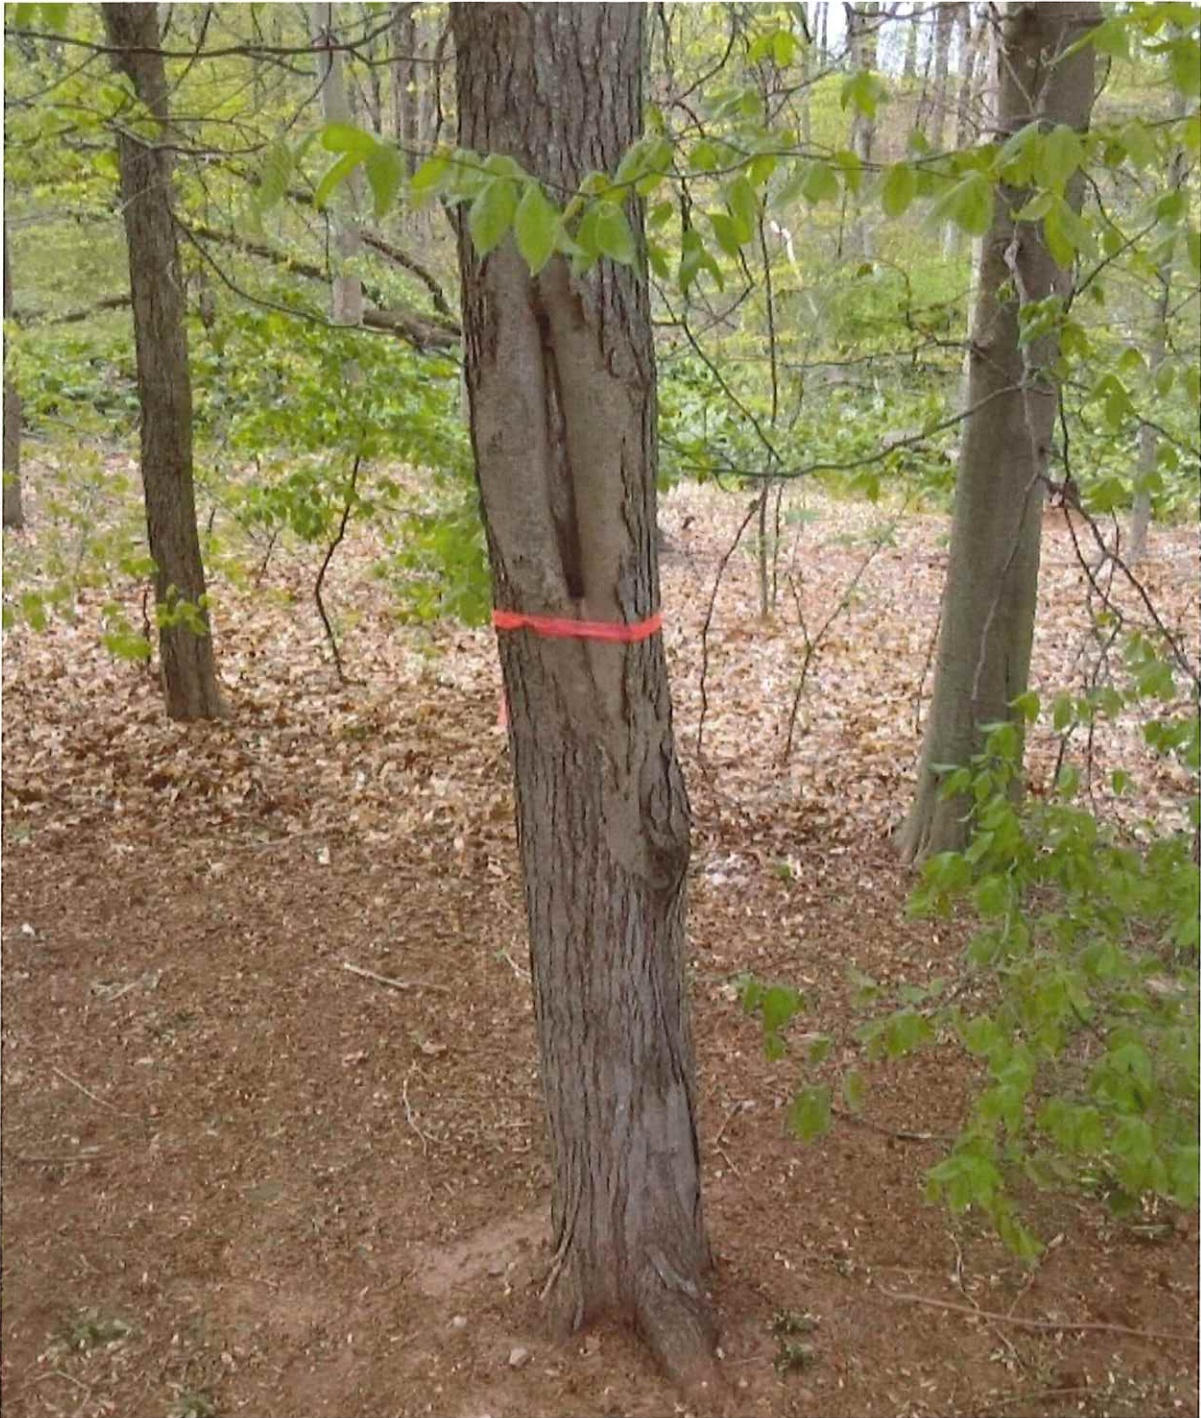
Photograph 10: Tree #10, partially sealed mechanical wound. This tree is healthy and assigned a Low risk rating.

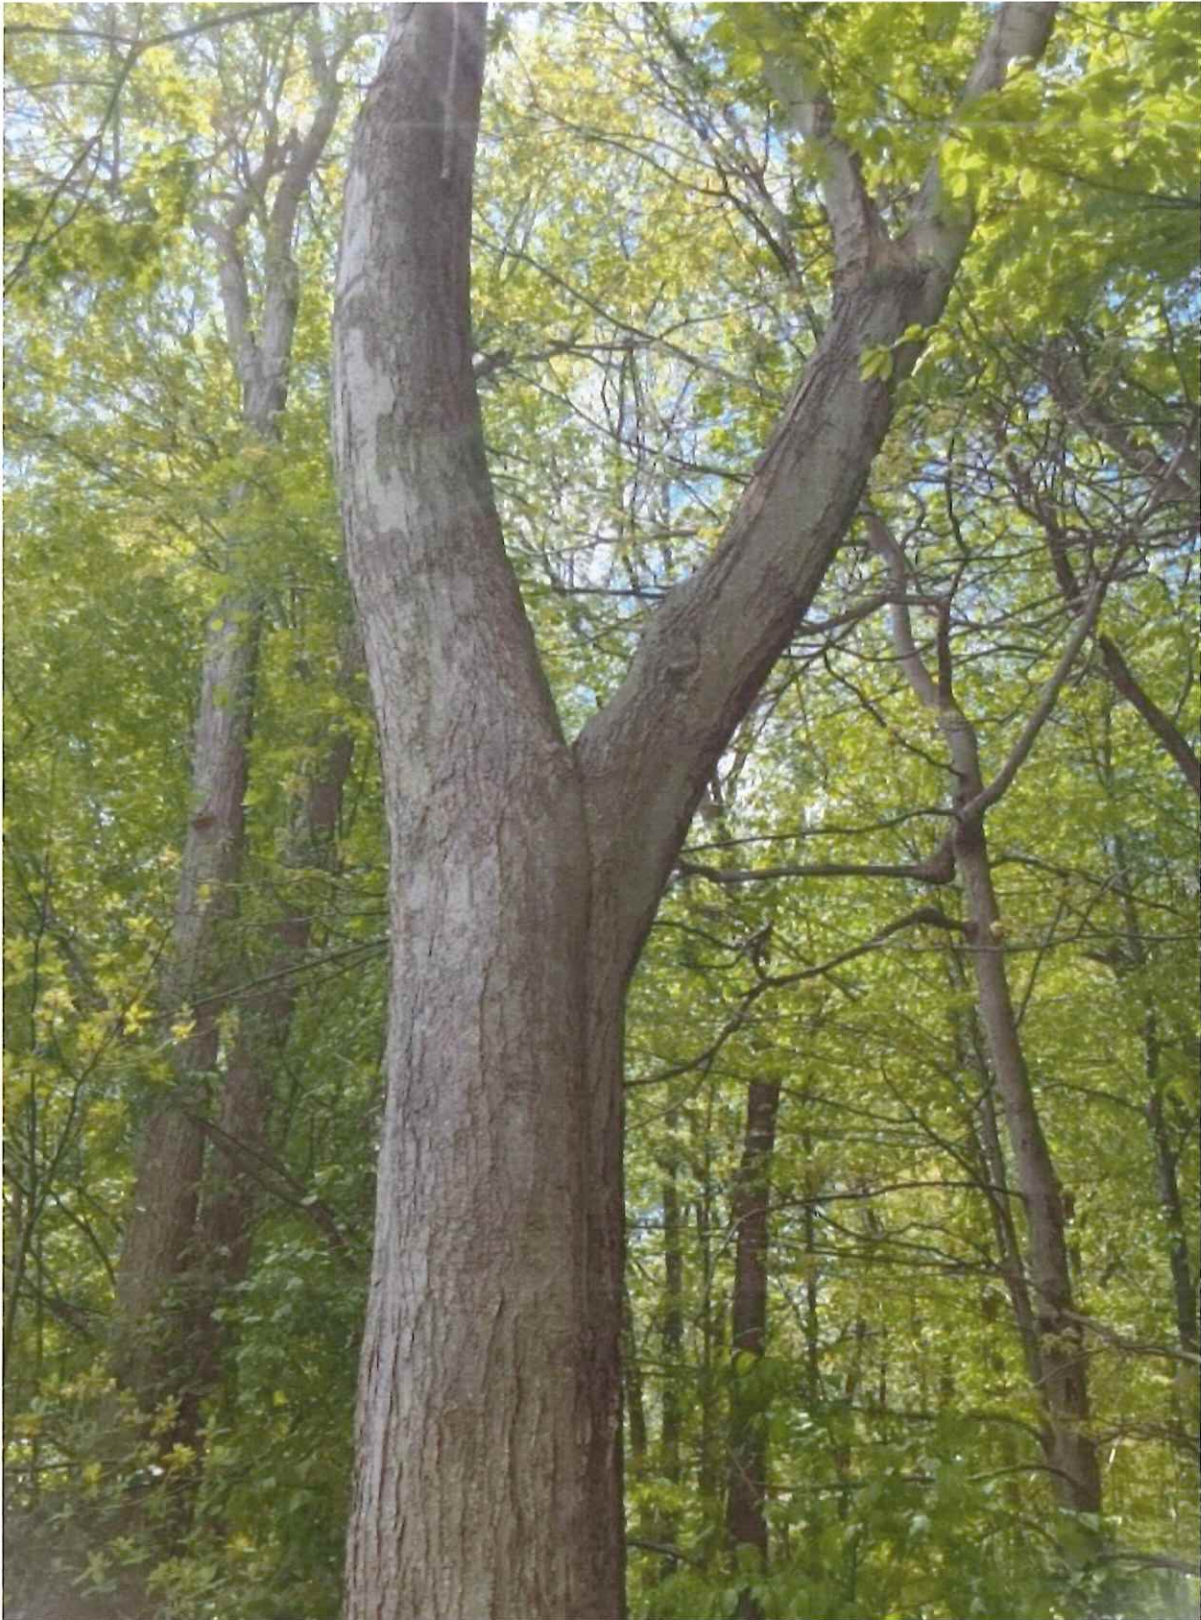
Photograph 11: Tree # 15, 25 inch diameter Red Maple, codominant crown with included bark. Mitigation can include supplemental cable installation, monitoring and health care.

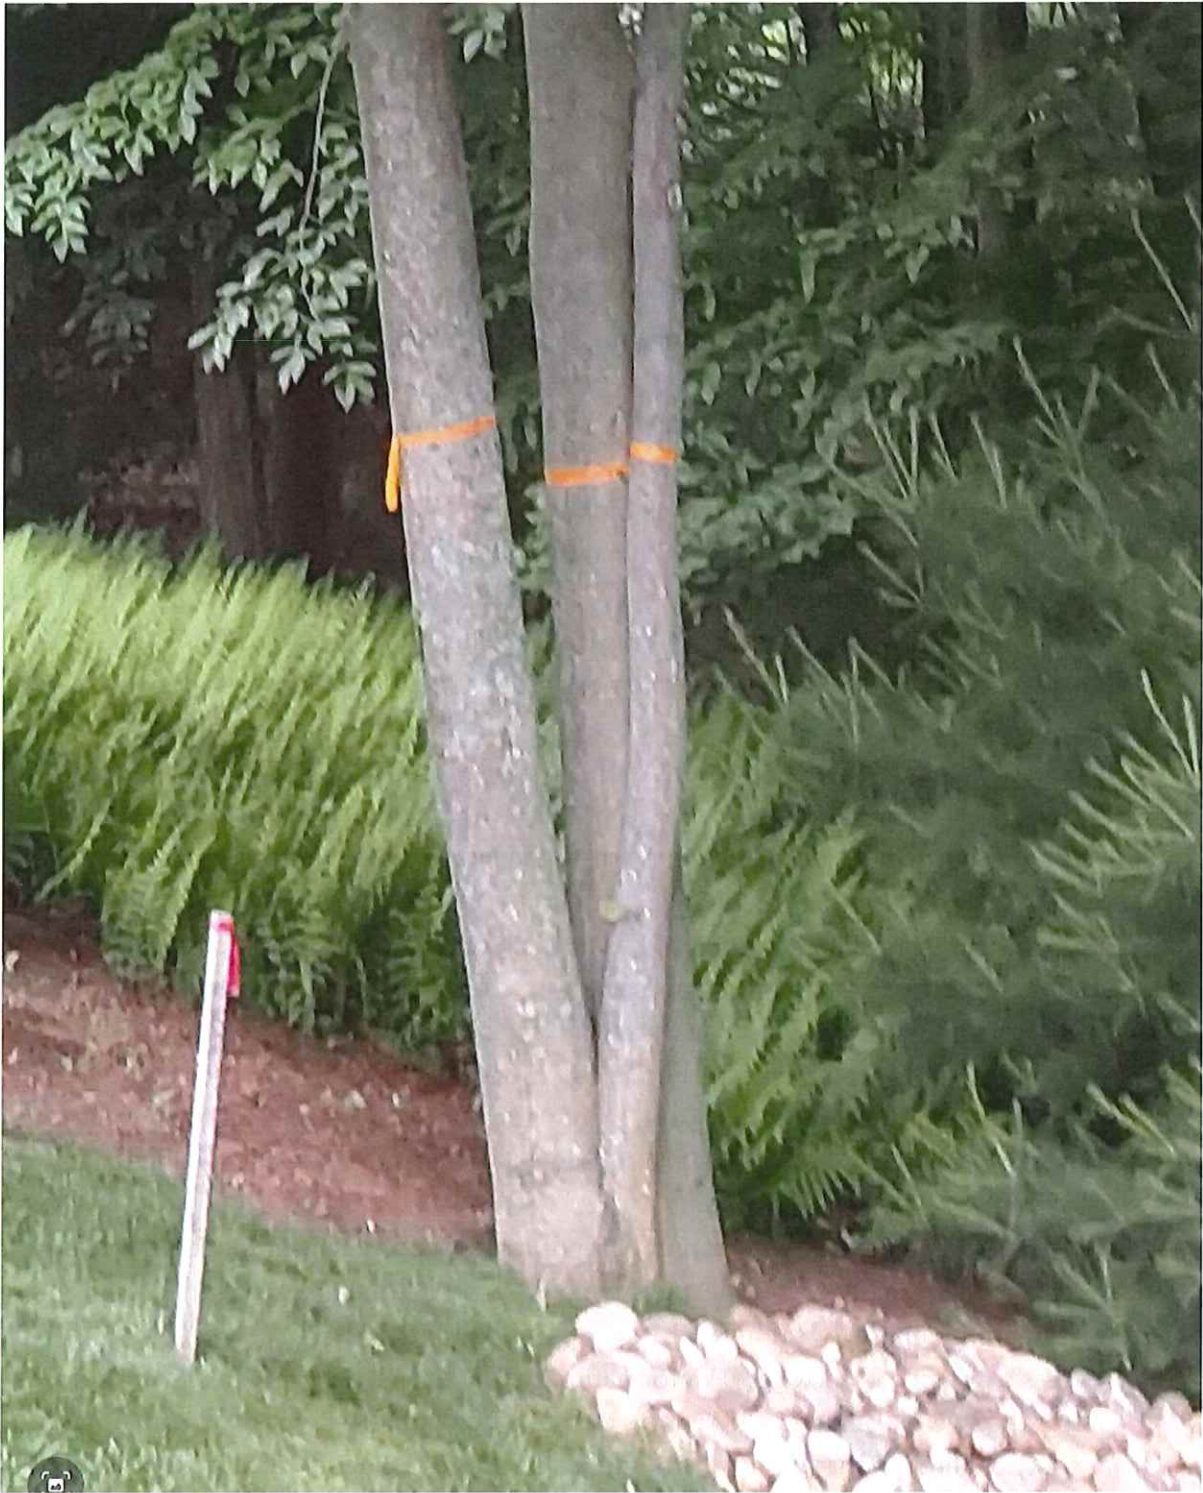
Photograph 12: Tree # 9, Multi-stem Beech. Mitigation could include supplemental steel cable, monitoring and plant health care.
