Attachment B

Pre-Demolition ACM and Lead Based Paint Survey
For 429 Marlborough Road
Prepared by Triton Environmental, LLC

June 30, 2009

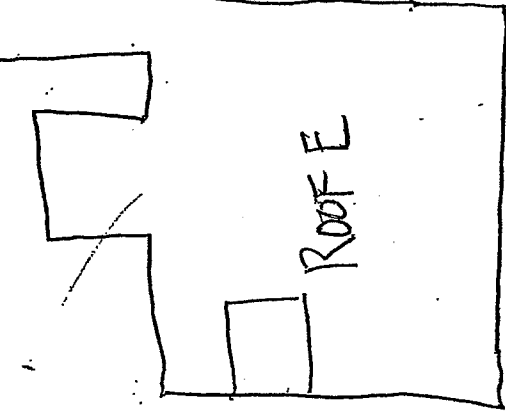
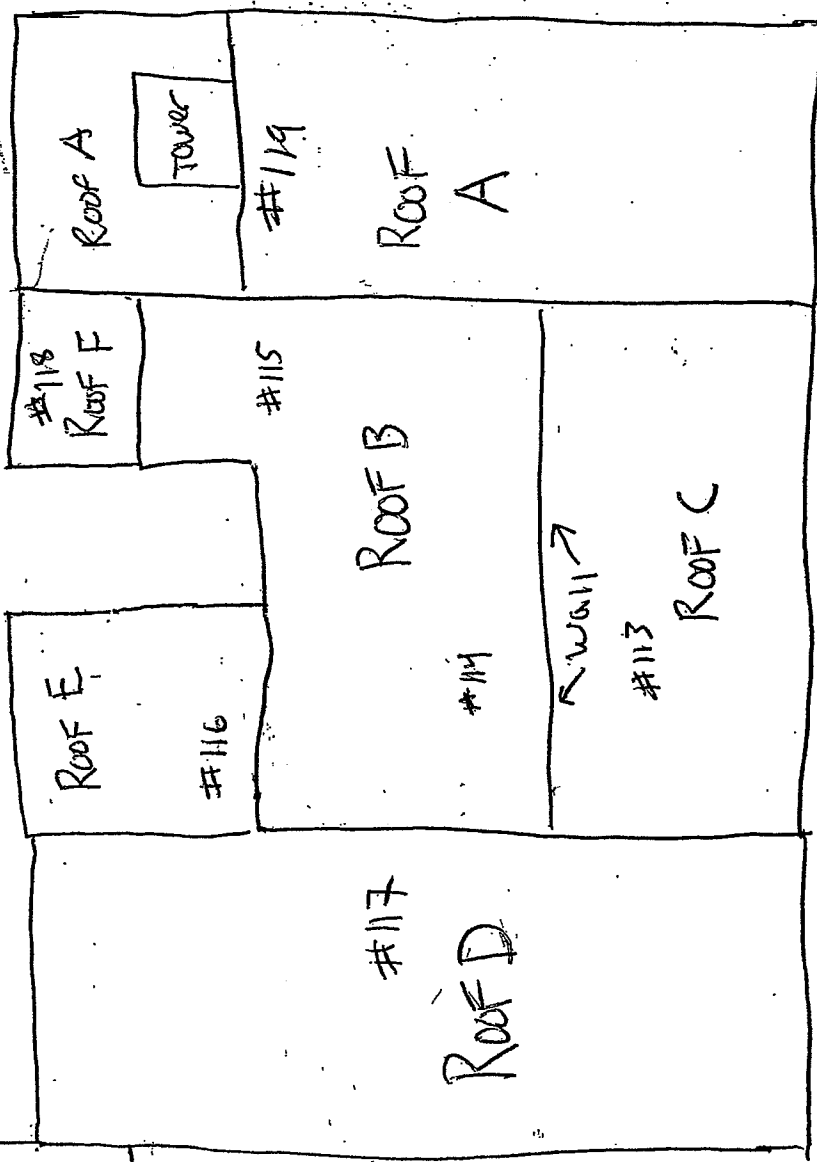
ROOF DIAGRAM

- ROOF F = 1500 FT²
- ROOF E = NO Field Samples Taken
- ROOF A = 10,000 FT²
- ROOF C = 1800 FT²
- ROOF B = 7000 FT²
- ROOF D = 6500 FT²
- ROOF E = 1800 FT²
