Pre-Demolition Asbestos Survey
For 68 Matson Hill Road
Prepared by Triton Environmental, LLC

PRE-DEMOLITION ASBESTOS SURVEY

**68 Matson Hill Road
Glastonbury, Connecticut**

**Subject: Pre-Demolition Asbestos Survey
68 Matson Hill Road – Glastonbury, Connecticut**

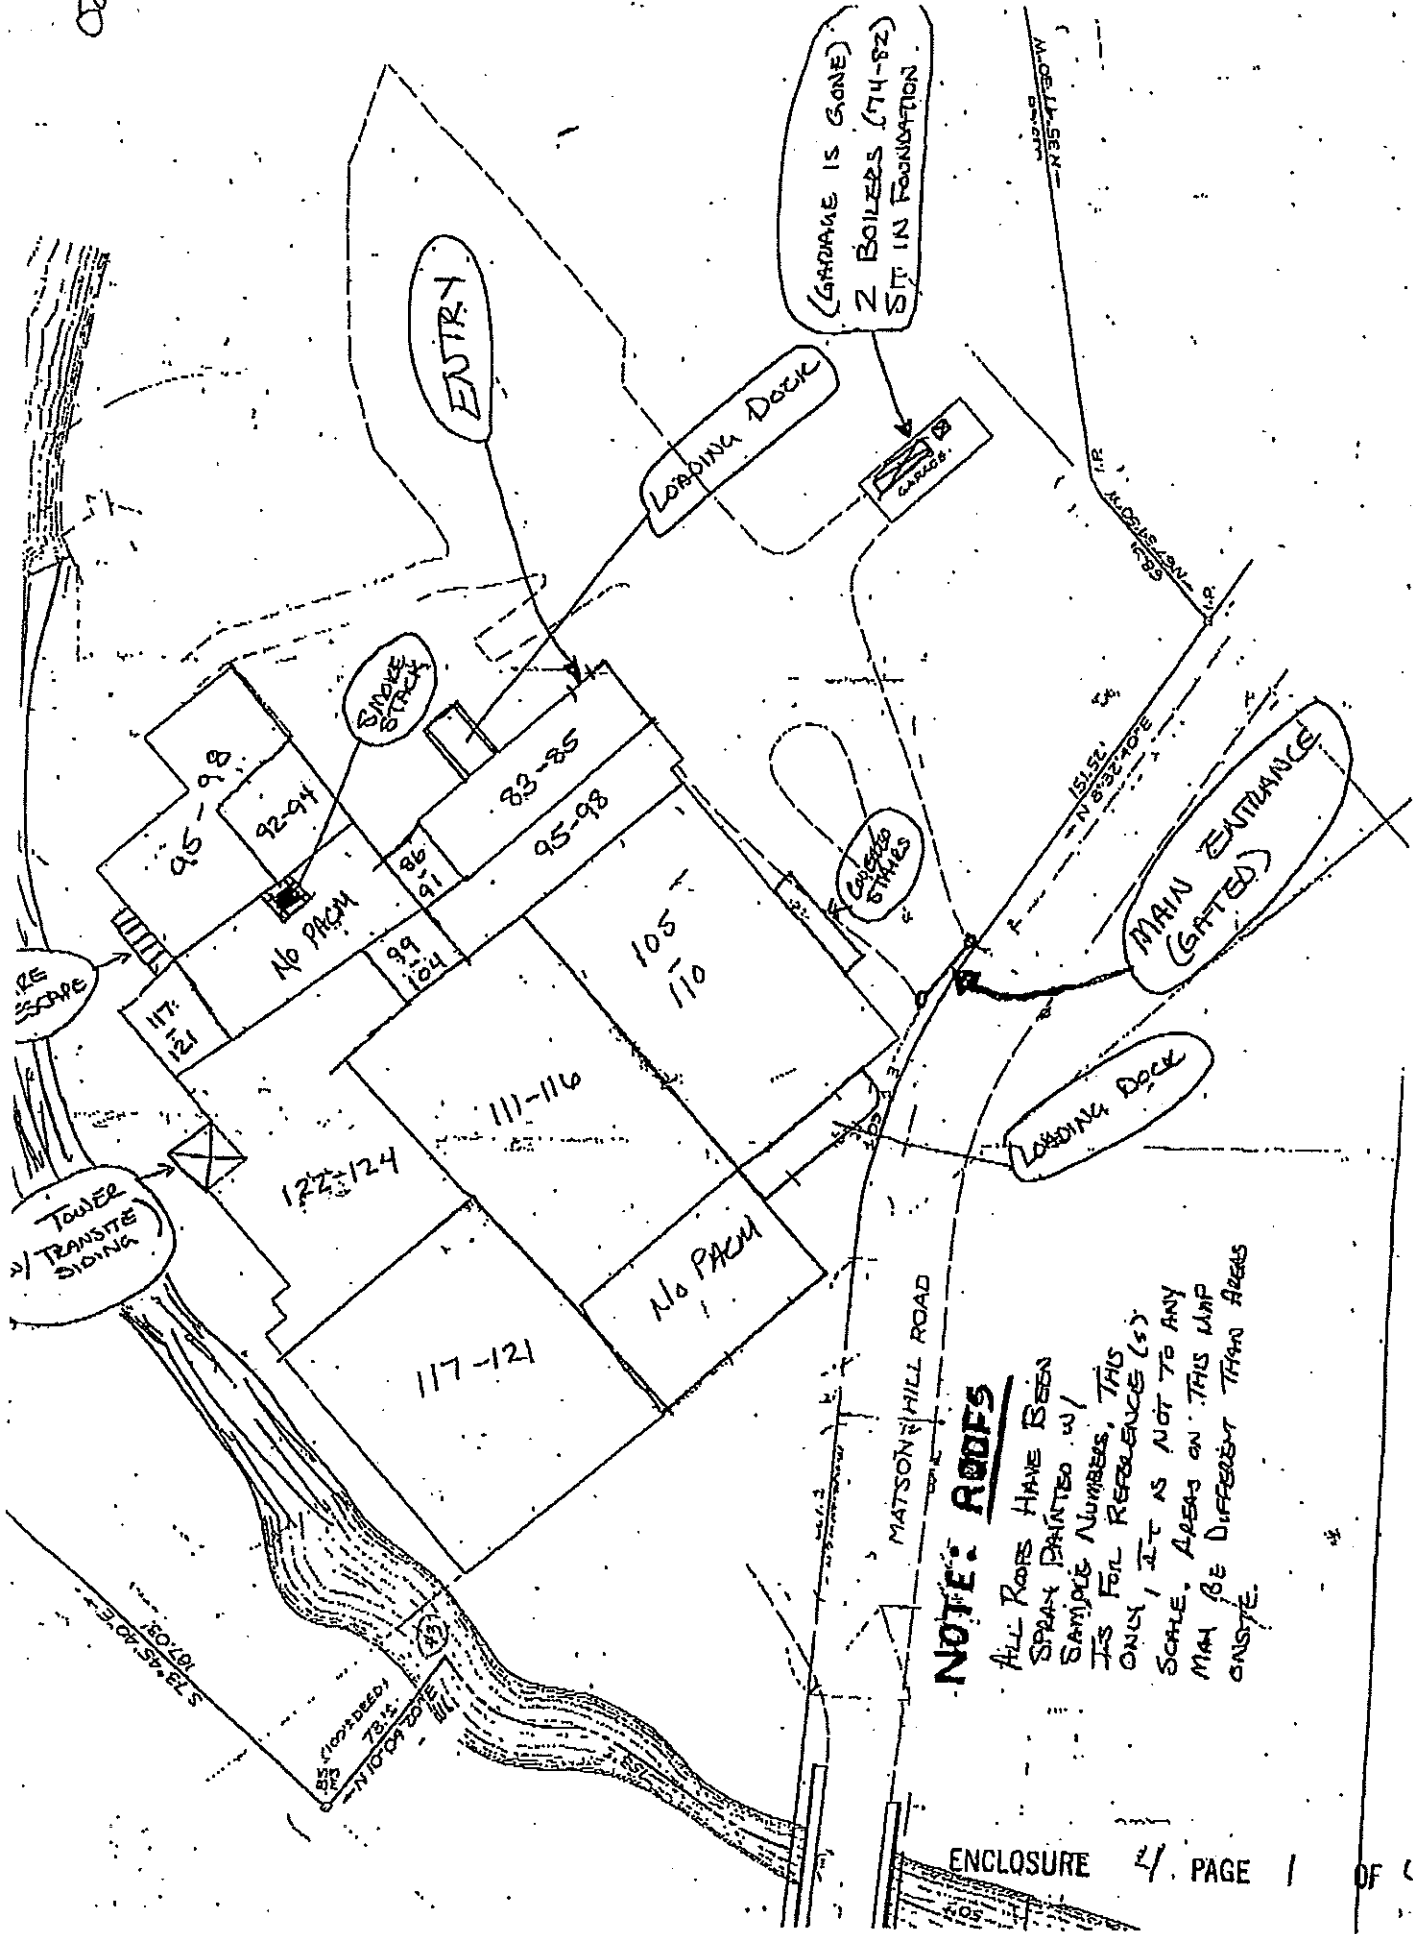
NOTE: ROOFS

ALL ROOFS HAVE BEEN
 SPRAY PAINTED w/
 SAMPLE NUMBERS. THIS
 IS FOR REFERENCE (s)
 ONLY, IT IS NOT TO ANY
 SCALE. AREAS ON THIS MAP
 MAY BE DIFFERENT THAN AREAS
 ON SITE.
