ADDENDUM NO. 1

**Contract Documents
for
REPLACEMENT OF BRIDGE NO. 04121
ADDISON ROAD OVER SALMON BROOK
GLASTONBURY, CONNECTICUT**

STRUCTURE NO. 04121

Routine Inspection
on
7/12/2011

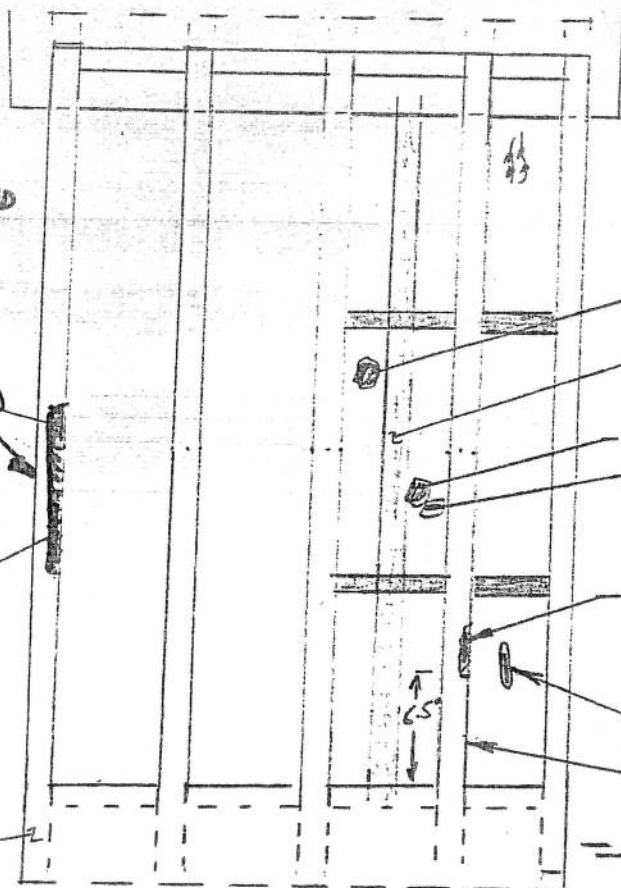
- ABUT. 2

LARGE SPALL W/ EXPOSED
REBAR
8' LONG x 4" WIDE x
UP TO 2" DEEP.

SPALL W/ EXPOSED
REBAR

POTENTIAL SPALL LIFE

SMALL SPALL W/ REBAR

SPALL W/ EXPOSED HEAVILY
RUSTY BOTTOM FLANGE
20" x 8" x 3"

SPALL W/ EXPOSED REBAR
12" x 3" x 1/2"

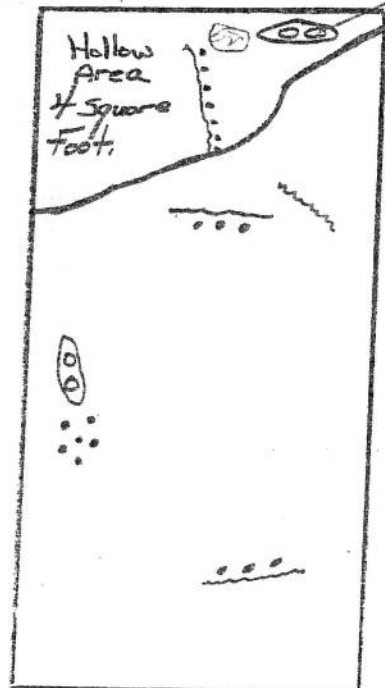
Abutment # 2

SEVERE SCALE TOTALING 1 FT².

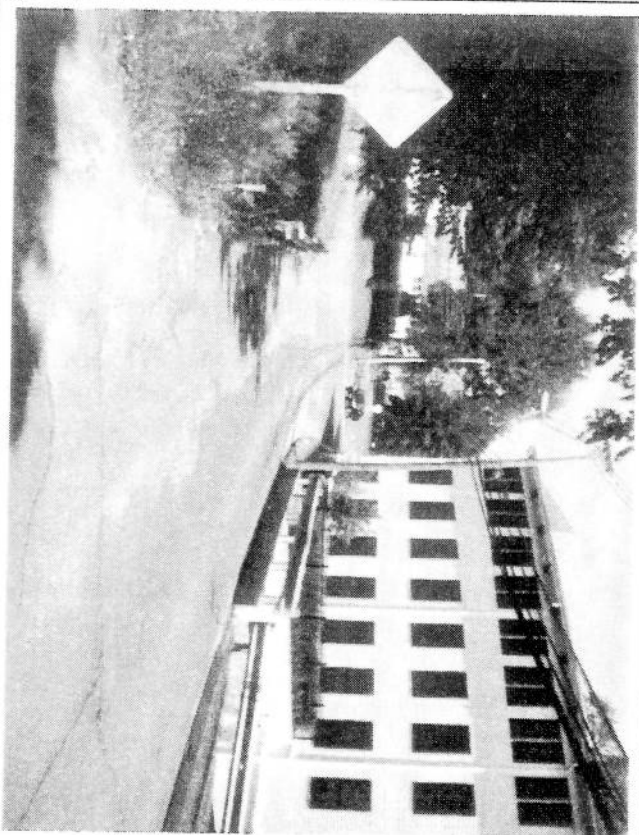
Photo # 1: SOUTH APPROACH.

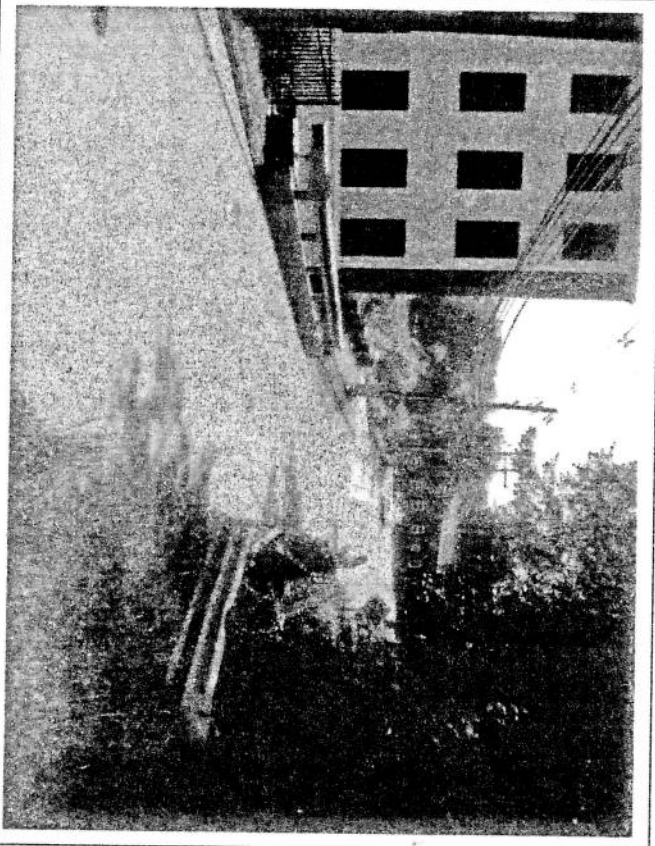
Photo # 2: NORTH APPROACH.

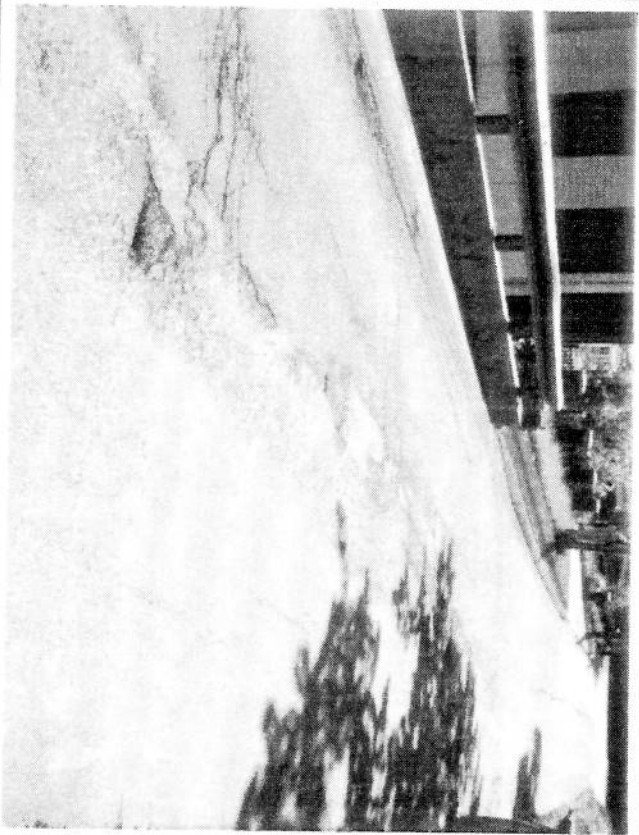
OVERLAY:	7	Bituminous concrete overlay : Several transverse, longitudinal & random slightly open cracks. Bit patches and areas of map cracks. Two gouged areas in the west shoulder.
DECK-STR. CONDITION:	6	Soffit : Several mortar patches. Random hairline cracks with efflorescence in bay # 3 at abutment 2. A small spall with exposed rebar in bays 3 and 4. Two 1 sf. potential spalls in bay 3. Fascias : Horizontal & random hairline cracks with efflorescence. Efflorescence along the cold joint of the rail bases also. The total deterioration of the soffit is less than 1 %. See attached BRI-10.
CURBS:	N	Curb reveal : East - 20" West - 17"
MEDIAN:	N	-
SIDEWALKS:	N	-
PARAPET:	7	Concrete :

Photo # 3: WEARING SURFACE.

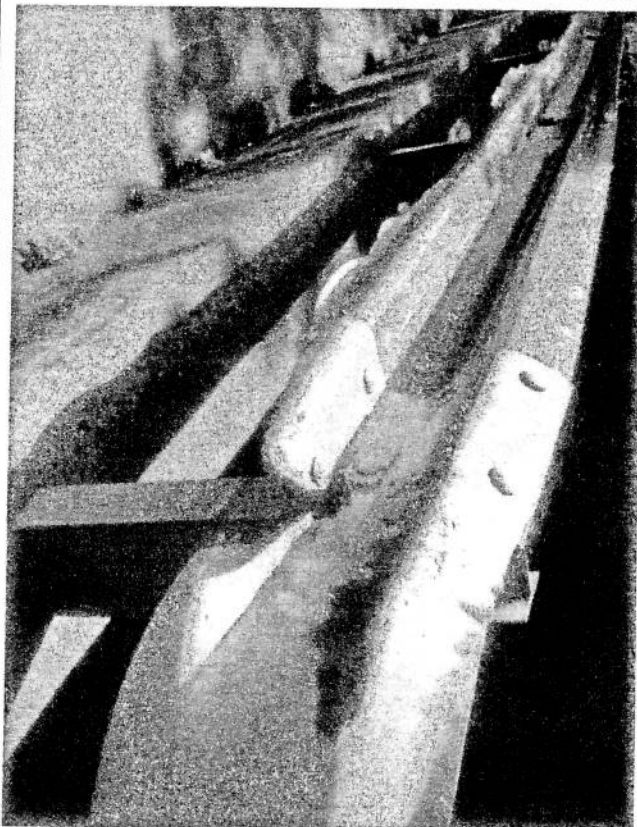
Photo # 4: NORTHWEST BRIDGE RAIL WITH A TORN END SECTION CREATING A POTENTIAL SNAGGING HAZARD.

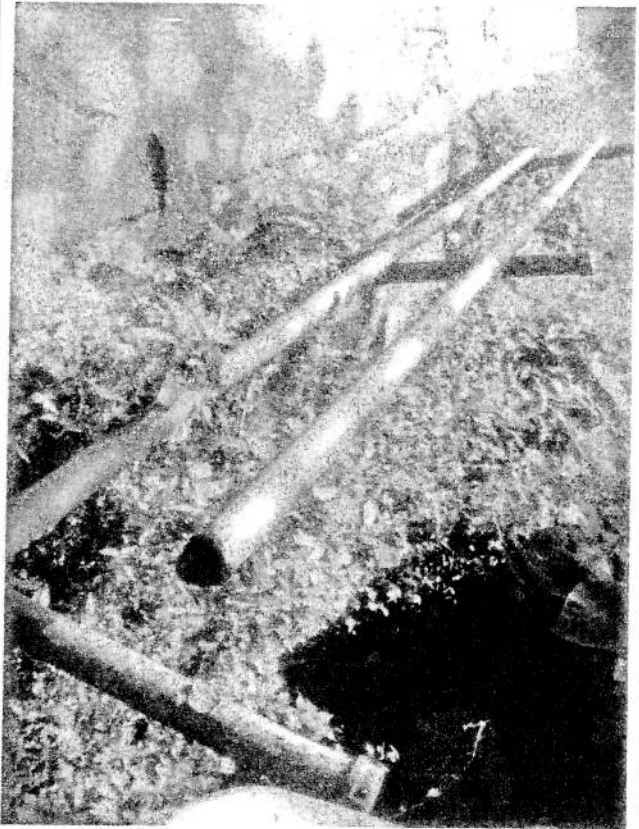
APPROACH SLAB:	N	-
RELIEF JOINTS:	N	-
APPROACH GUIDE RAIL:	2	Flex beam rail with steel posts at southeast & northwest. No rail at the northeast. The northwest shows collision damage. Two pipe rail with pipe posts at southwest , top pipe disconnected at north

end (See photo # 5). The base of pipe post # 2 is rusted through. Some pipes are also bent. This rail offers no protection to the traveling public.
APPROACH PAVEMENT:	7	Numerous transverse & longitudinal cracks, open to 1".
APPROACH EMBANKMENT:	7	Small bituminous patches in both approaches. Minor erosion of southwest bank.

Photo # 5: LOOSE, RUSTED AND BROKEN PIPE RAIL AND POSTS AT THE SOUTH WEST APPROACH OFFERS NO PROTECTION.

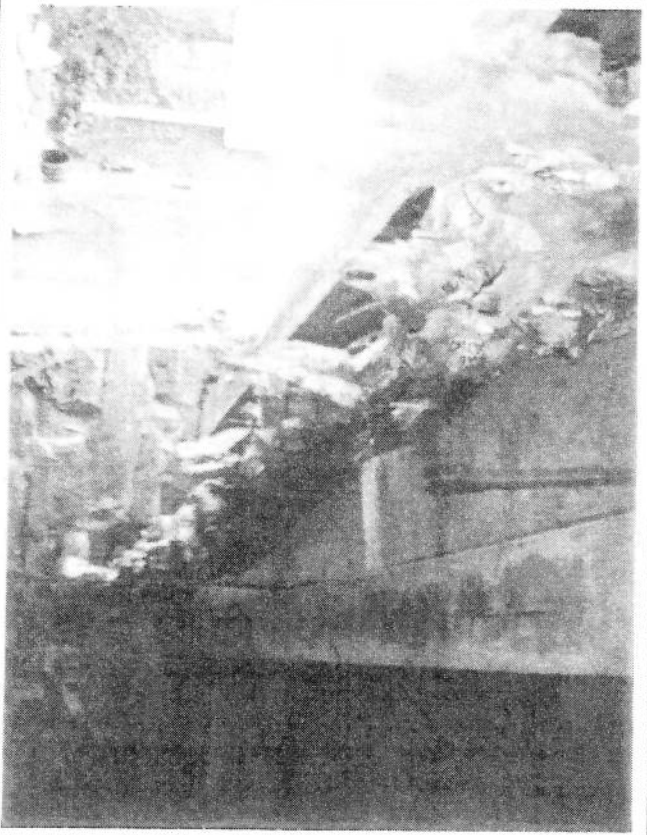
<p>Both parapets exhibit horizontal hairline cracks in the outside fascias, some with light efflorescence.</p> <p>Scrapes & gouges along inside faces.</p> <p>East - Vertical & transverse hairline cracks at the rail posts and efflorescence along the outside face of the cold joint.</p> <p>Southwest & northwest ends have minor chips.</p>
RAILING:	7	<p>Flex beam rail on steel posts :</p> <p>East side : Minor collision damage at north end.</p> <p>West side : moderate collision damage causing a torn section and potential snagging hazard.</p>
PAINT:	N	-
FENCE:	N	-
DRAINS:	N	-
LIGHTING STANDARD:	N	-
UTILITIES TYPE/SIZE:	3	<p>12" Water Main In Bay # 3 - Shows the following :</p> <p>All the wood supports are missing. The vertical metal supports are heavily rusted & unattached.</p> <p>The insulation is ripped, loose and detached, some is missing & hanging (See photo # 6).</p> <p>The 30 ft. L. pipe is supported only at the abutments.</p>

Photo # 6: 12 IN. WATER MAIN IN BAY 3 WITH WOODEN SUPPORT BRACKETS MISSING AND PIPE INSULATION DETACHED. THE ONLY SUPPORT FOR THE 30 FT. L. PIPE IS AT THE ABUTMENTS.

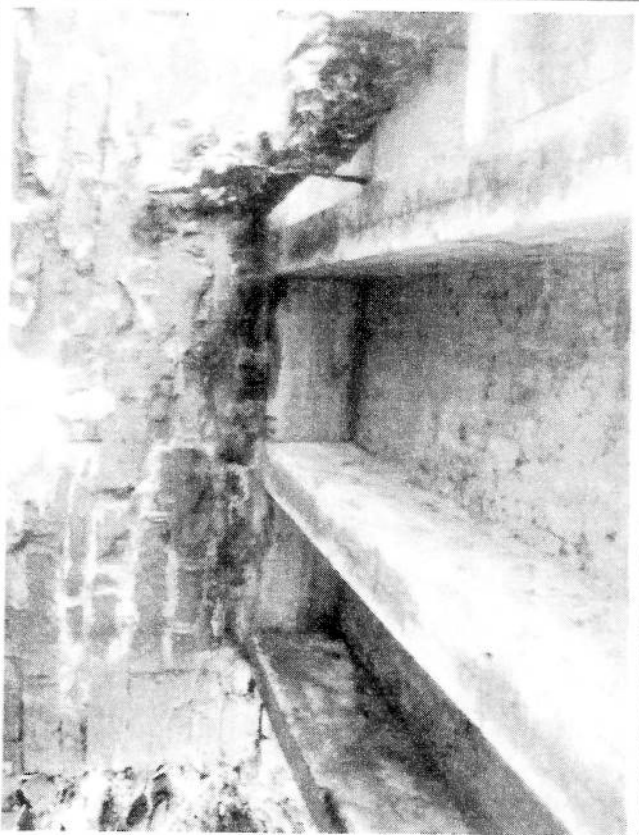
ABUTMENTS-STEM:	7	<p>Abutment # 1 (Masonry) :</p> <p>Minor mortar joint cracks with efflorescence & small stone voids & cracks, mainly along the waterline.</p> <p>Abutment # 2 (Concrete) : Large areas of light scale on the stem.</p> <p>A hollow area, 80" x 30", in bay # 3.</p> <p>West face - A 4 sf. hollow area, hairline cracks with efflorescence and severe scale totaling 1 sf.</p>
ABUTMENTS-BACKWALL:	7	Concrete.
ABUTMENTS-FOOTINGS:	6	<p>Abutment # 2 - Footing exposed full length x up to 36 in. deep.</p> <p>The upstream end appears to have a pocket undermined. See the attached Channel sheet.</p> <p>See Erosion / Scour also.</p> <p>The exposed portion of the footing shows severe scale with exposed rebar, up to 4" deep for full length along beveled top.</p>
ABUTMENTS-SETTLEMENT:	6	Old evidence of movement on the northwest wing. No new evidence found this inspection.
ABUTMENTS-WINGWALLS:	6	<p>Concrete and Masonry type wings :</p> <p>Concrete : Exhibits areas of light scale.</p> <p>Northwest (dry rubble) : Signs of previous movement.</p>

<p>Photo # 7: UNDERSIDE AND ABUTMENT 1.</p>

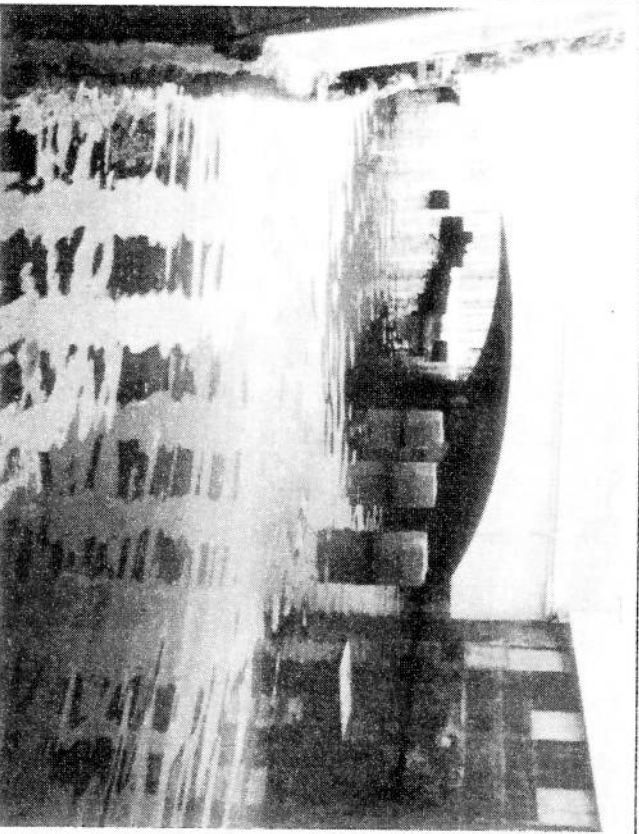
<p>Photo # 8: UPSTREAM VIEW.</p>
--	--
