STAFF REPORT

**APPLICATION: AGENDA ITEMS I.1 and II.1
MAY 30, 2024 MEETING**

**Re: IWWA Application and CC Recommendation: 769 Hebron Ave
Streambank stabilization**

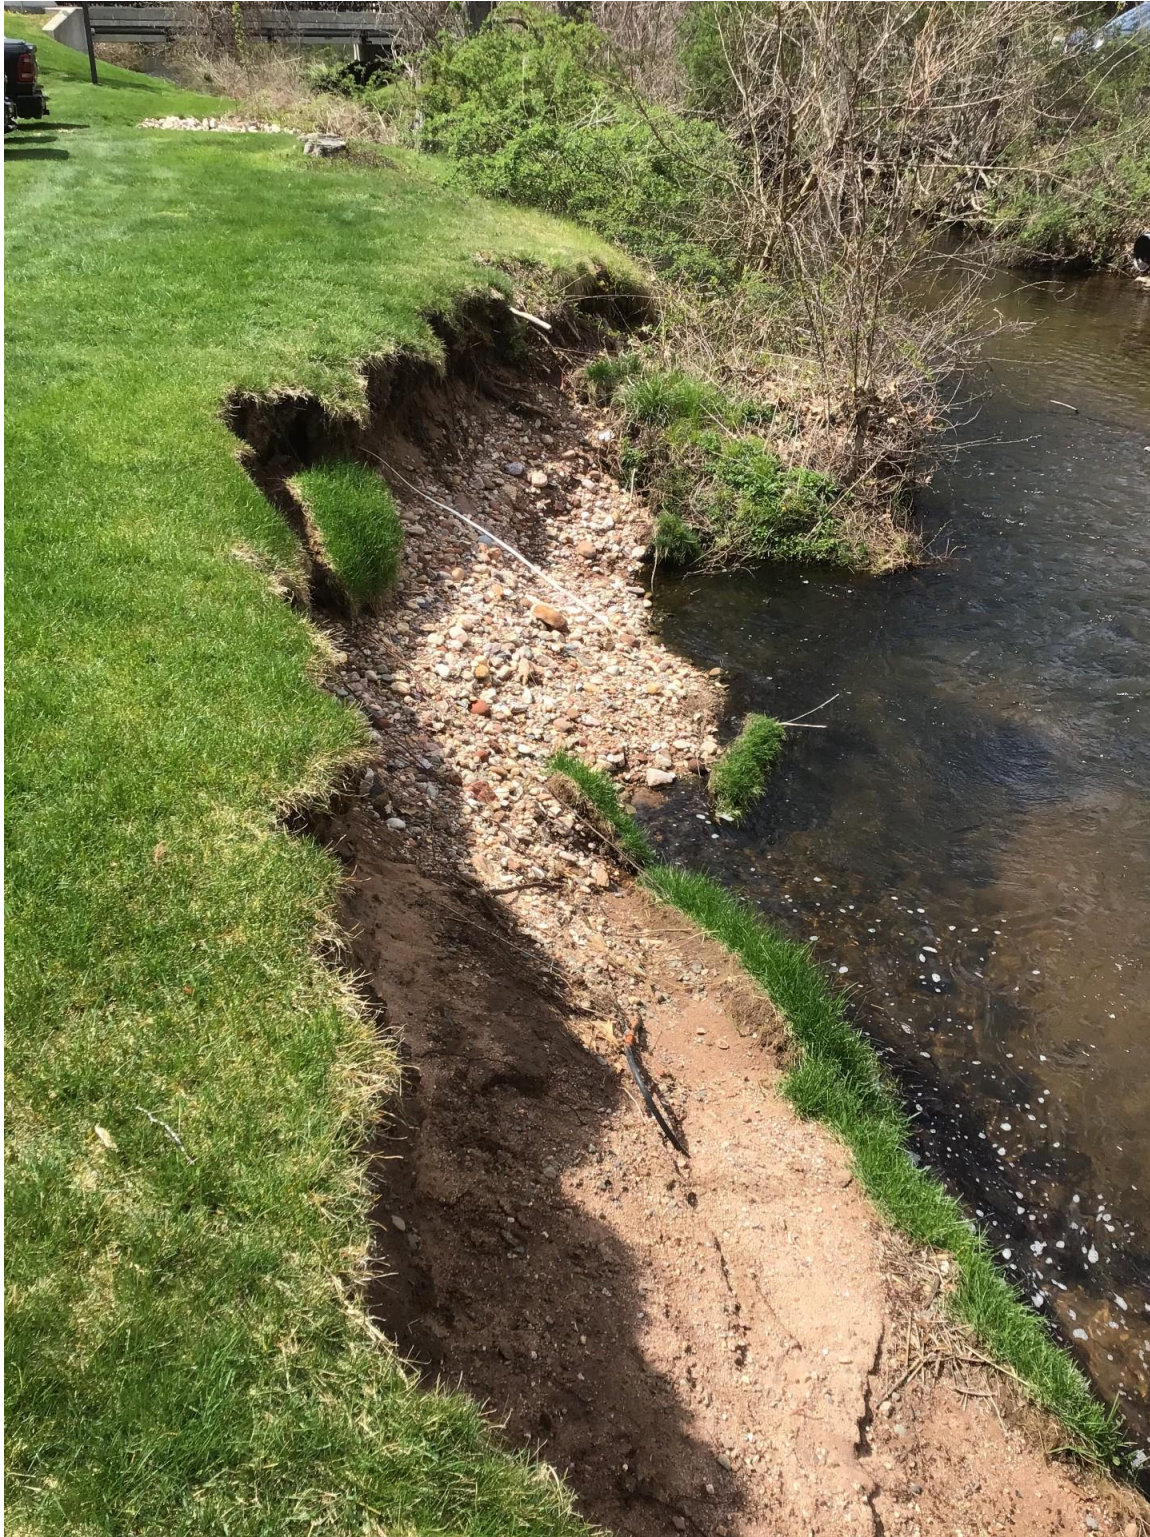
The property is approximately 1.72 acres within the Planned Employment Zone. The property is not encumbered by a conservation easement. The plan locates Salmon Brook on the north side of the property, flowing from east to west. The erosion is affecting the south bank of the brook. The eroded streambank/lawn area has exposed tubing, presumably to siphon water from the brook to water the lawn.

Photo 1: Looking west, lawn and stone eroding into the south bank of the brook. Irrigation tubing in the foreground.

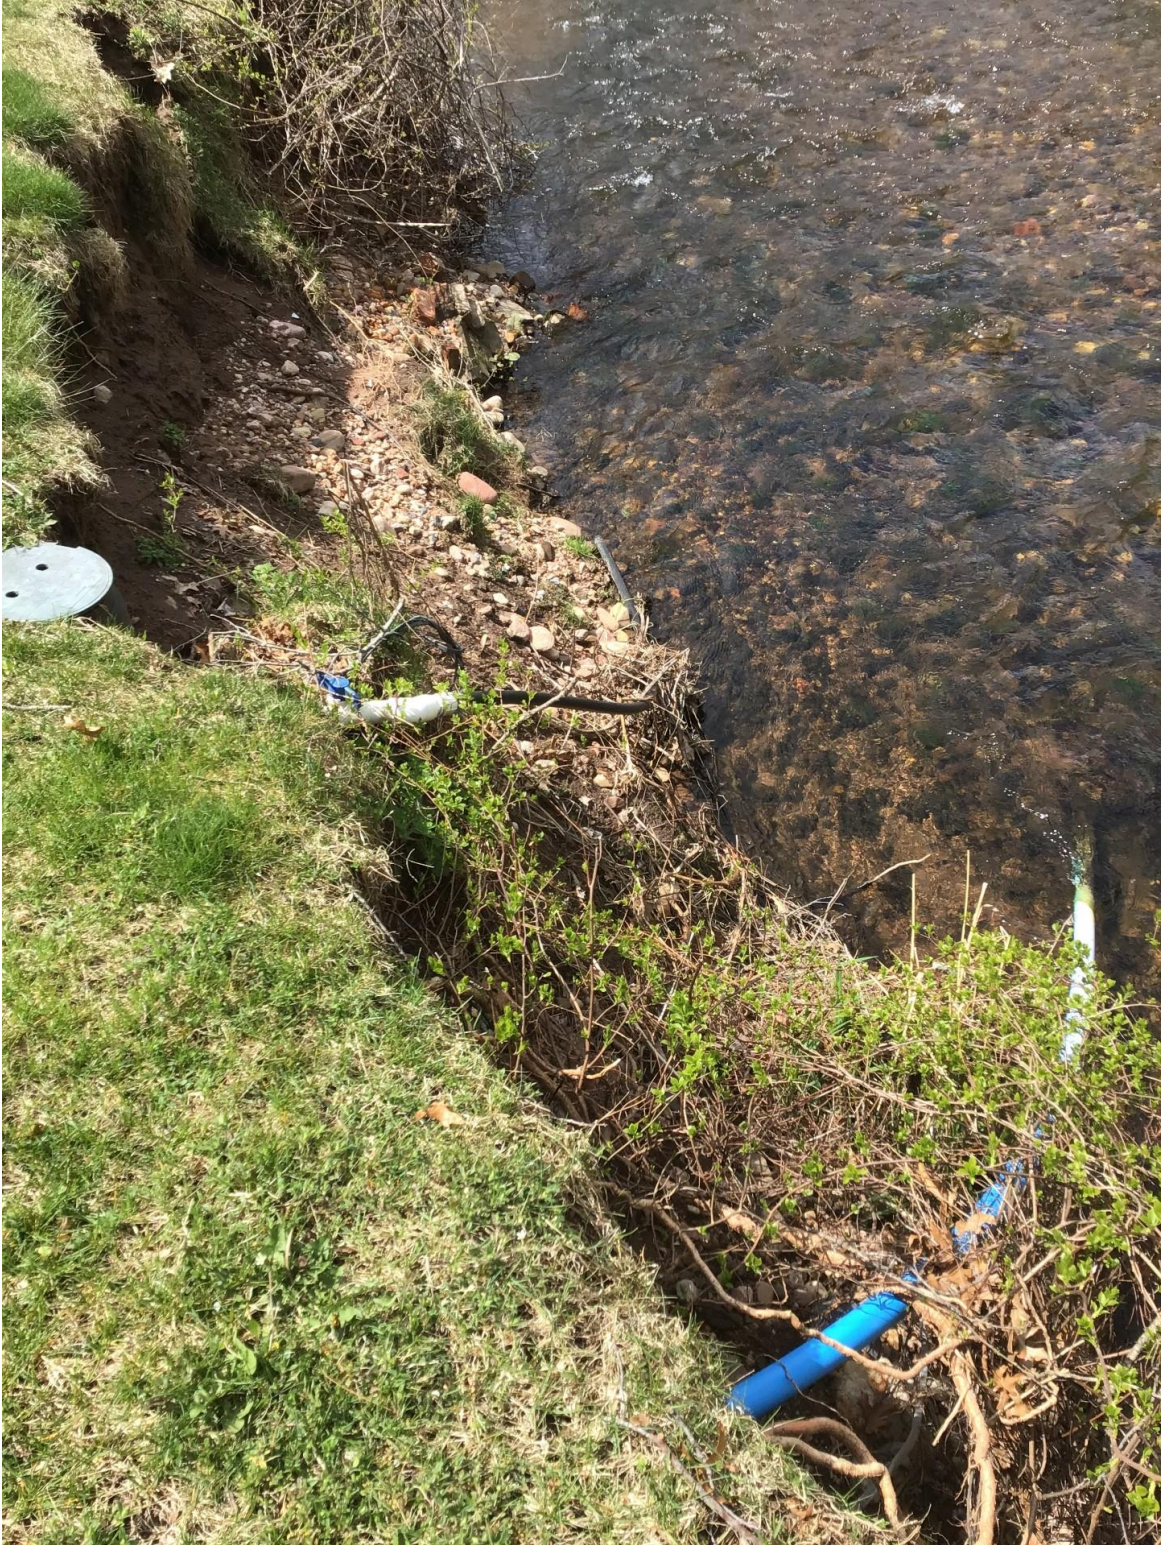
Photo 2: Irrigation tubing, valve and control box.

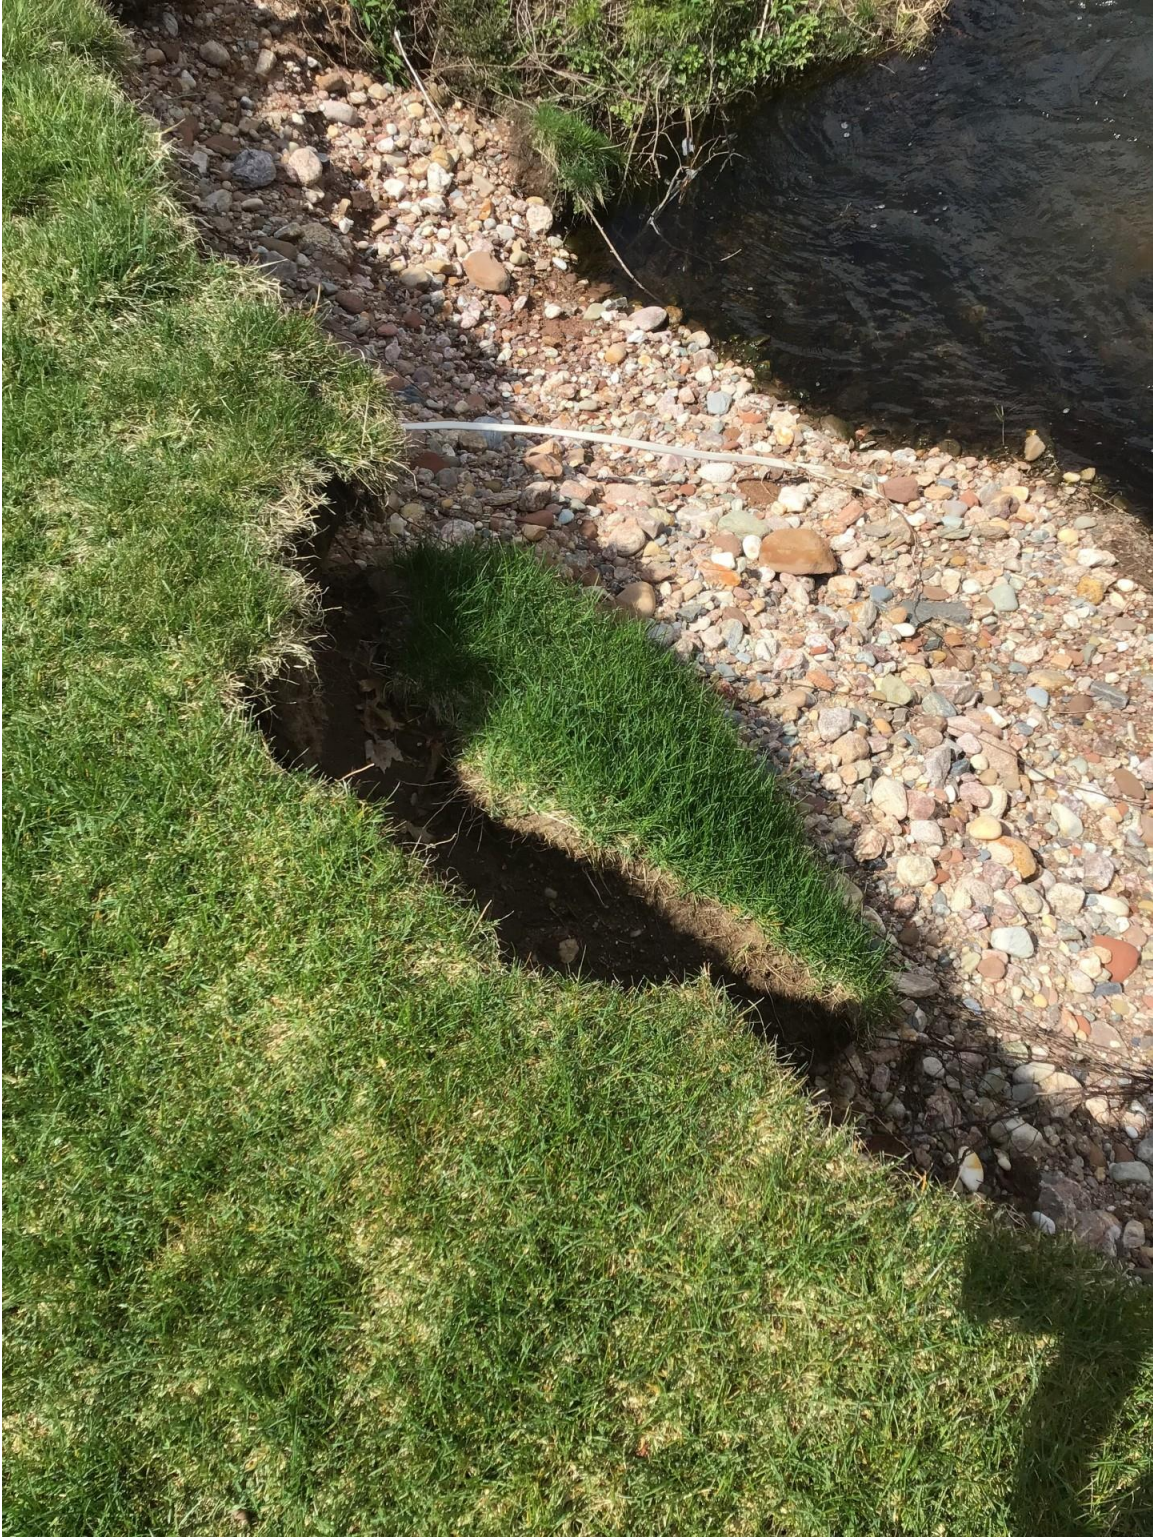
Photo 3: Undermining of established lawn, section breaking towards the brook

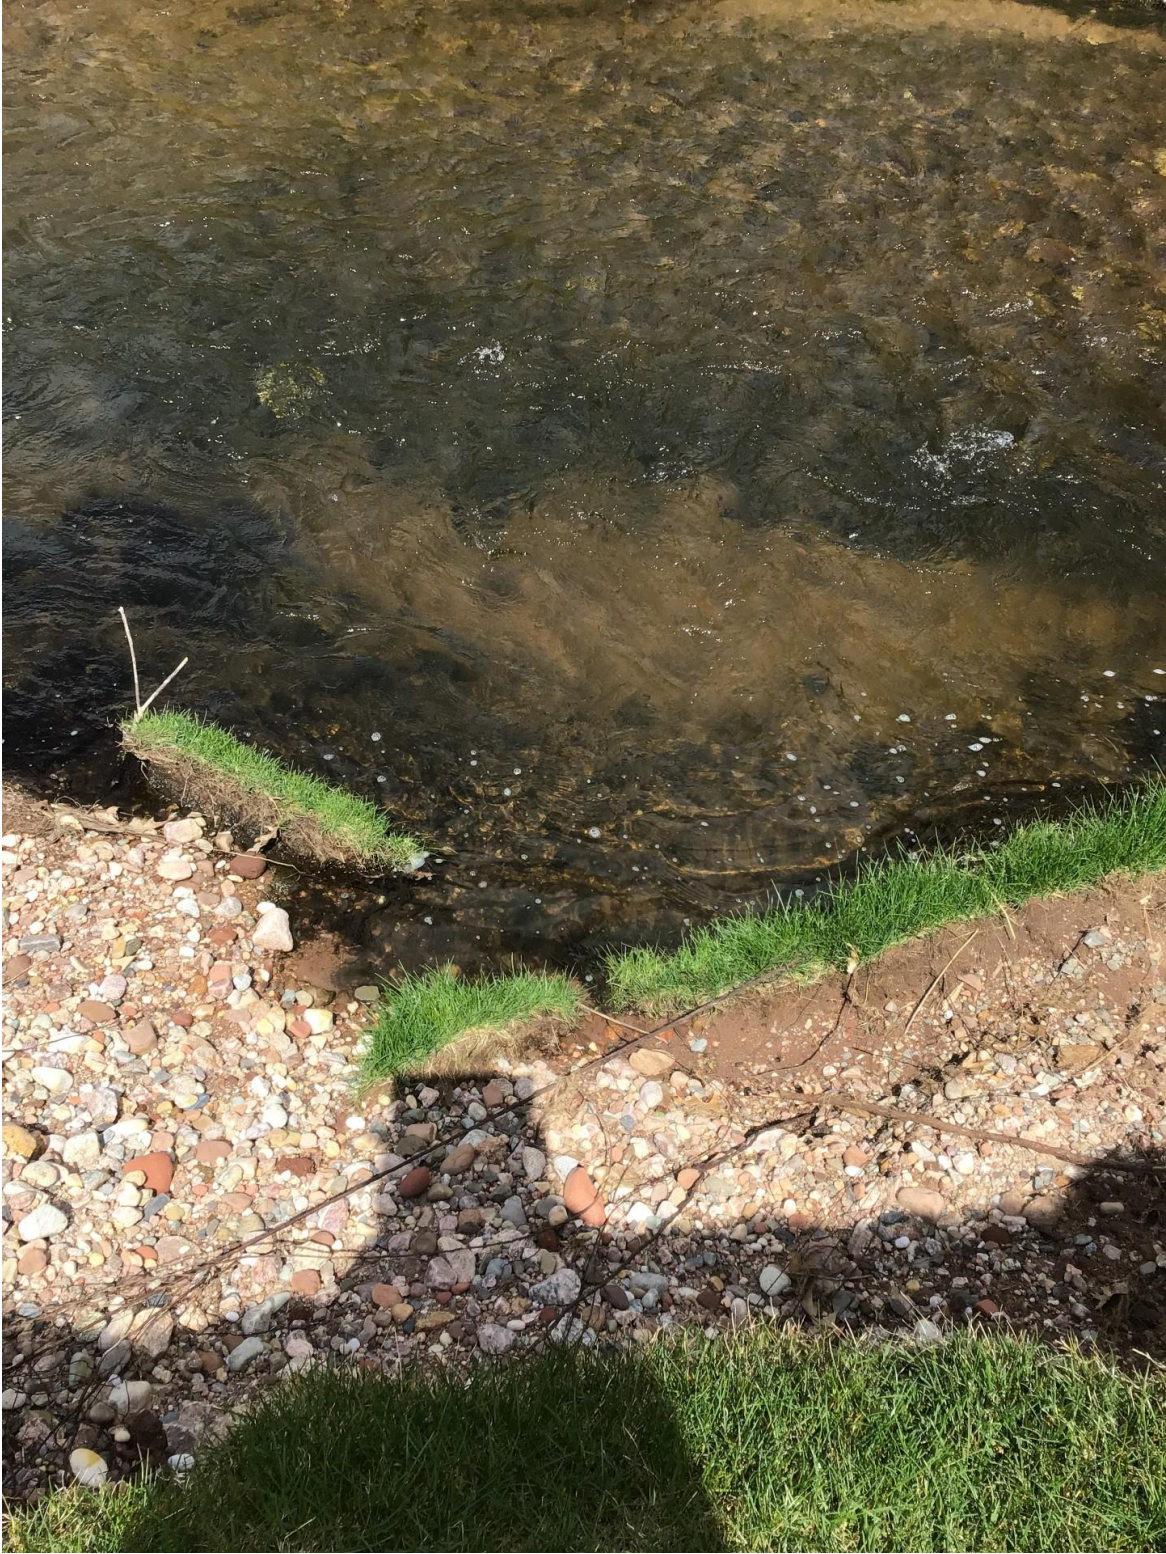
Photo 4: Sections of lawn in the brook
