Re: Glastonbury Gateway V - Western Boulevard, Glastonbury, CT
Wetland Existing Conditions and Project Impact Report

Proposed Glastonbury Gateway V Commercial Facility
280 Western Boulevard, Glastonbury, CT

ATTACHMENT B: Gateway Phase V, 280 Western Boulevard, Glastonbury, CT

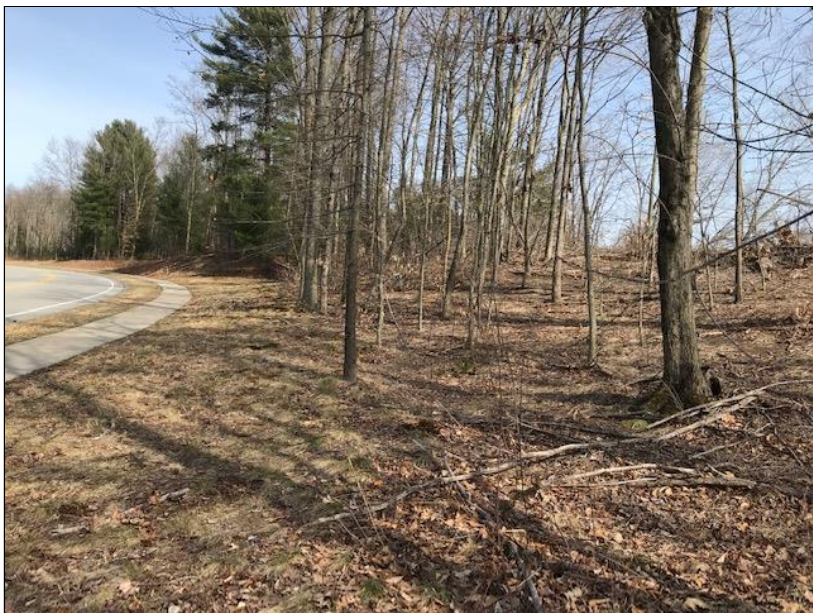
Photo 1: Northerly view of dry upland forest and roadside meadow adjacent to Western Boulevard. Far west end of parcel.

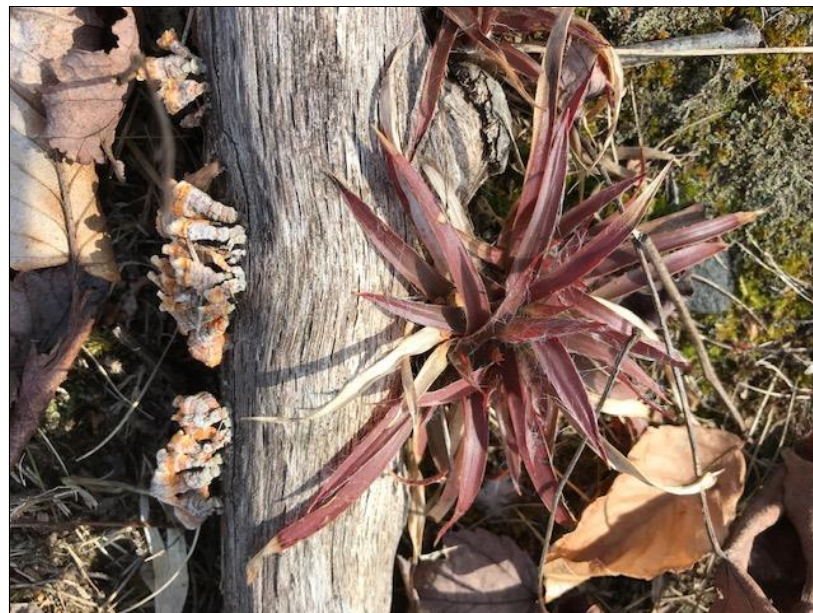
Photo 2: Perennial sedge in heavy-seeding Laxiflorae tribe by woody debris with moss cover (upper right) & turkey fungus in western roadside meadow swath by forest edge.

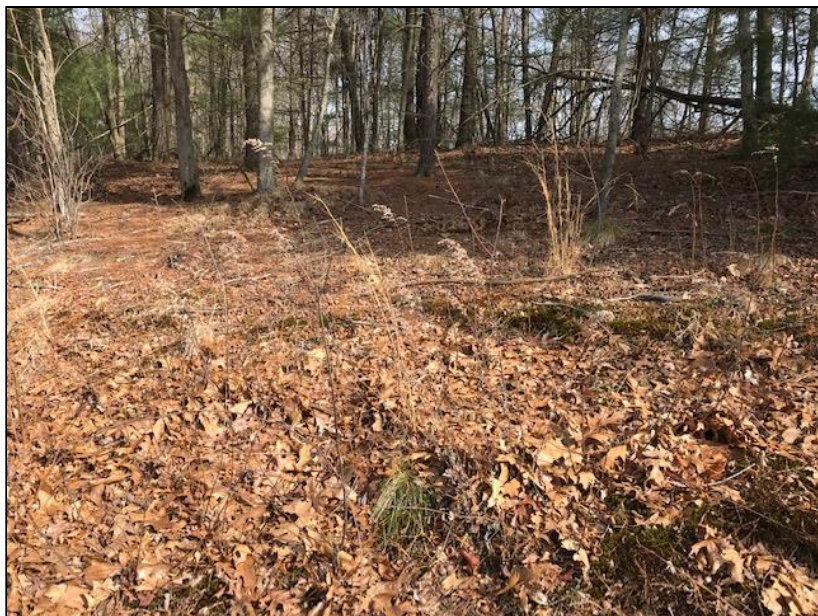
Photo 3: Pole-size evergreen (white pine) woods on S. side of Western Boulevard in the central portion of the parcel, where bank is steep and less than 40 feet wide.

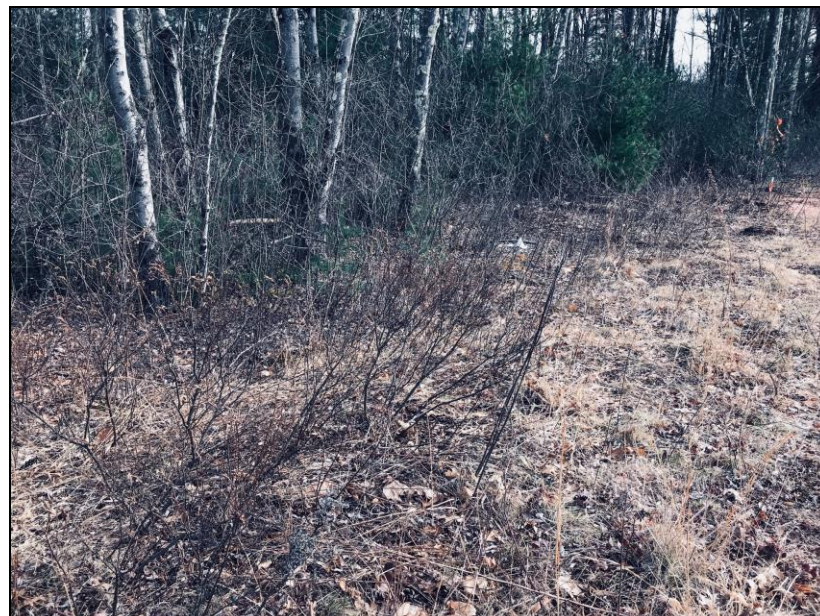
Photo 4: Shrubs, saplings & warm season native grasses and very few invasive plants on the open roadside slope along Western Boulevard. REMA recommends salvaging/reusing topsoil with its seedbank.

REMA recommends the saving and stockpiling of native topsoil in areas to be heavily graded or converted to buildings or parking areas, in view of the low numbers of invasives and the

relatively high quality meadow/shrub community with some species of value to pollinators, and very few invasives, it is recommended that topsoil and propagules from this area, be reused where naturalized vegetation is suitable, such as on the well-drained perimeter of stormwater management area, and along herptile potential travel routes.

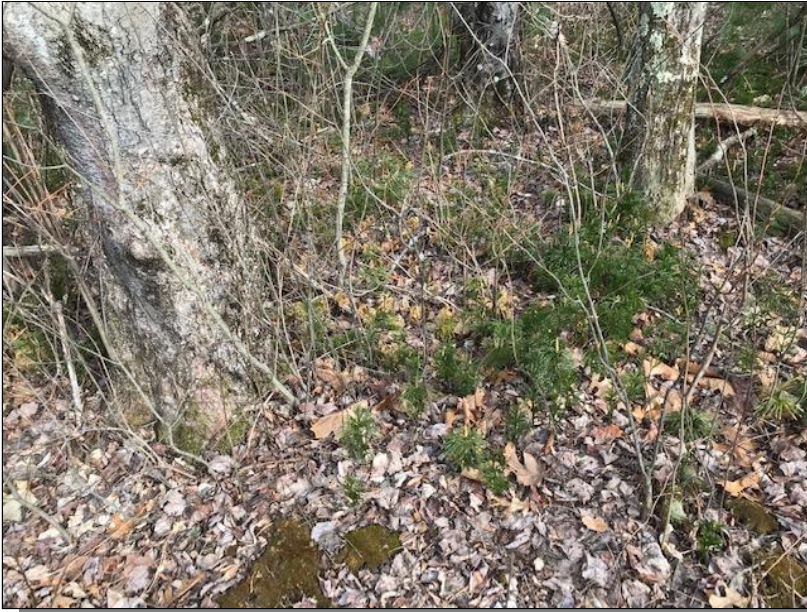
Photo 5: Moist upland forest occupies much of the eastern part of site. Red maple and princess pine are shown in photo near edge. This is suitable habitat for the target plant, climbing fern, which was not found.

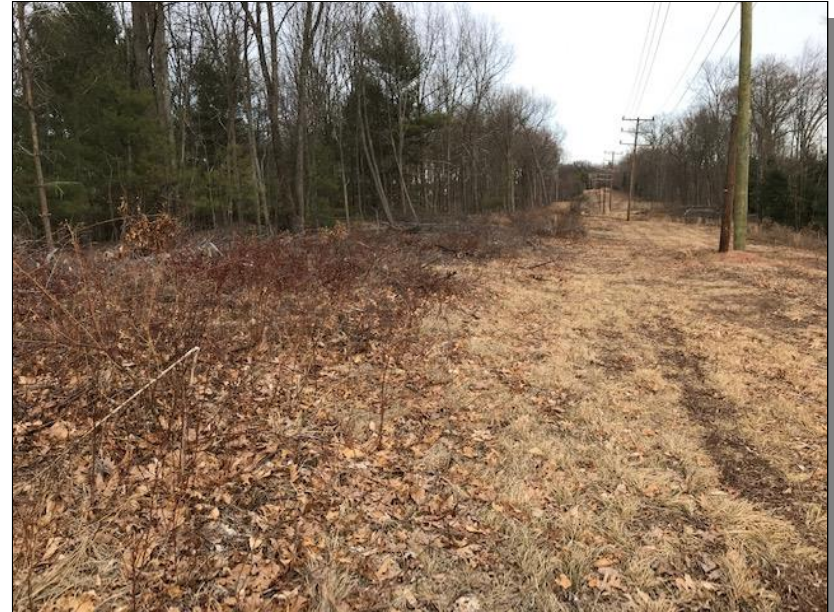
Photo 6: Easterly view of the electric ROW, just off-site and south of the parcel. Recently logged swath at left. ROW habitat in Glastonbury is documented habitat may provide connectivity for the two target herptiles.

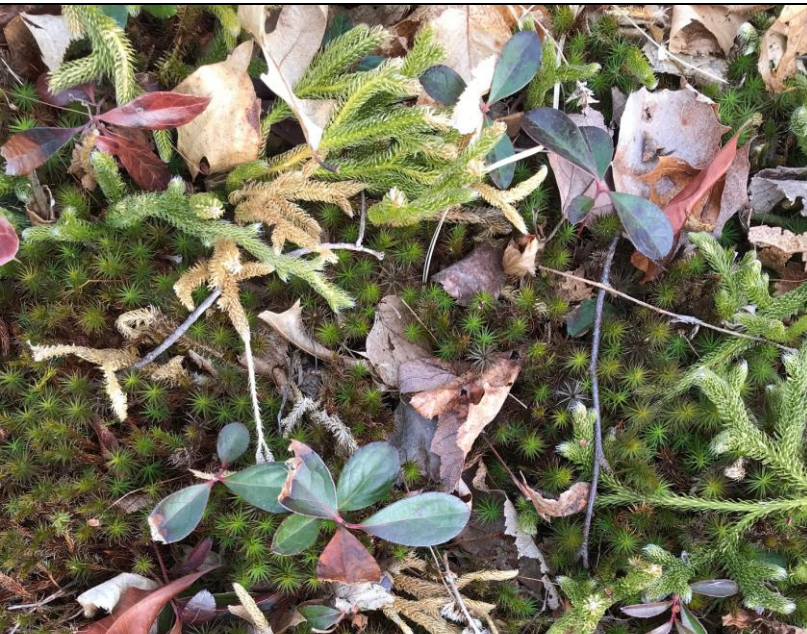
Photo 7: In the ROW, a patch of uncommon, but not state-listed spikemoss (*Selaginella rupestris*) was found, a primitive vascular plant. Photo also shows wintergreen with a strong minty aroma and flavor.

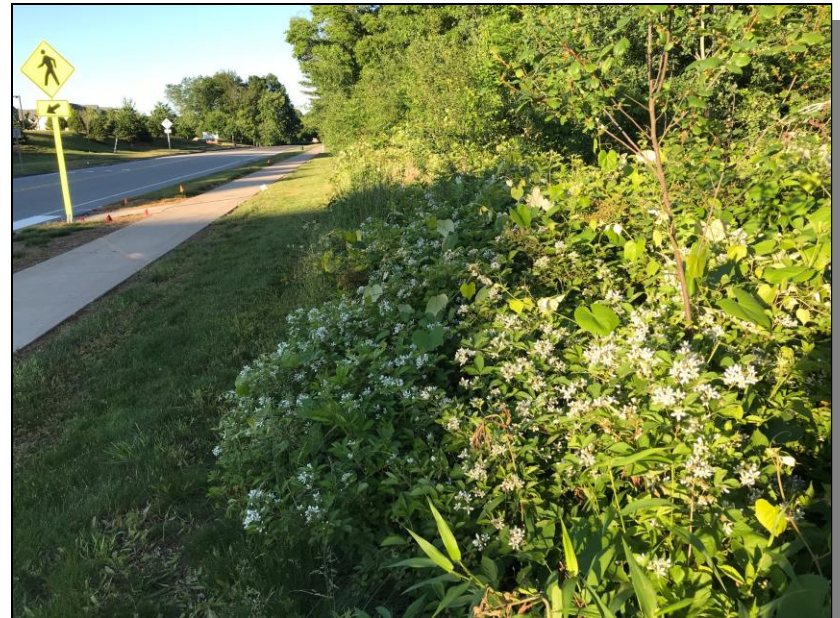
Photo 8: June 13, 2020. A large blackberry patch (preferred food for box turtles), saplings & warm season native grasses (deer tongue grass in foreground) in eastern part of non-forested habitat along Western Blvd.
