May 21, 2021
Project 2101248.2.1

**Re: Geologic Assessment
1040 Main Street
South Glastonbury, CT**

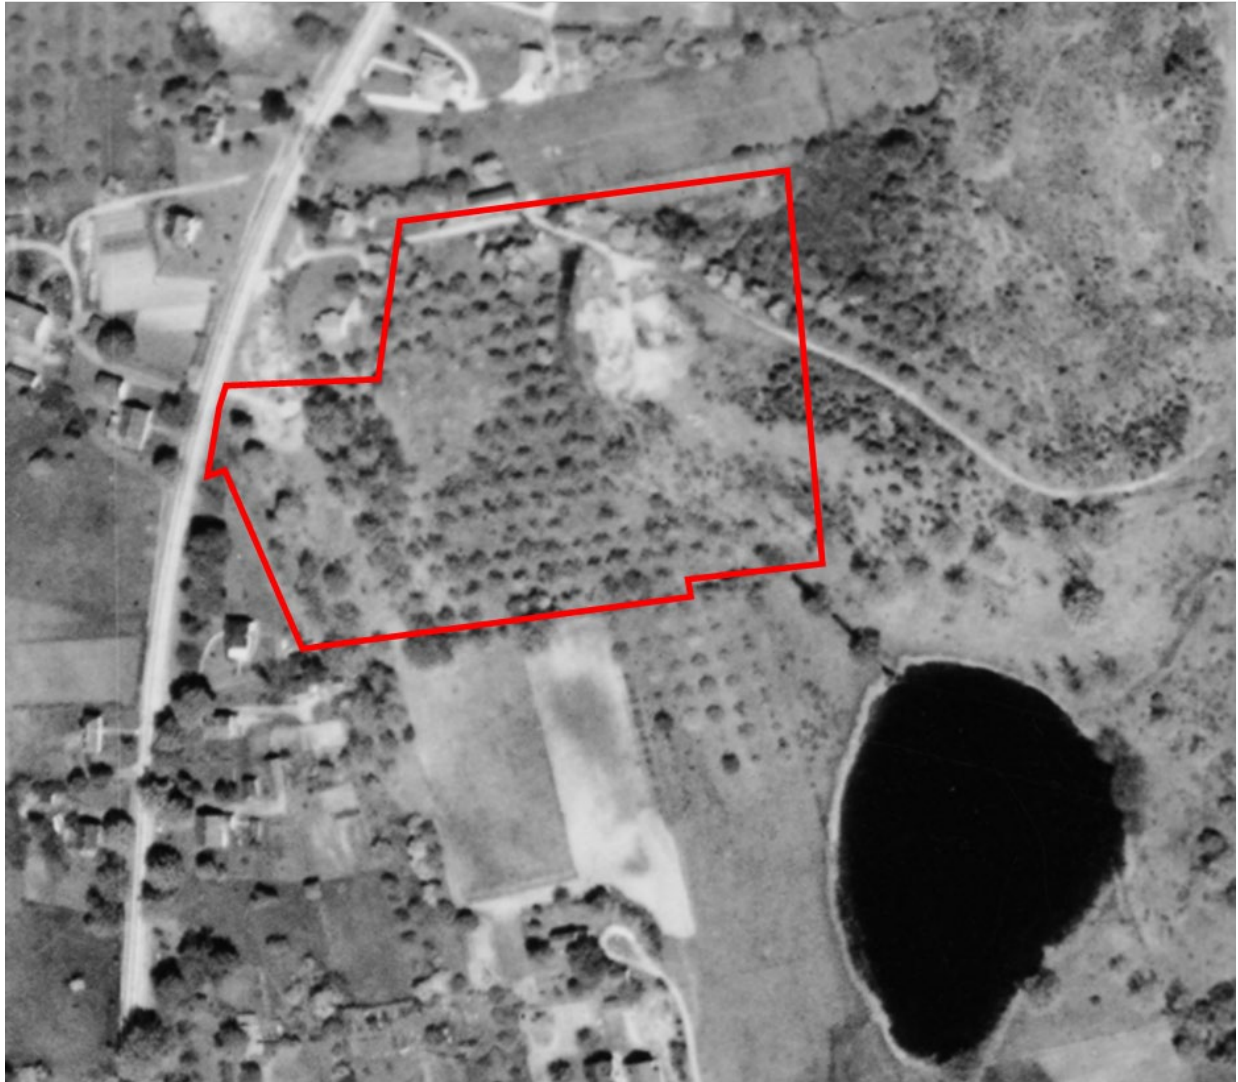
1934 Aerial and Approximate Site Boundary

A review of the 1934, 1952, and 1970 aerial photographs for the Site show that significant changes in the Site's use and topography appear to have occurred. Attachment C presents the Aerial Photographs with the approximate Site outlined. In 1934, the central portion of the Site appears to have been used as an orchard, with a stream crossing the Site from South to North, draining the large pond located near the southeast corner of the Site. The 1952 aerial photograph shows that the orchard is apparently no longer present, a field has been cleared on the north-central portion of the Site, and adjacent to the stream, an area of excavation is present just to the east side of the stream. The 1970 aerial photograph shows that much of the Site is now forested and the excavation area east of the stream contains a small pond.

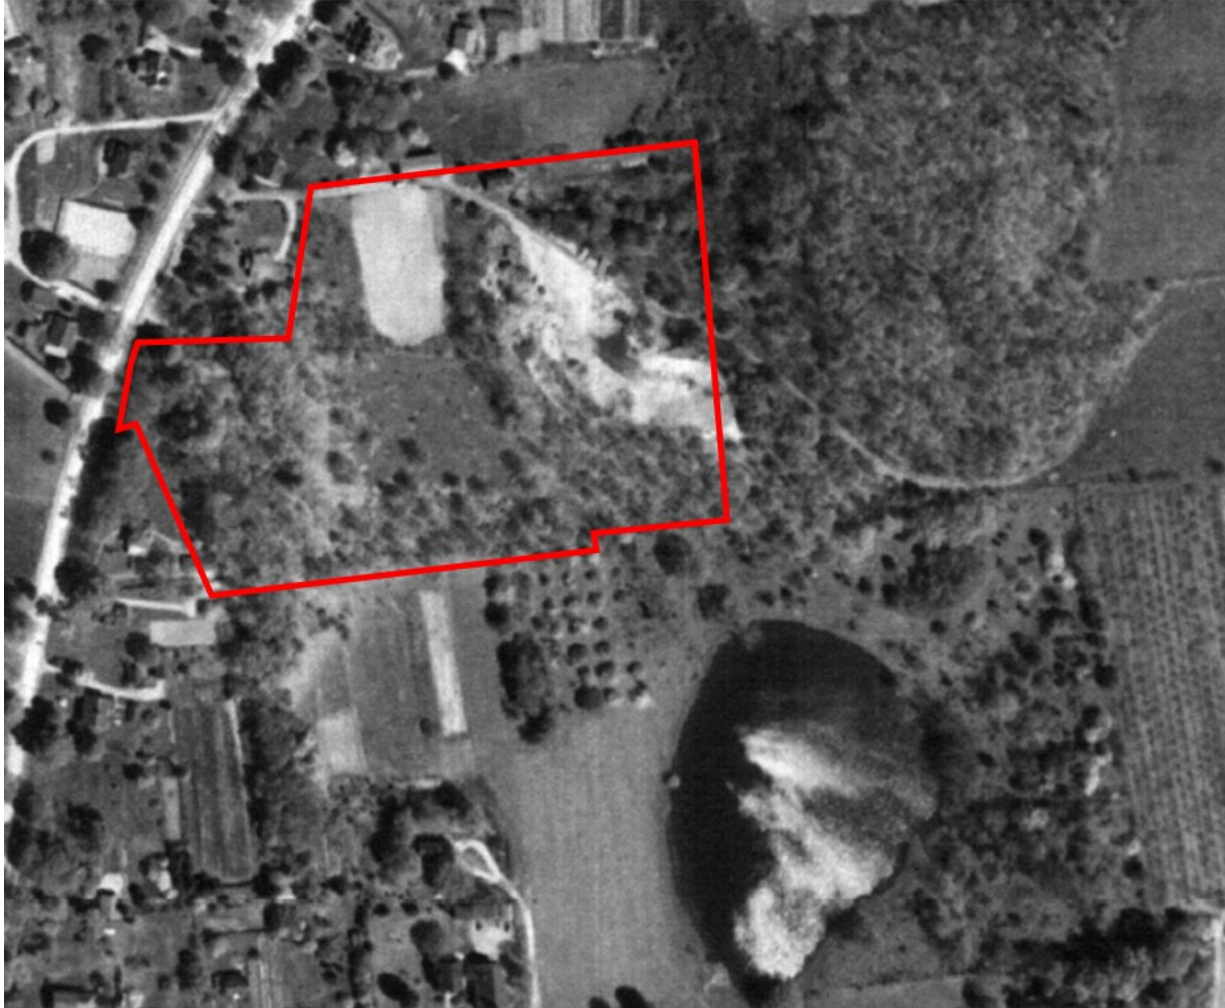
1952 Aerial and Approximate Site Boundary

Historic topographic maps from 1900, 1946, 1953, 1964, and 1992 were reviewed and are included in Attachment D with the approximate Site boundary depicted. The largest change in Site topography appears to be a change between 1900 and 1946. In 1900, a northerly flowing stream crosses the Site. However, by 1946, the topography has been modified to show an easterly oriented valley near the eastern end of the Site and the stream is no longer depicted. This change is consistent with the excavation observed in the 1952 aerial photograph.

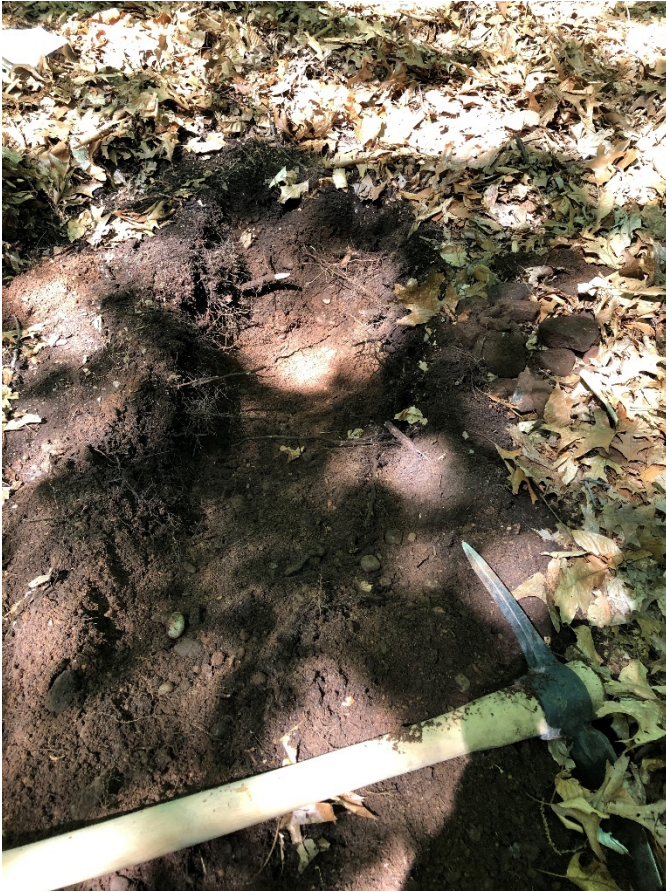
During the Site visit on May 19, 2021, three shallow test pits were hand-dug to evaluate the nature of the soils. Test pit TP-1 was dug into the eastern slope of Geomorphic Feature 1, TP-2 was dug into the eastern slope of Geomorphic Feature 2, and TP-3 was dug into the hillside slope west of the intermittent stream adjacent to Geomorphic Feature 2 to evaluate if the materials on Geomorphic Feature 2 were similar to those on the other side of the drainage. Photographs of the test pits and soils are included in Attachment E.

Test Pit 1 (East slope Geomorphic Feature 1)

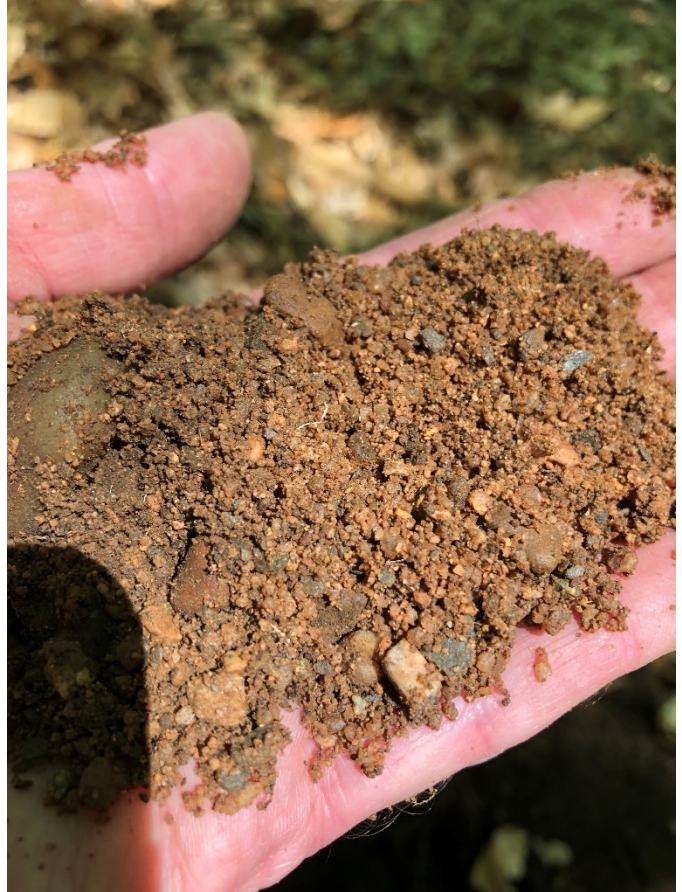
Soils at TP-1 (Geomorphologic Feature 1) consisted of loose, dark red-brown coarse to very coarse sand with some gravel and few angular cobbles. These materials are consistent with ice-marginal deltaic deposits as mapped by the USGS.

TP-1 Soils - dark red-brown coarse to very coarse sand with some gravel and few angular cobbles

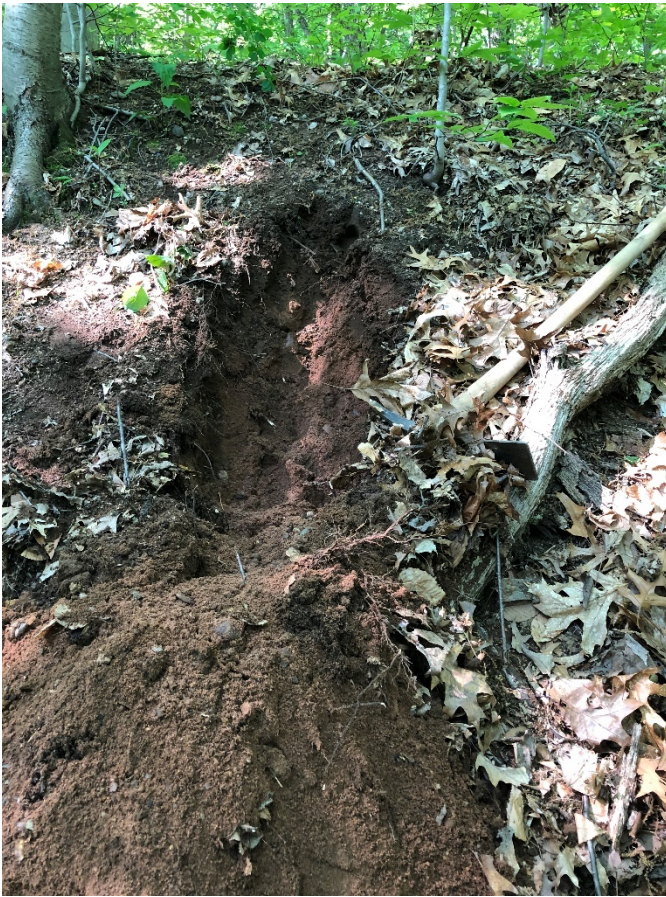
Test Pit 2 (East slope Geomorphic Feature 2)

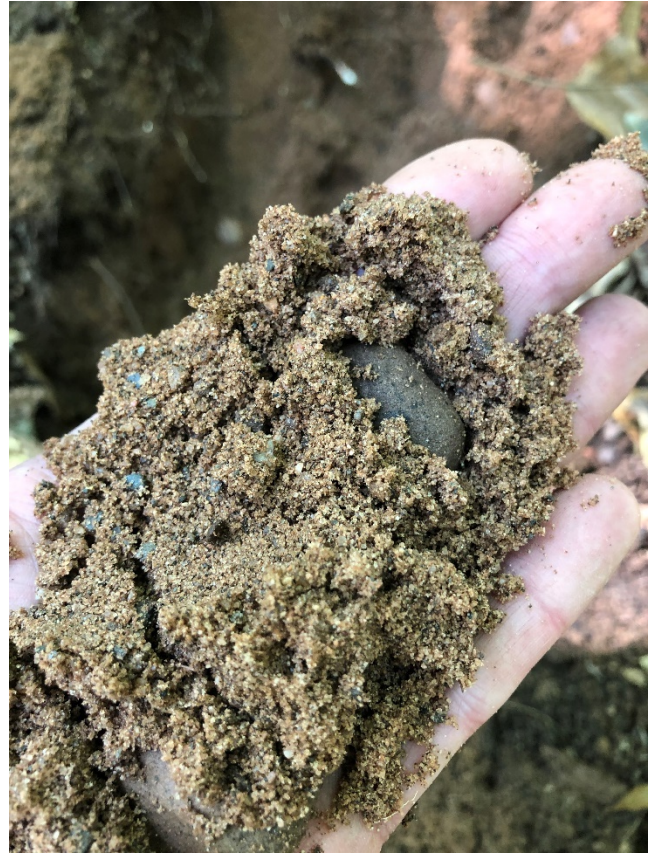
Soils at TP-2 (Geomorphologic Feature 2) consisted of loose, red-brown medium to fine sand with little gravel and trace cobbles. These materials are consistent with ice-marginal deltaic deposits as mapped by the USGS.

TP-2 Soils - red-brown medium to fine sand with little gravel and trace cobbles

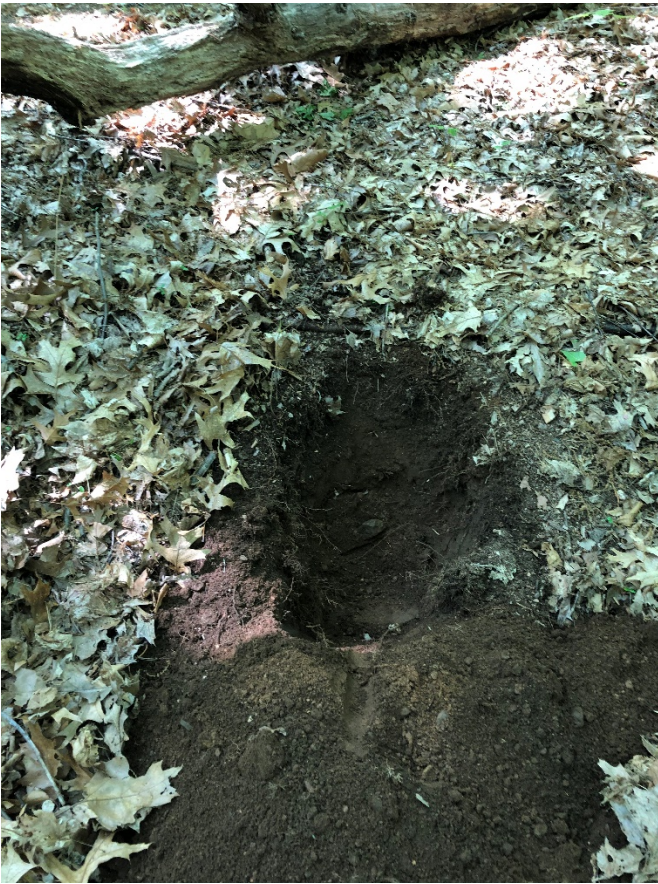
Test Pit 3 (SW of Geomorphic Feature 2)

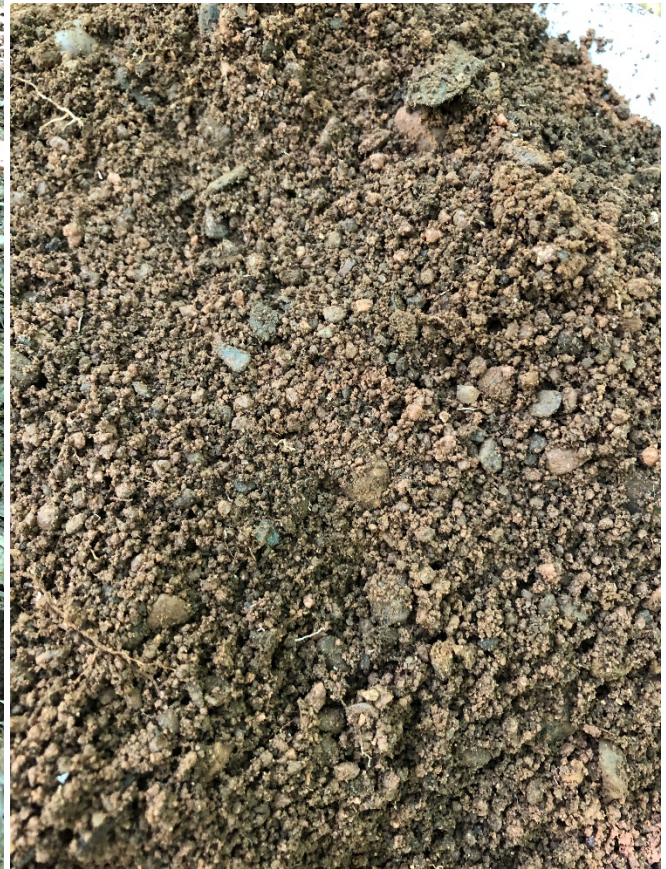
Soils at TP-3 (located west of the intermittent drainage adjacent to Geomorphic Feature 2) were similar to those observed at TP-2 and consisted of loose to moderately dense red-brown fine to coarse sand with little gravel. These materials are also consistent with ice-marginal deltaic deposits and the similarity with the materials at TP-2 support that the intermittent stream downcut through the deltaic deposits creating the southwestern slope of Geomorphic Feature 2.

TP-3 Soils - red-brown fine to coarse sand with little gravel
