# **Wetland Assessment Report**

## **Proposed Development Project**

**2283-2289, 2327-2333, 2341-2355, and 2389 Main Street**  
**Glastonbury, Connecticut**

**November 8, 2021**

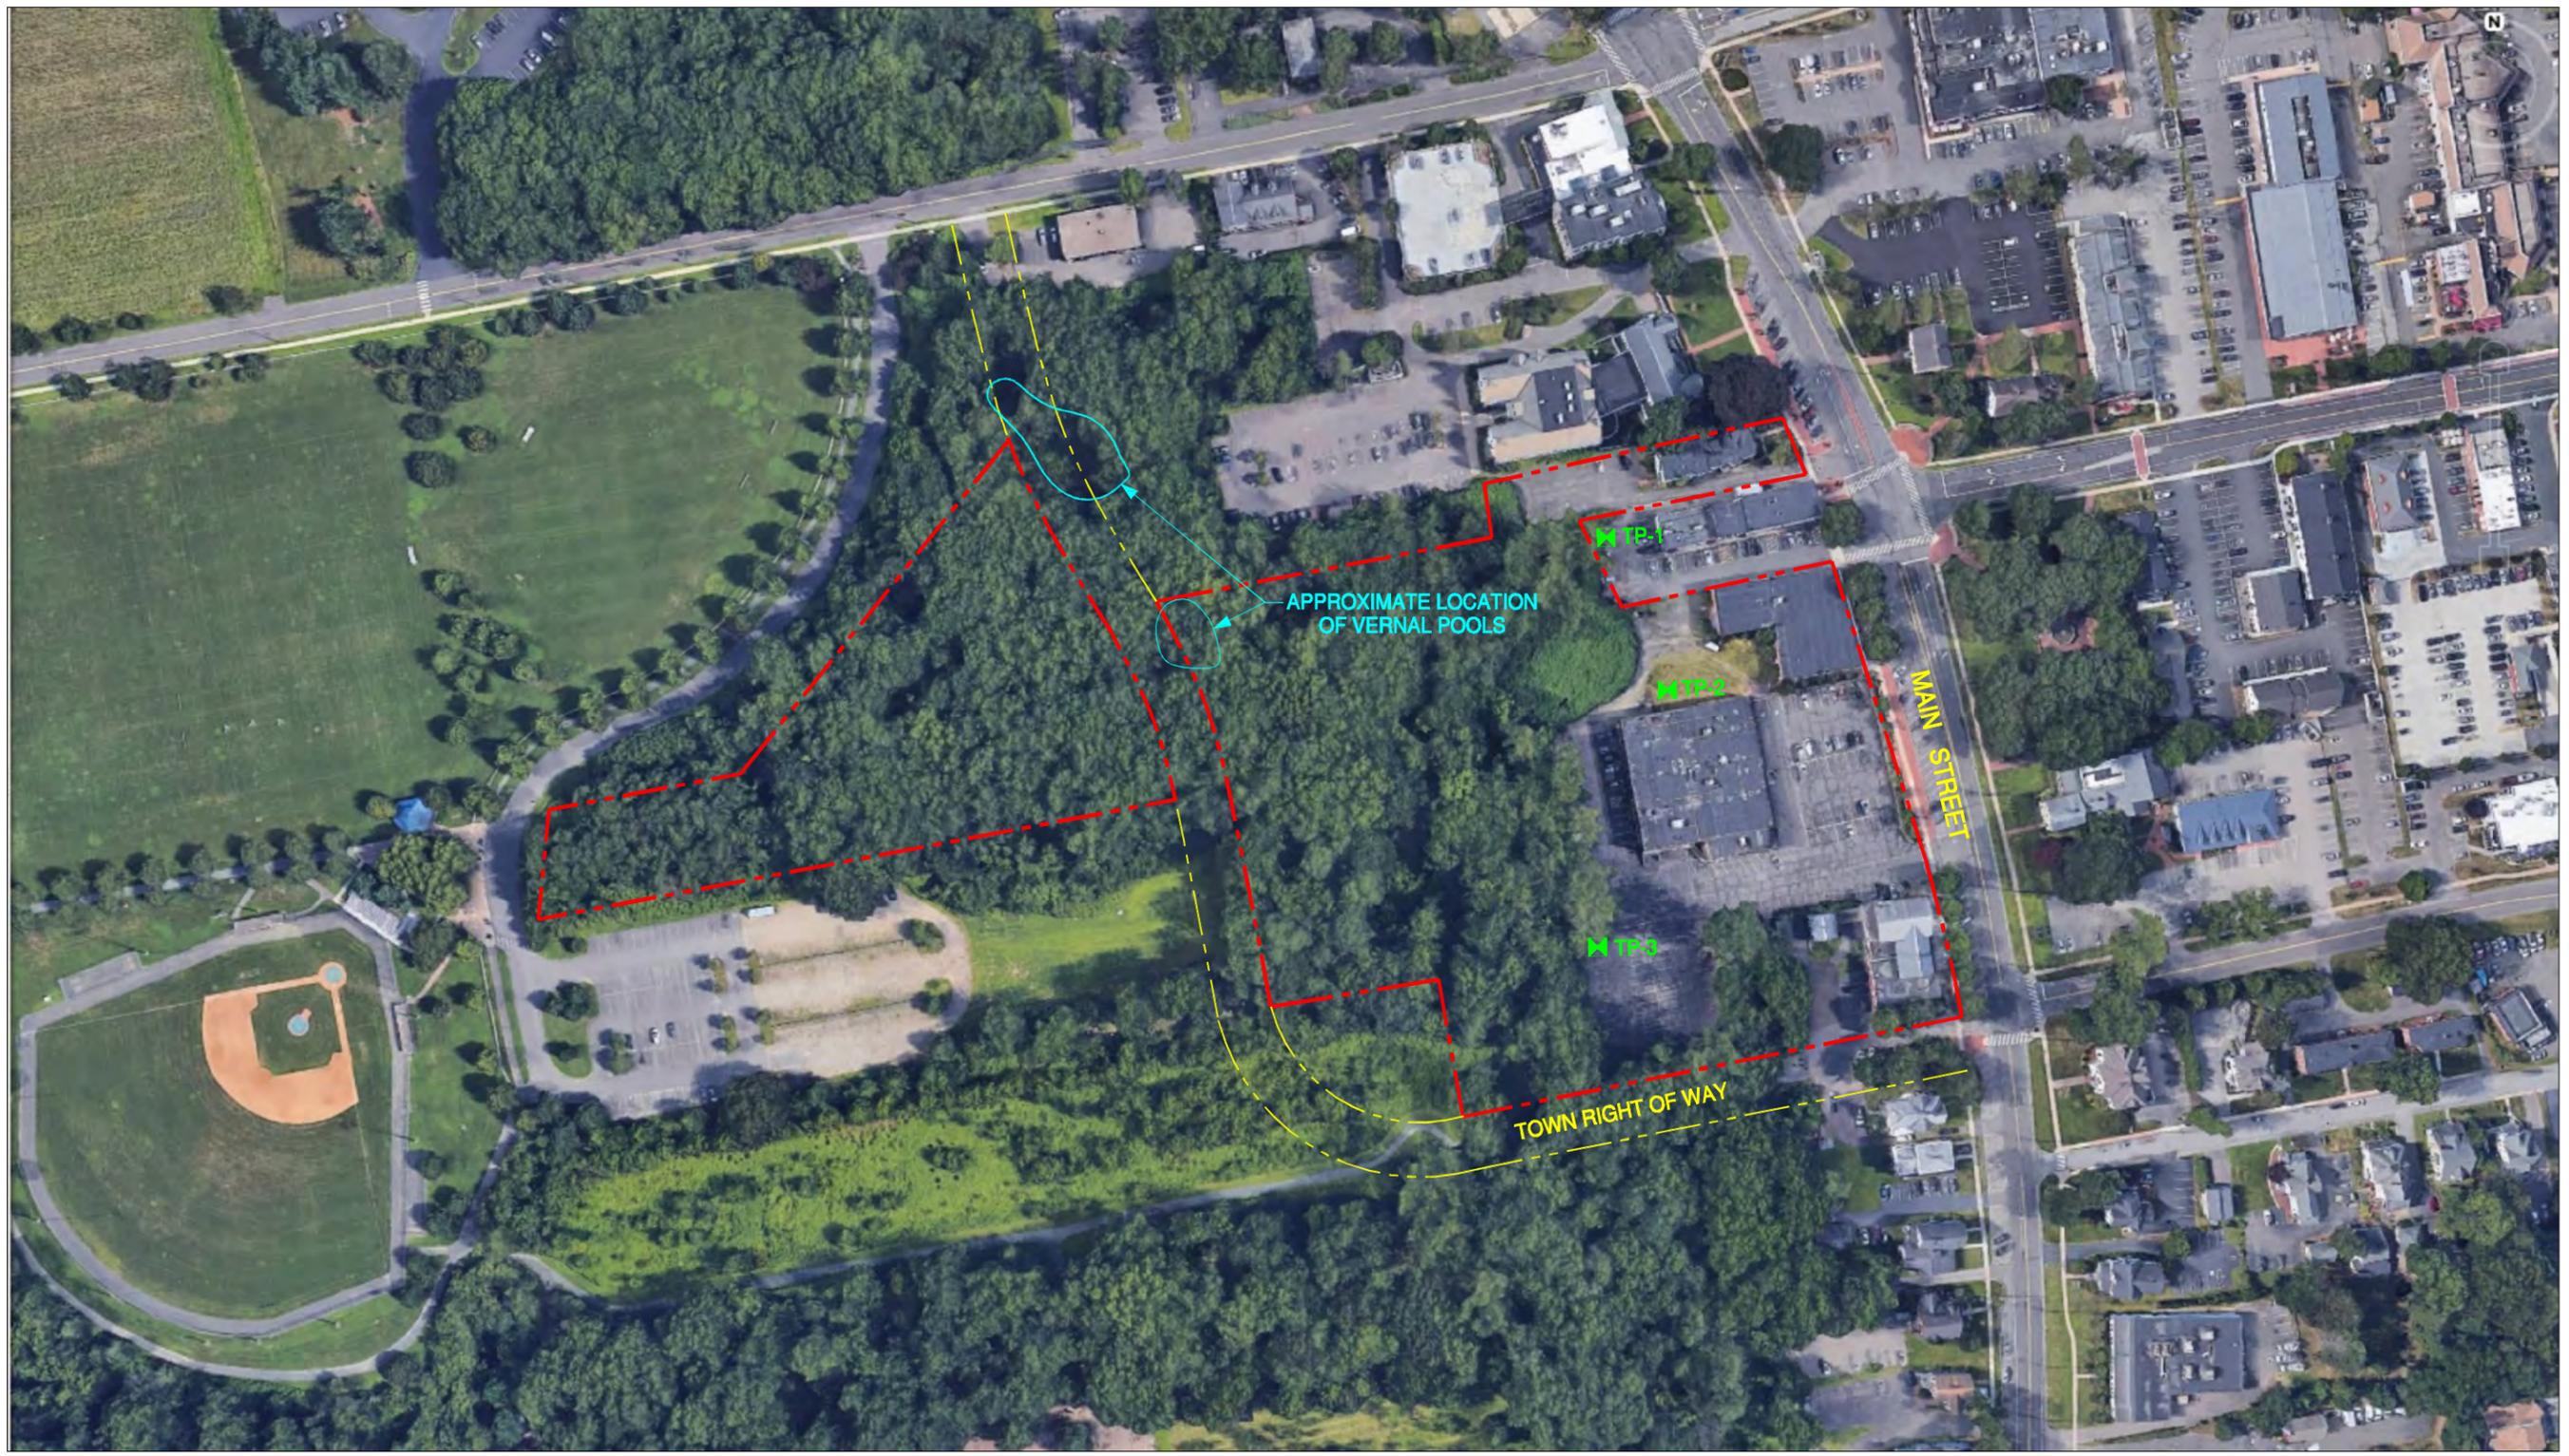
**Figure 2 - Aerial Site Plan**  
2333 Main Street  
Glastonbury, Hartford County, Connecticut

■ TP-3 — TEST PIT LOCATION

Two shallow ponds are located on and adjacent to the northwestern portion of the site (see Figure 2). The southern pond is approximately 80 feet in diameter and appears to range in depth from 6 inches to 2 feet and may dry up in summer. The northern pool is approximately 100 by 200 feet in size and ranges from 1 to 3 feet in depth. It may dry up during very dry seasons. These ponds were identified as Vernal Pools by others who explored the area during Spring.

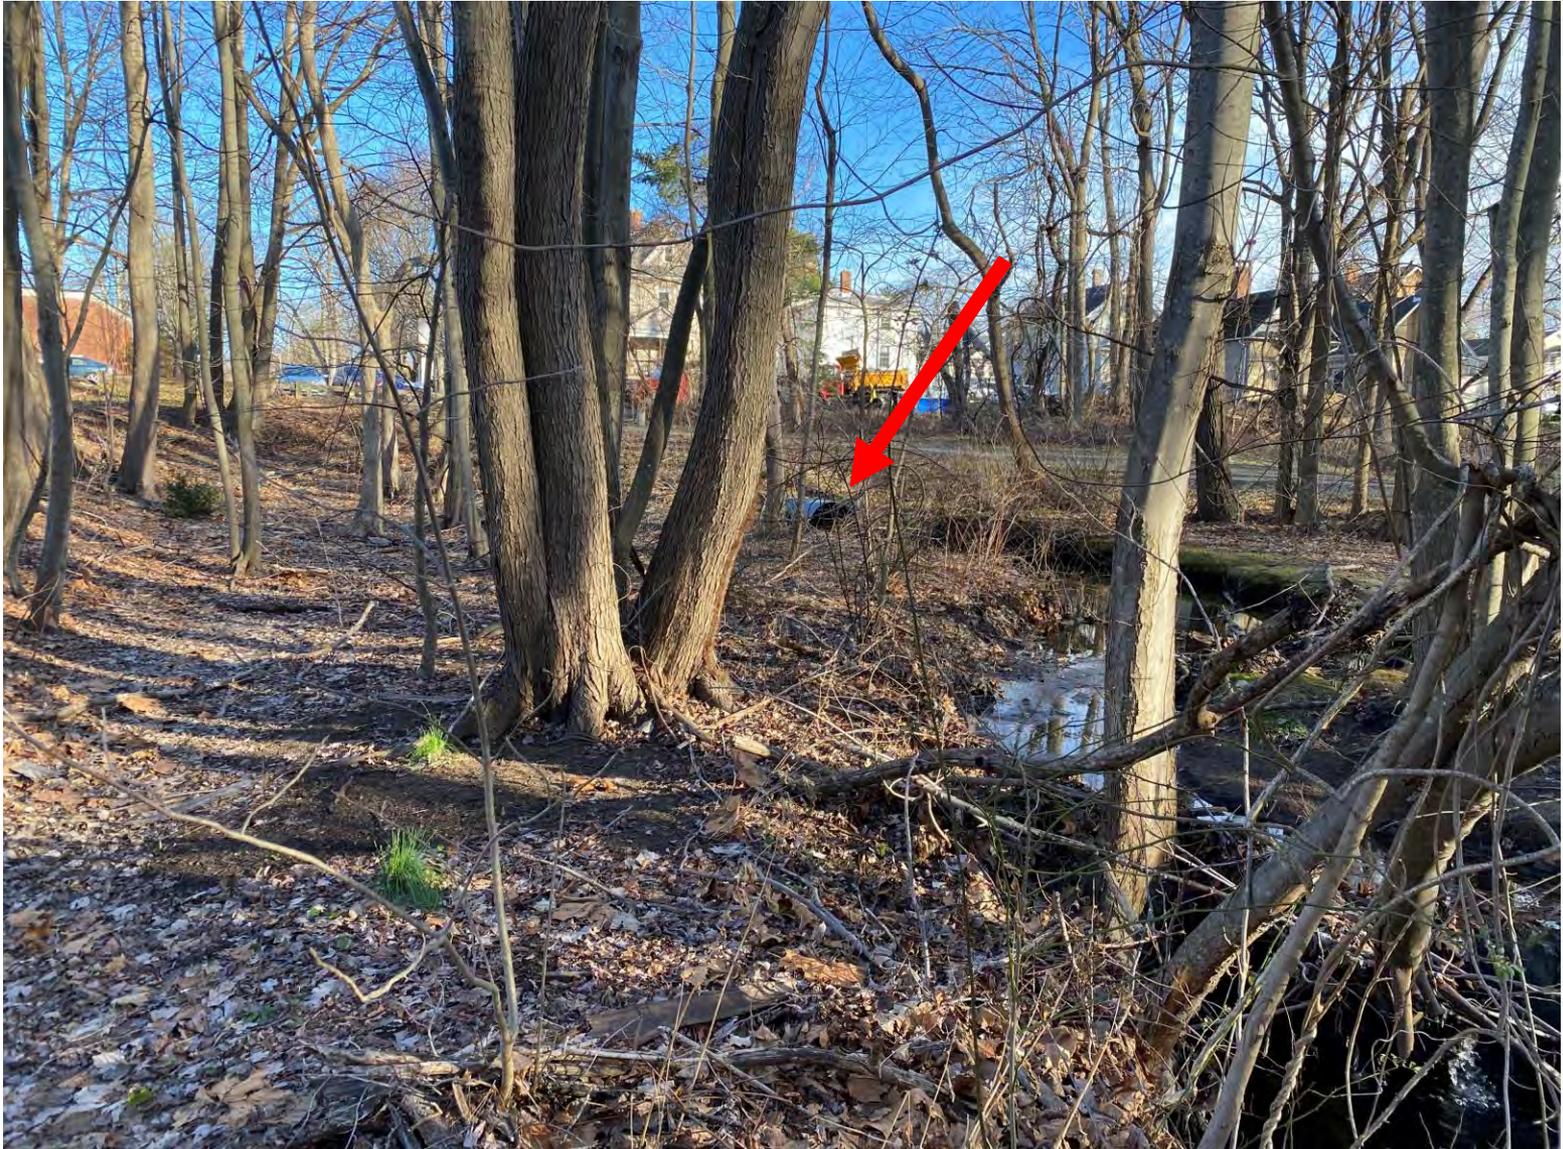
SOUTHERN PORTION OF SITE LOOKING EAST TOWARD CORRUGATED METAL PIPE OUTFALL (SEE ARROW) AND ASSOCIATED STREAMBED. NOTE FLOOD DEPOSITION IN FRONT OF MAPLE TREE CLUSTER IN LEFT CENTER OF PHOTOGRAPH.

A 48-inch, corrugated metal pipe discharges on to the southeastern portion of the property adjacent to a walking path that borders the property to the south. The watercourse associated with the discharge appears to exhibit perennial flows and bank floods during periods of heavy precipitation.

MBI accessed the property via the paved parking lot behind 2327-2333 Main Street and commenced the evaluation along the southern property boundary. A 48-inch, corrugated metal pipe discharges on to the southeastern portion of the property adjacent to a walking path that borders the property to the south. The watercourse associated with the discharge appears to exhibit perennial flows and bank floods during periods of heavy precipitation. Evidence of scour and rack lines were noted along the streambed. Subsurface exploration in this area using a hand auger exhibited soil generally consistent with the Scarboro Muck Soil Series. The adjacent non-wetland soil consisted of sandy, gravelly fill material along the edge of the paved parking area. Subsurface exploration west of the paved area, within the wooded wetland, exhibit similar soil as previously described with an apparent increase in organic matter. Wetland soils were generally characterized by 18-24 inches of black, mucky silt loam underlain with grey fine silty sand.

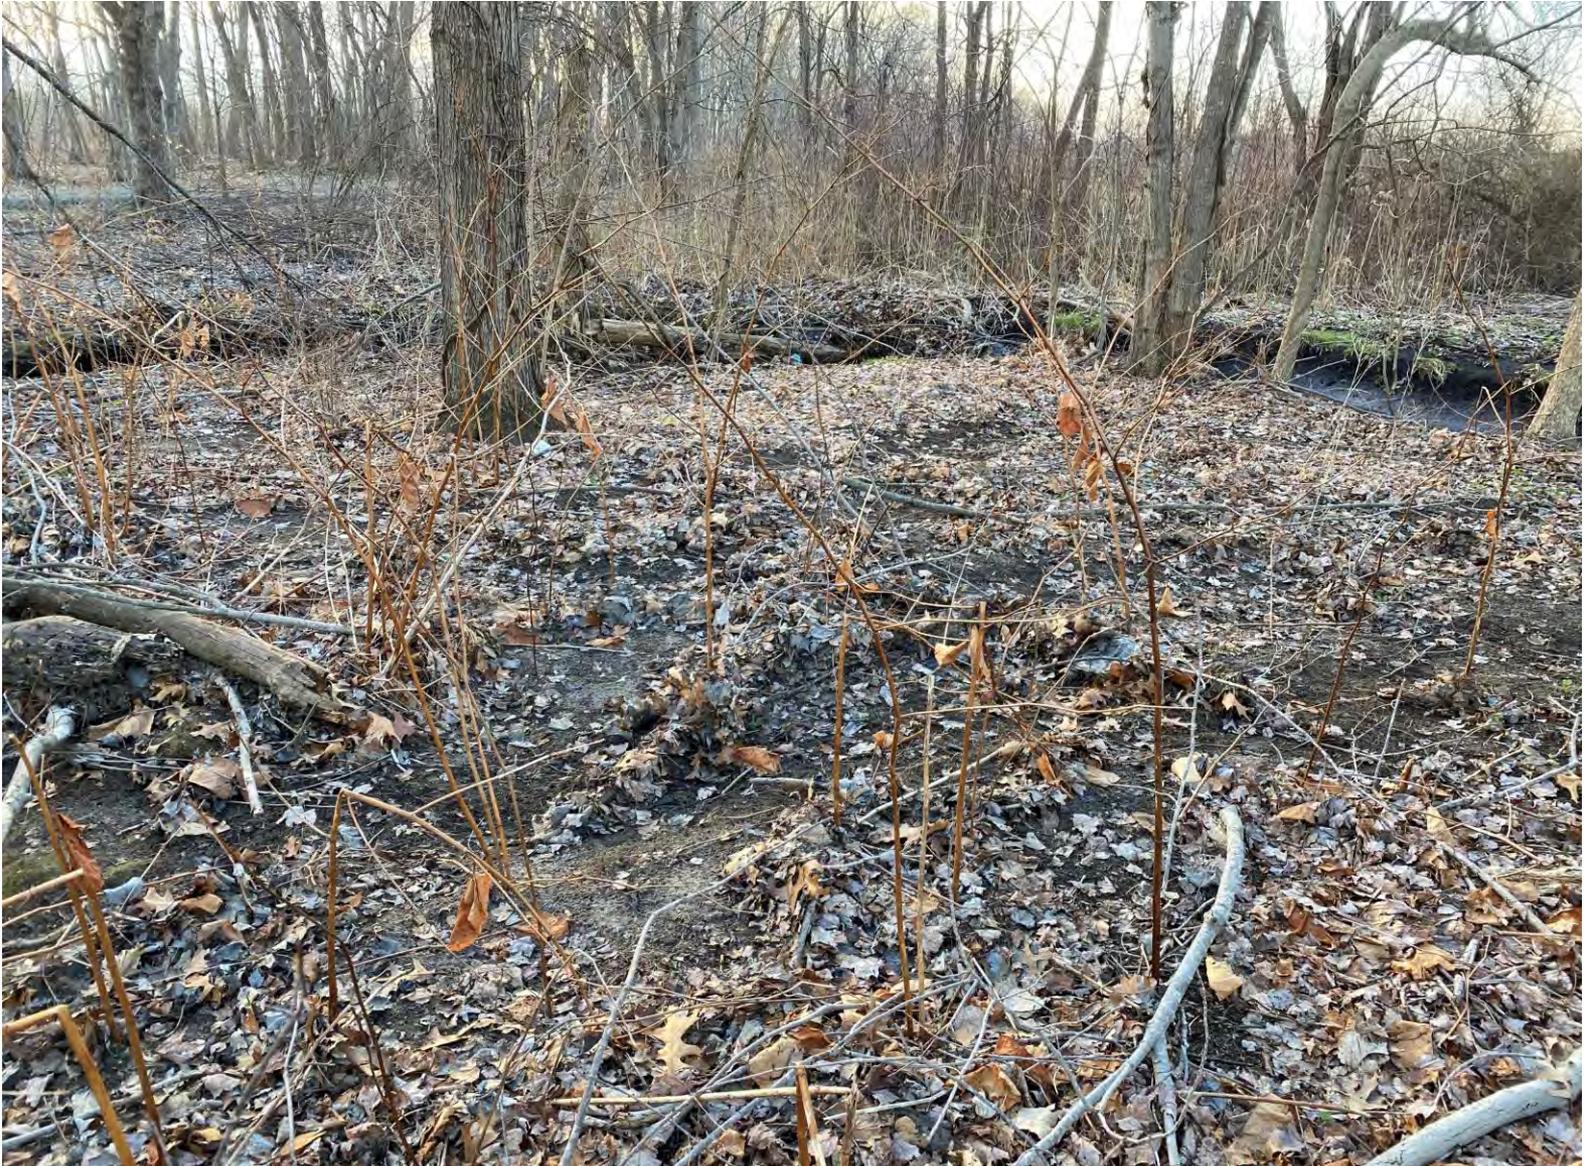
WETLAND AREA SOUTHWEST OF PAVED PARKING AREA WITH EVIDENCE OF FLOOD FLOWS ALONG BROOK

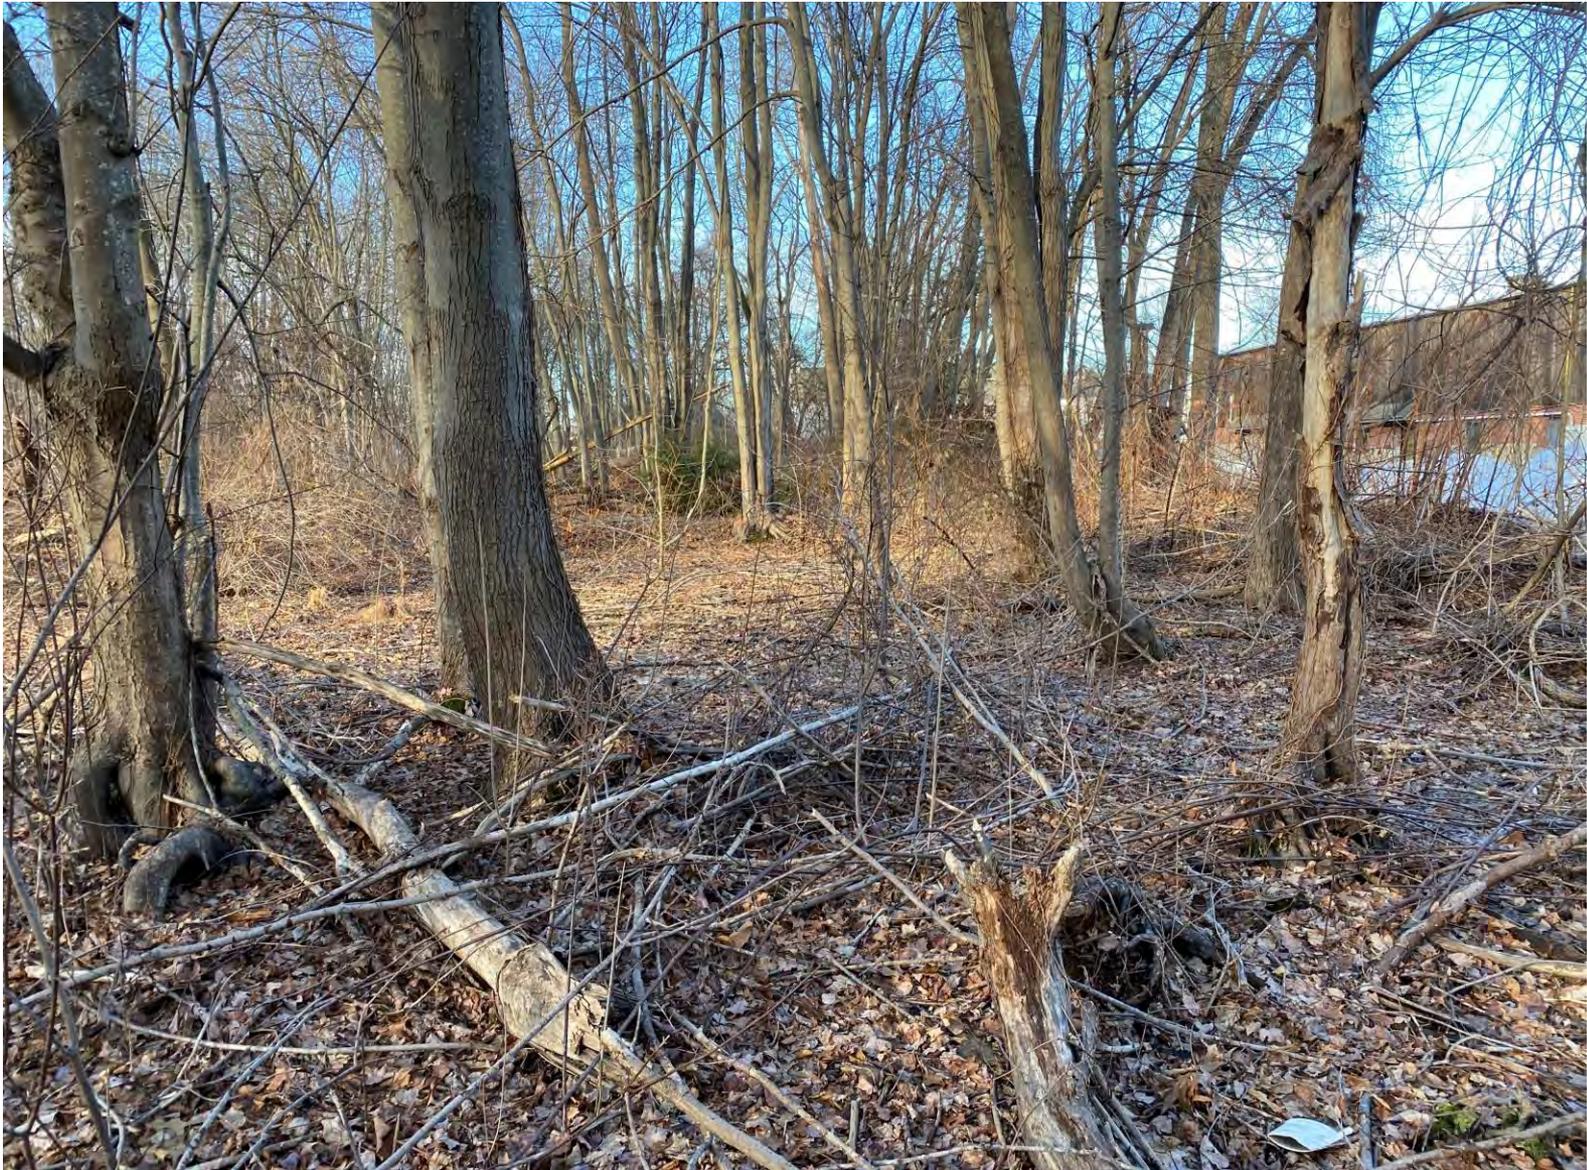
TYPICAL WETLAND AREA CONTAINING BUTTRESSED RED MAPLES. NOTE SITE COMMERCIAL BUILDING IN BACKGROUND..

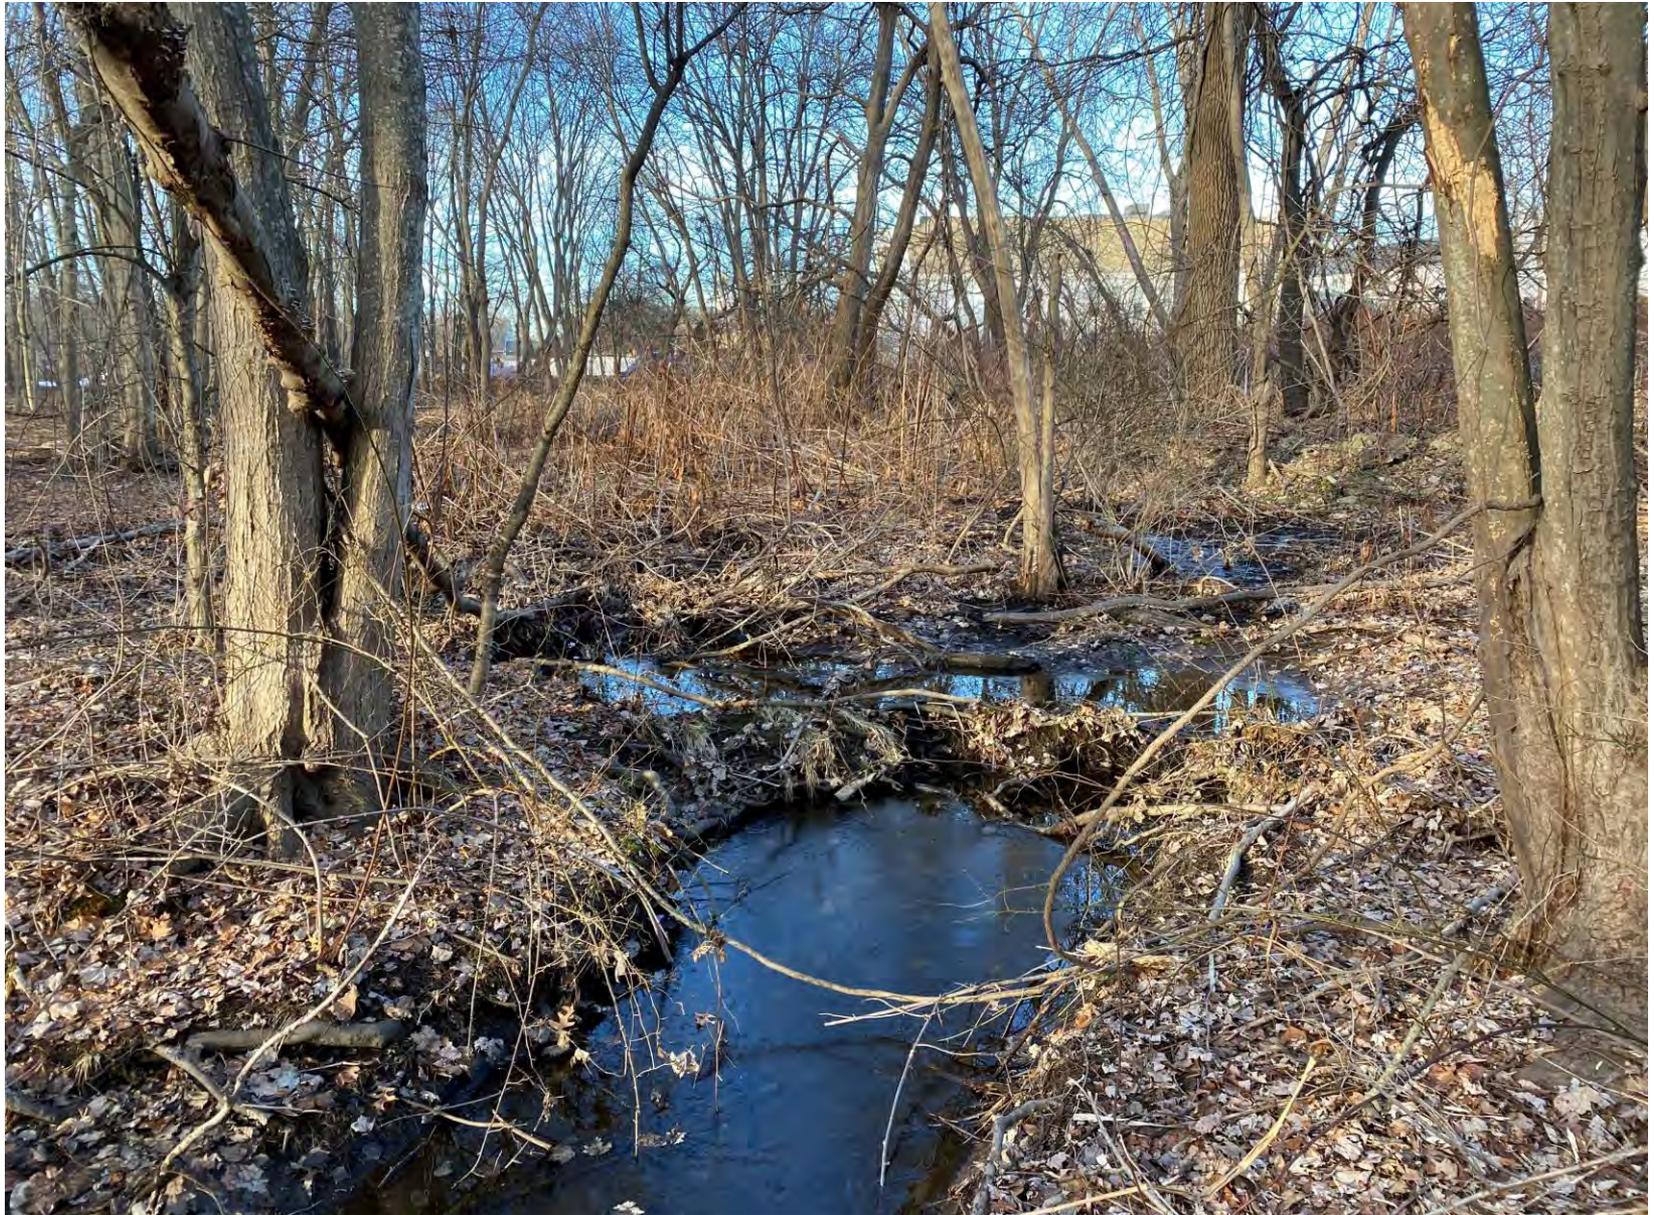
**SURFACE WATER FLOWS FROM NORTHEAST PORTION OF WETLAND FLOWING SOUTHWARD**

The northern outfalls ultimately deliver surface flows that follow the sewer easement southward. The leak-off from the paved parking area joins these surface flows from the east where they join and form a channel that turns westward and joins the channel from the southern watercourse near the western property boundary. The confluence flows west and southwest, eventually discharging into the Connecticut River approximately 1500 feet west of the property.

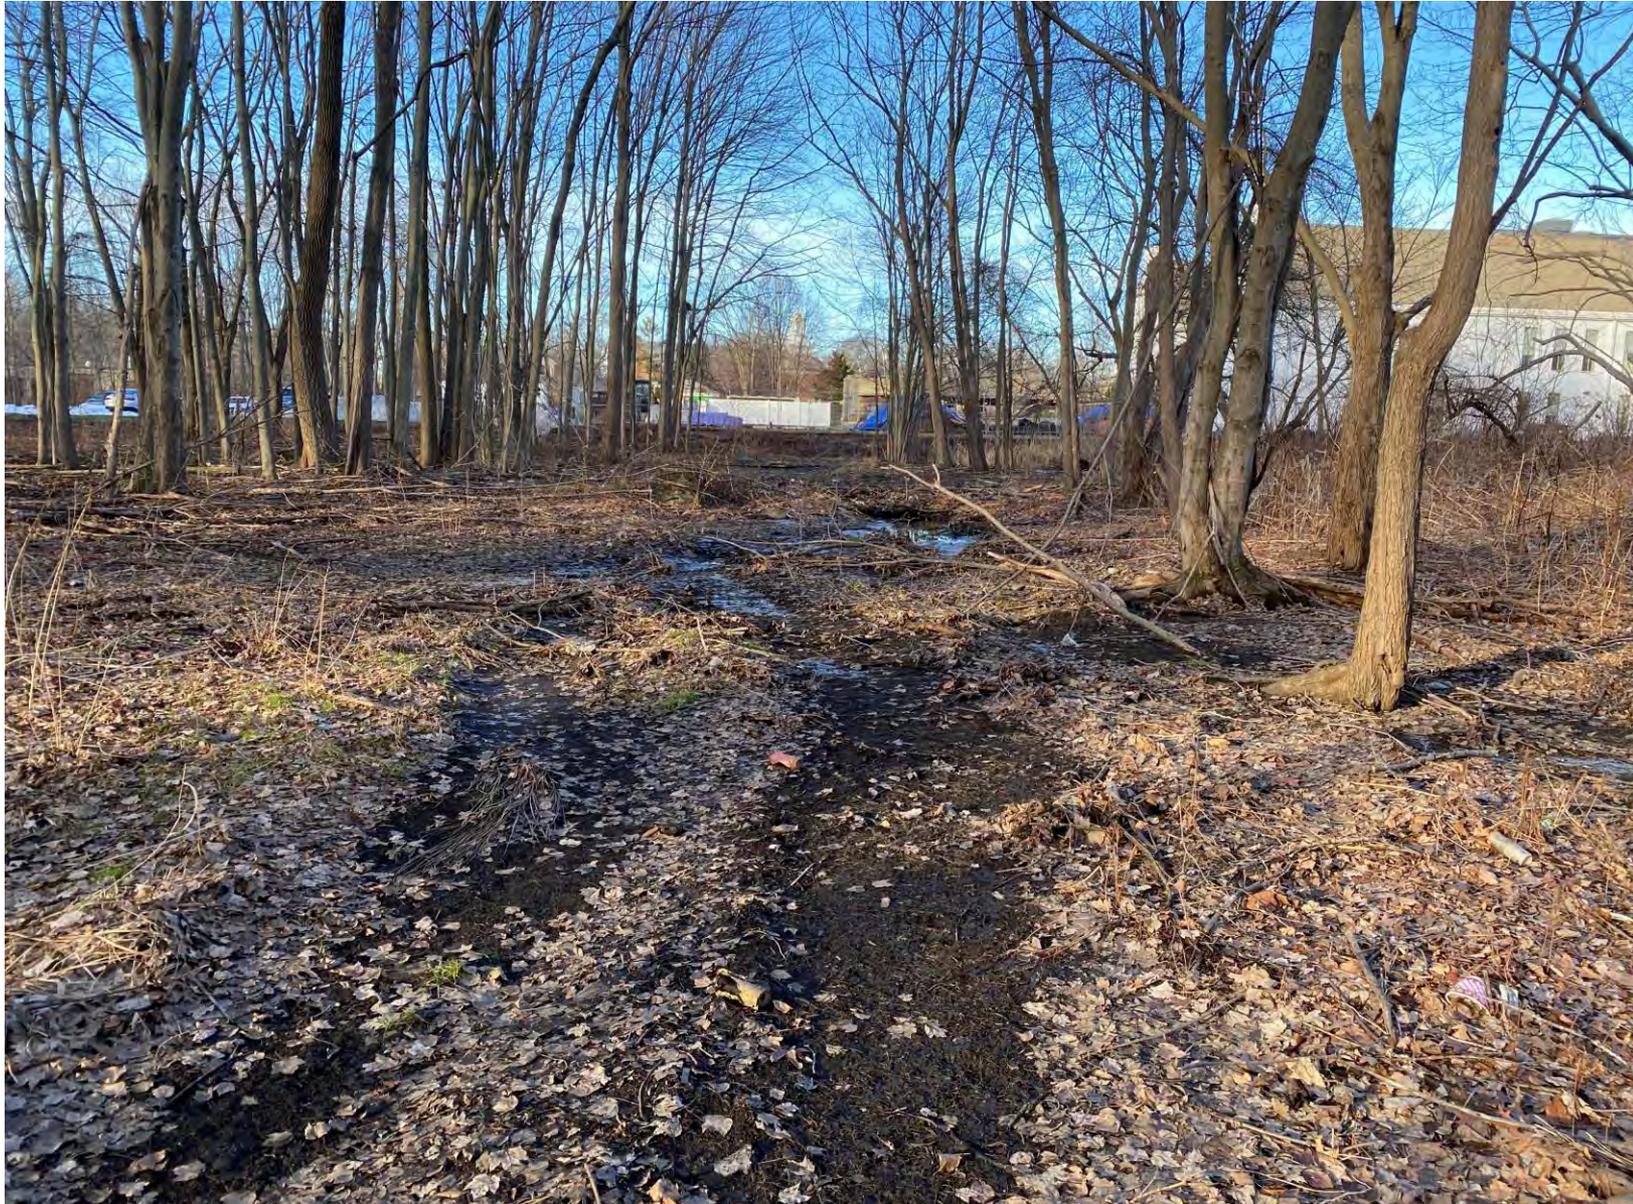
VIEW LOOKING NORTH ALONG SEWER EASEMENT SHOWING THE CLEARED EASEMENT AREA AND SURFACE FLOWS.

A sanitary sewer easement crosses the central portion of the wetland from north to south. The easement is generally cleared of trees and carries overland flows from the northeastern portion of the site resulting primarily from a 36" storm water outfall located to the rear of 2377 Main Street. Similar to the southerly outfall, some base flow, possibly resulting from groundwater exfiltration, is evident although the discharge could dry up in summer months. MBI observed the pipe outfall in March and January so no dry season data was collected.

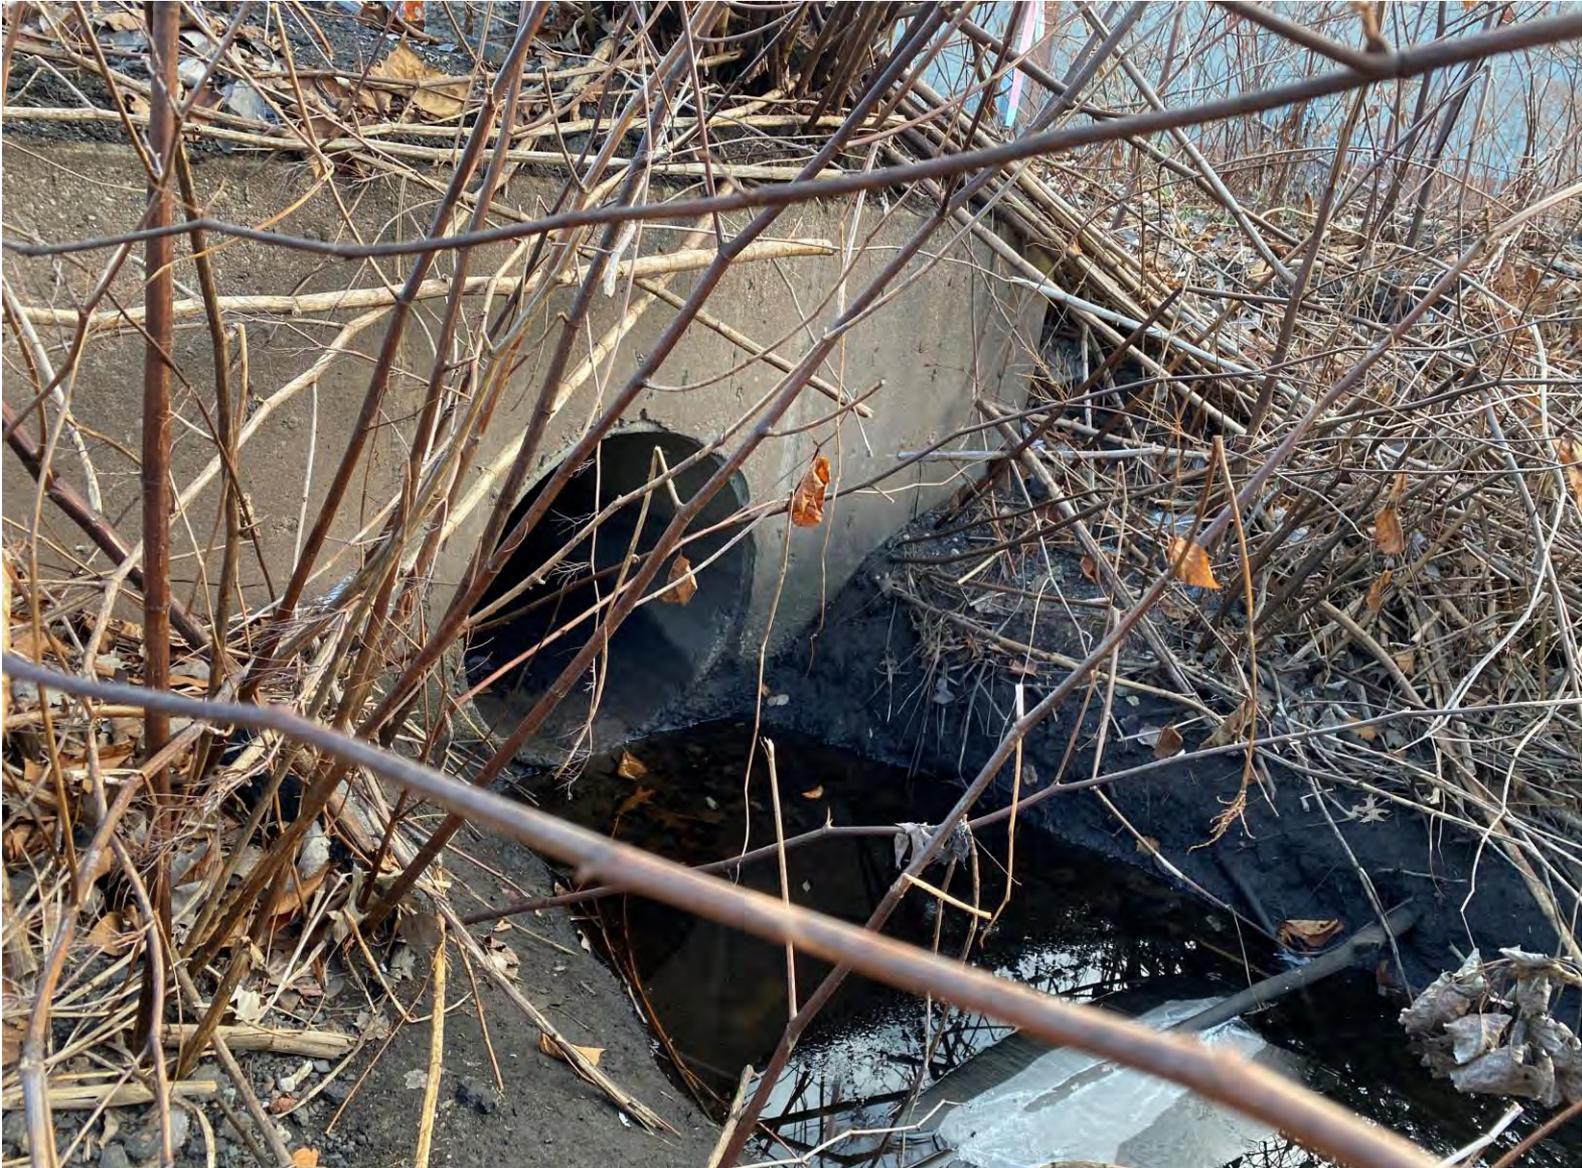
STORMWATER OUTFALL IN NORTHEASTERN PORTION OF WETLAND LOCATED WITHIN KNOTWEED STAND.

The northern portion of the wetland also receives intermittent stormwater discharges from a flared concrete pipe outfall located on the northern property boundary (adjacent to the library parking area). This pipe appears to discharge stormwater generated by the adjacent paved parking area.

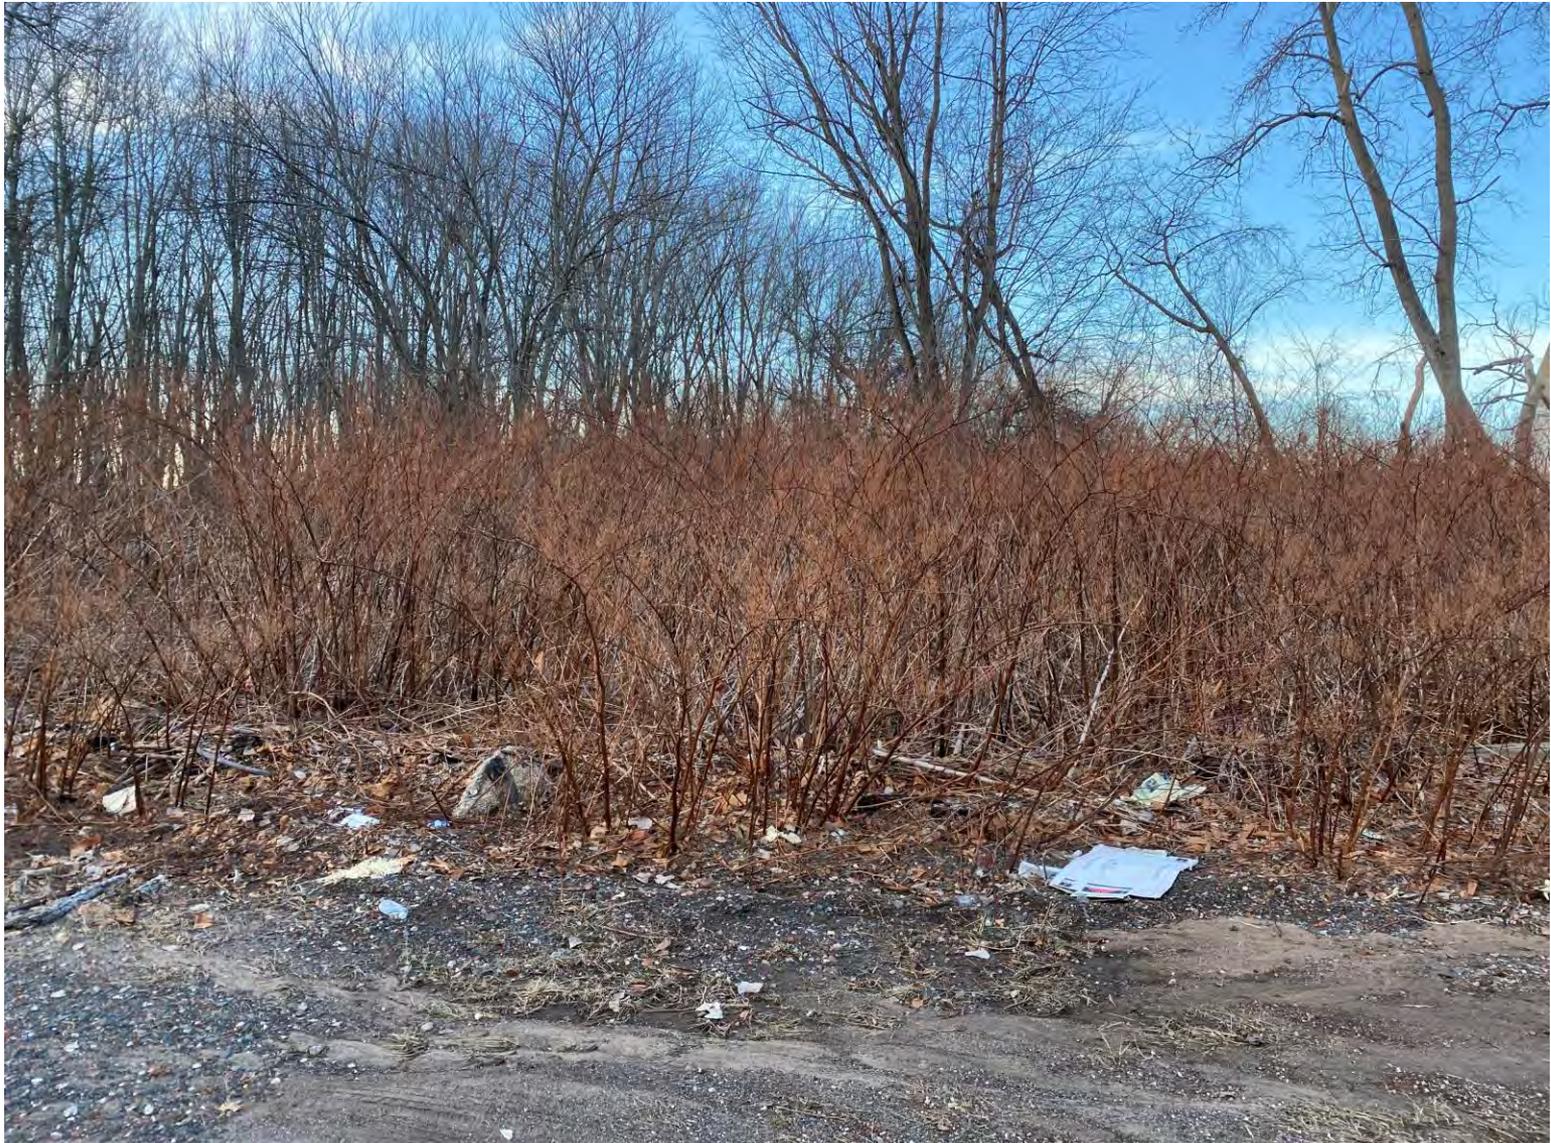
KNOTWEED STAND IN NORTHEAST PORTION OF WETLAND. BEHIND 2341-2355 MAIN STREET BUILDING

Plans that include the removal of invasive species from the site are currently under development for consideration. The stand of Knotweed along the watercourse represents a source of invasive seed stock that can be mobilized downstream. An aggressive plan for removal of these plants is strongly advised.

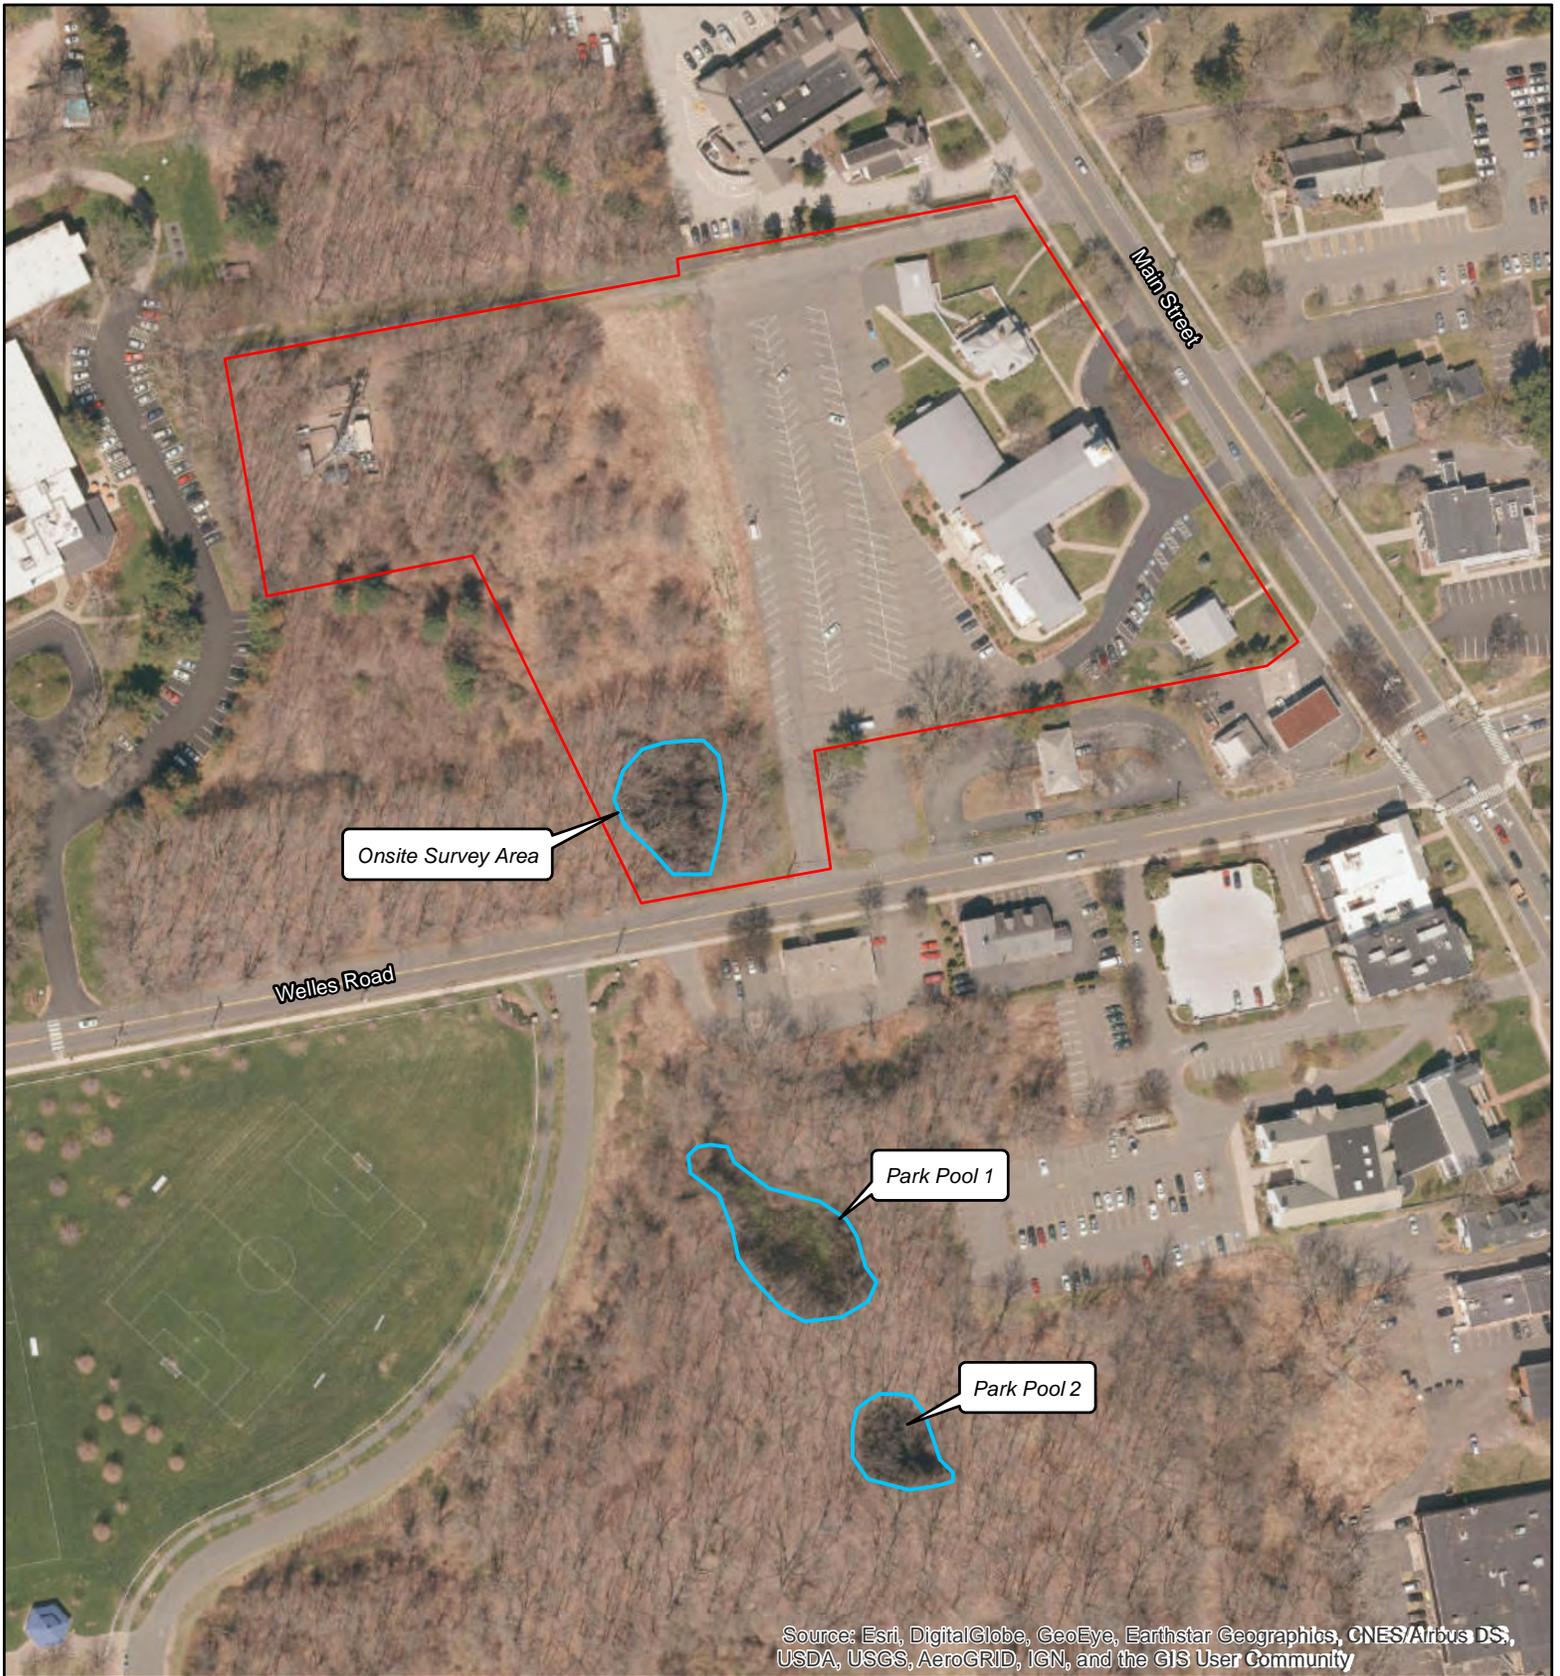
**FIGURE 1**  
**Aerial Map**  
**2019 Vernal Pool Survey**  
**St. Paul Church**  
**Glastonbury, CT**

- Site Boundary (approx)
- Wetlands Surveyed for Vernal Pools

Site visits were conducted on March 25<sup>th</sup> and 30<sup>th</sup> and April 17<sup>th</sup>. In addition to surveying the onsite wetland I also surveyed the wetland south of Welles Road within the riverfront park where two pools are located as shown on attached Figure 1. My observations were as follows:
