## Action 6.1.6 Worksheet

Information Requested	<b>Responses (Please also refer to any relevant document titles included in your submission)</b>
Project title	GLASTONBURY BLVD PEDESTRIAN SAFETY IMPROVEMENTS AND PAVEMENT REHABILITATION
Is the project a spot or area-wide improvement (please see full action write-up for distinction)? Is the project on a municipal road or non- municipal road (i.e. a state road)? If it is on a non-municipal road, provide a description of	This was an area wide improvement. Project limits covered 2824' of roadway across 4 + lanes. Glastonbury Blvd is a Municipally owned and maintained road.
the municipality's role in the project. Short project description, including how the project expands safe, connected active transportation networks. Please refer to the action description for project examples.	This project was completed in 2020 and include pavement rehabilitation and bicycle/pedestrian improvements on Glastonbury Boulevard over the full 2824' length from Main Street to Naubuc Avenue. This Town owned roadway is classified as a minor arterial and intersects the State Route 3 northbound on ramp. Glastonbury Boulevard has an average daily traffic count of

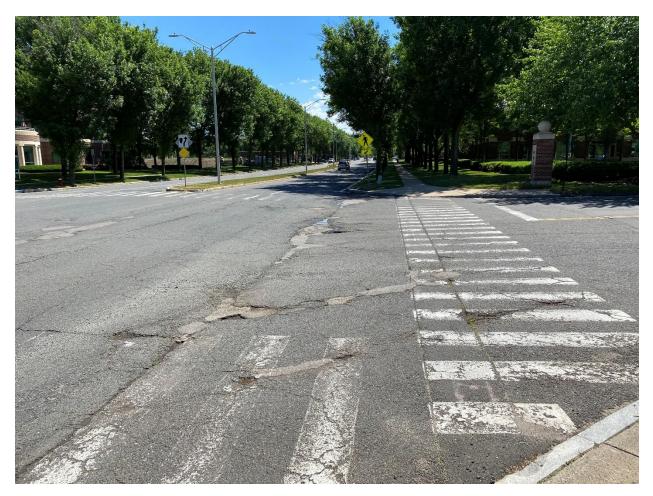
Pedestrian Crossing prior to construction

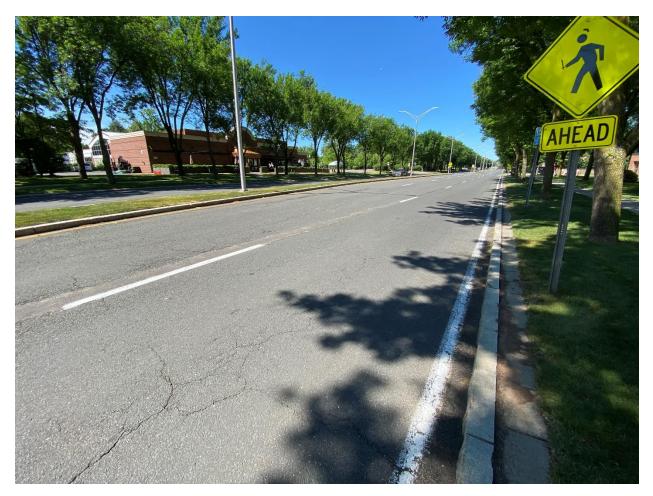
Absence of shoulder width prior to construction

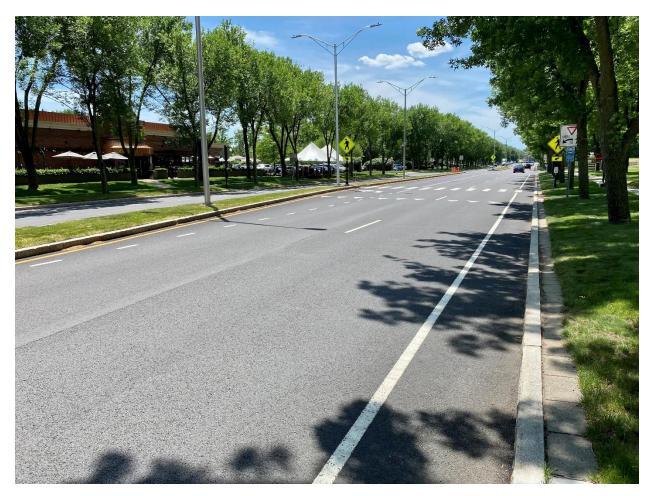
Wider shoulder width to accommodate cyclists post construction

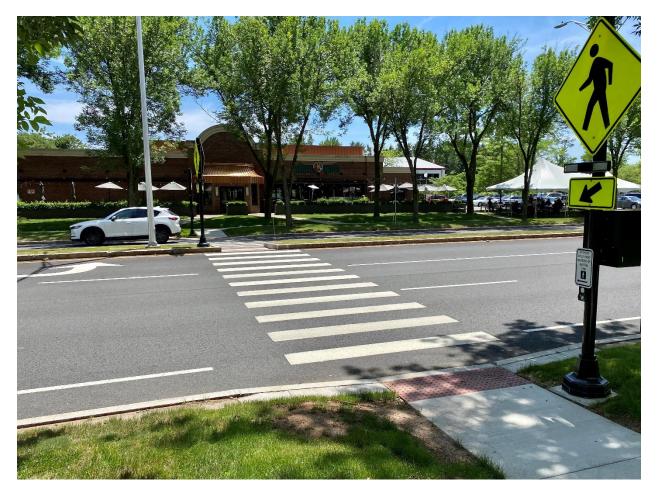
One of three newly installed RRFB signalized pedestrian crossings. Pedestrian phases also added to three existing signalized intersections.
