MEMORANDUM

Re: IWWA permit application for proposed bank stabilization along Wickham Brook on private residential property; 59 Olde Stage Road, Residence AA Zone & Groundwater Protection Zone 1.

Application Proposal

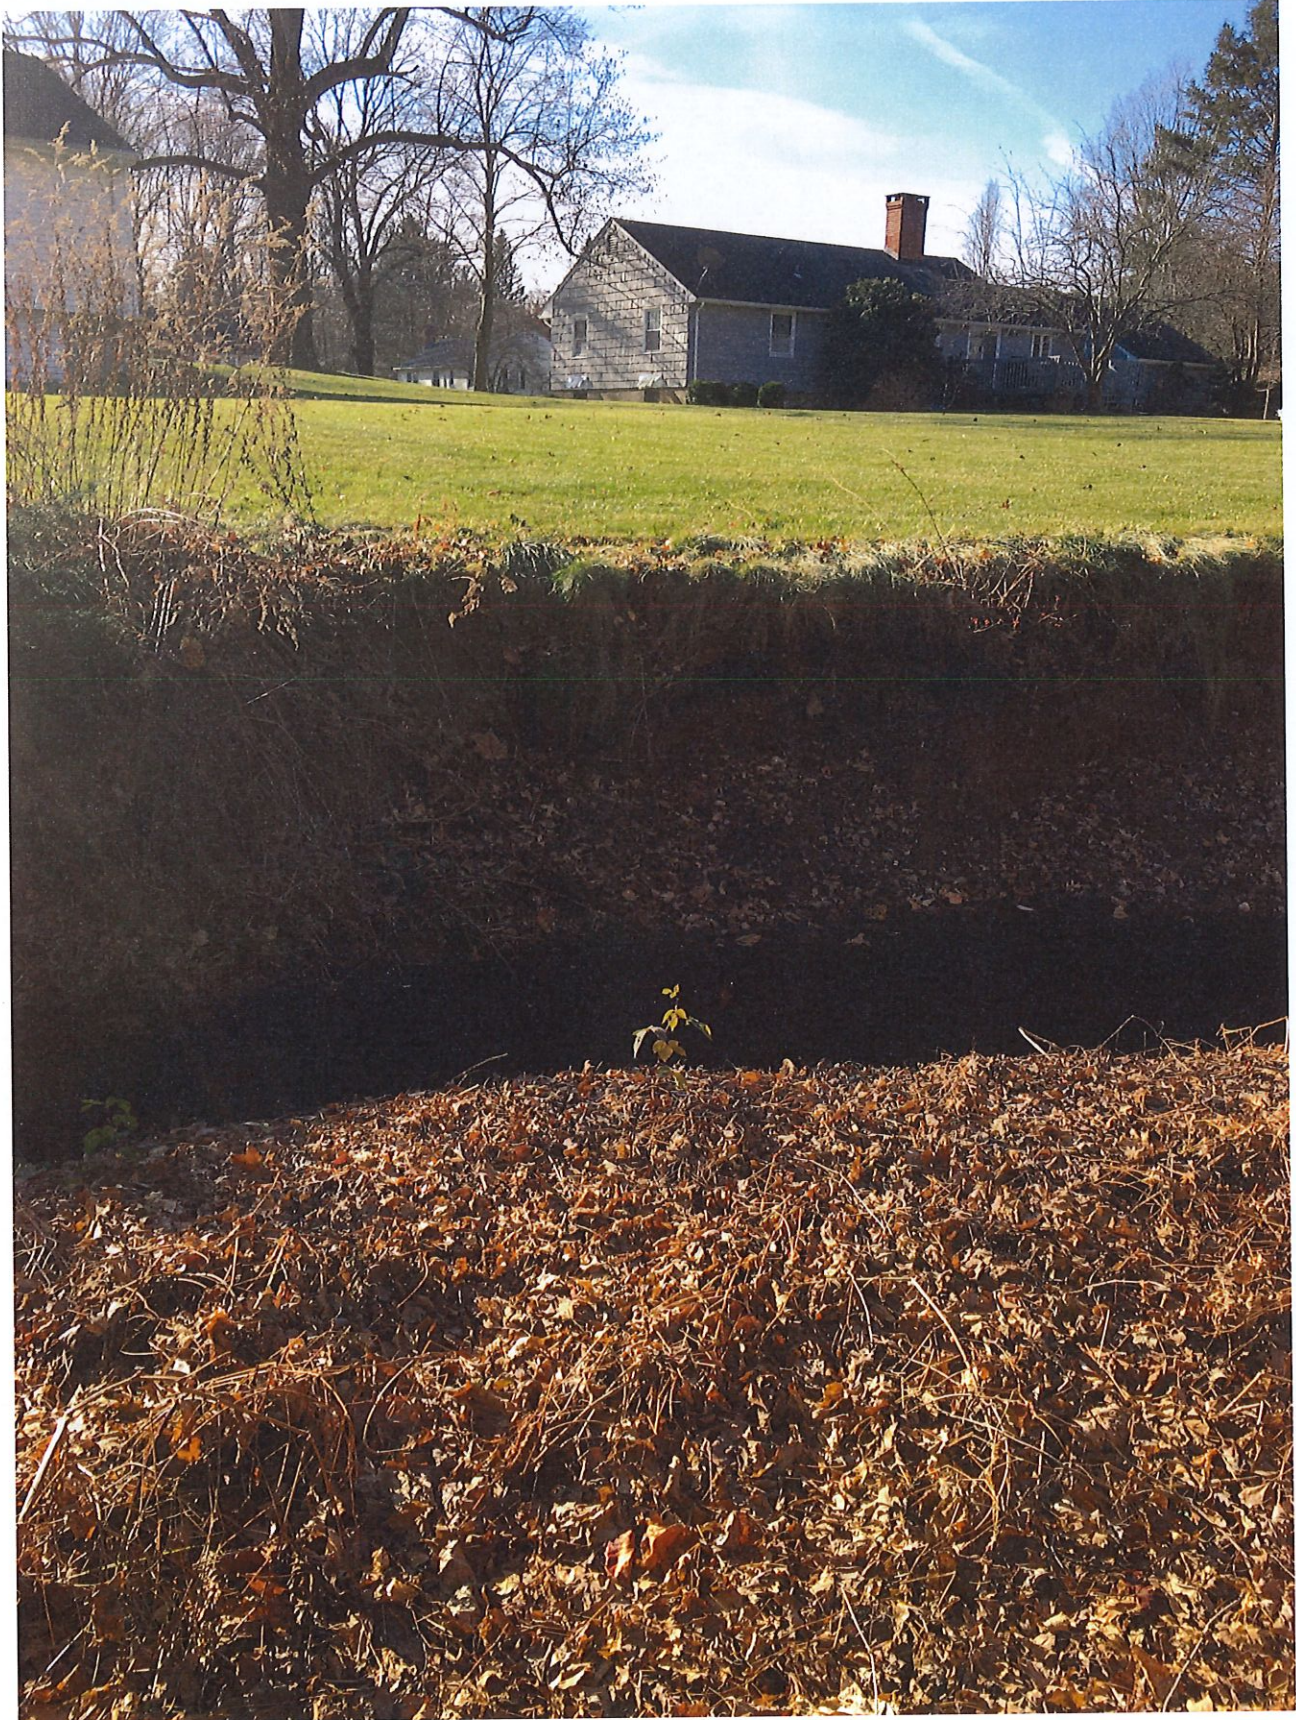
59 Olde Stage Road.

Picture taken facing the western stream bank of Wickham Brook. Erosion of soil at top of slope.

The owner of 59 Olde Stage Road has submitted a permit application to regrade and stabilize the presently eroding western bank of Wickham Brook. The applicant seeks permission to regrade the western stream bank at a 45 degree angle and anchor the soil in place with stone. The purpose of the proposal is to eliminate further erosion of soil into the brook. The proposed work area contains wetland soil.

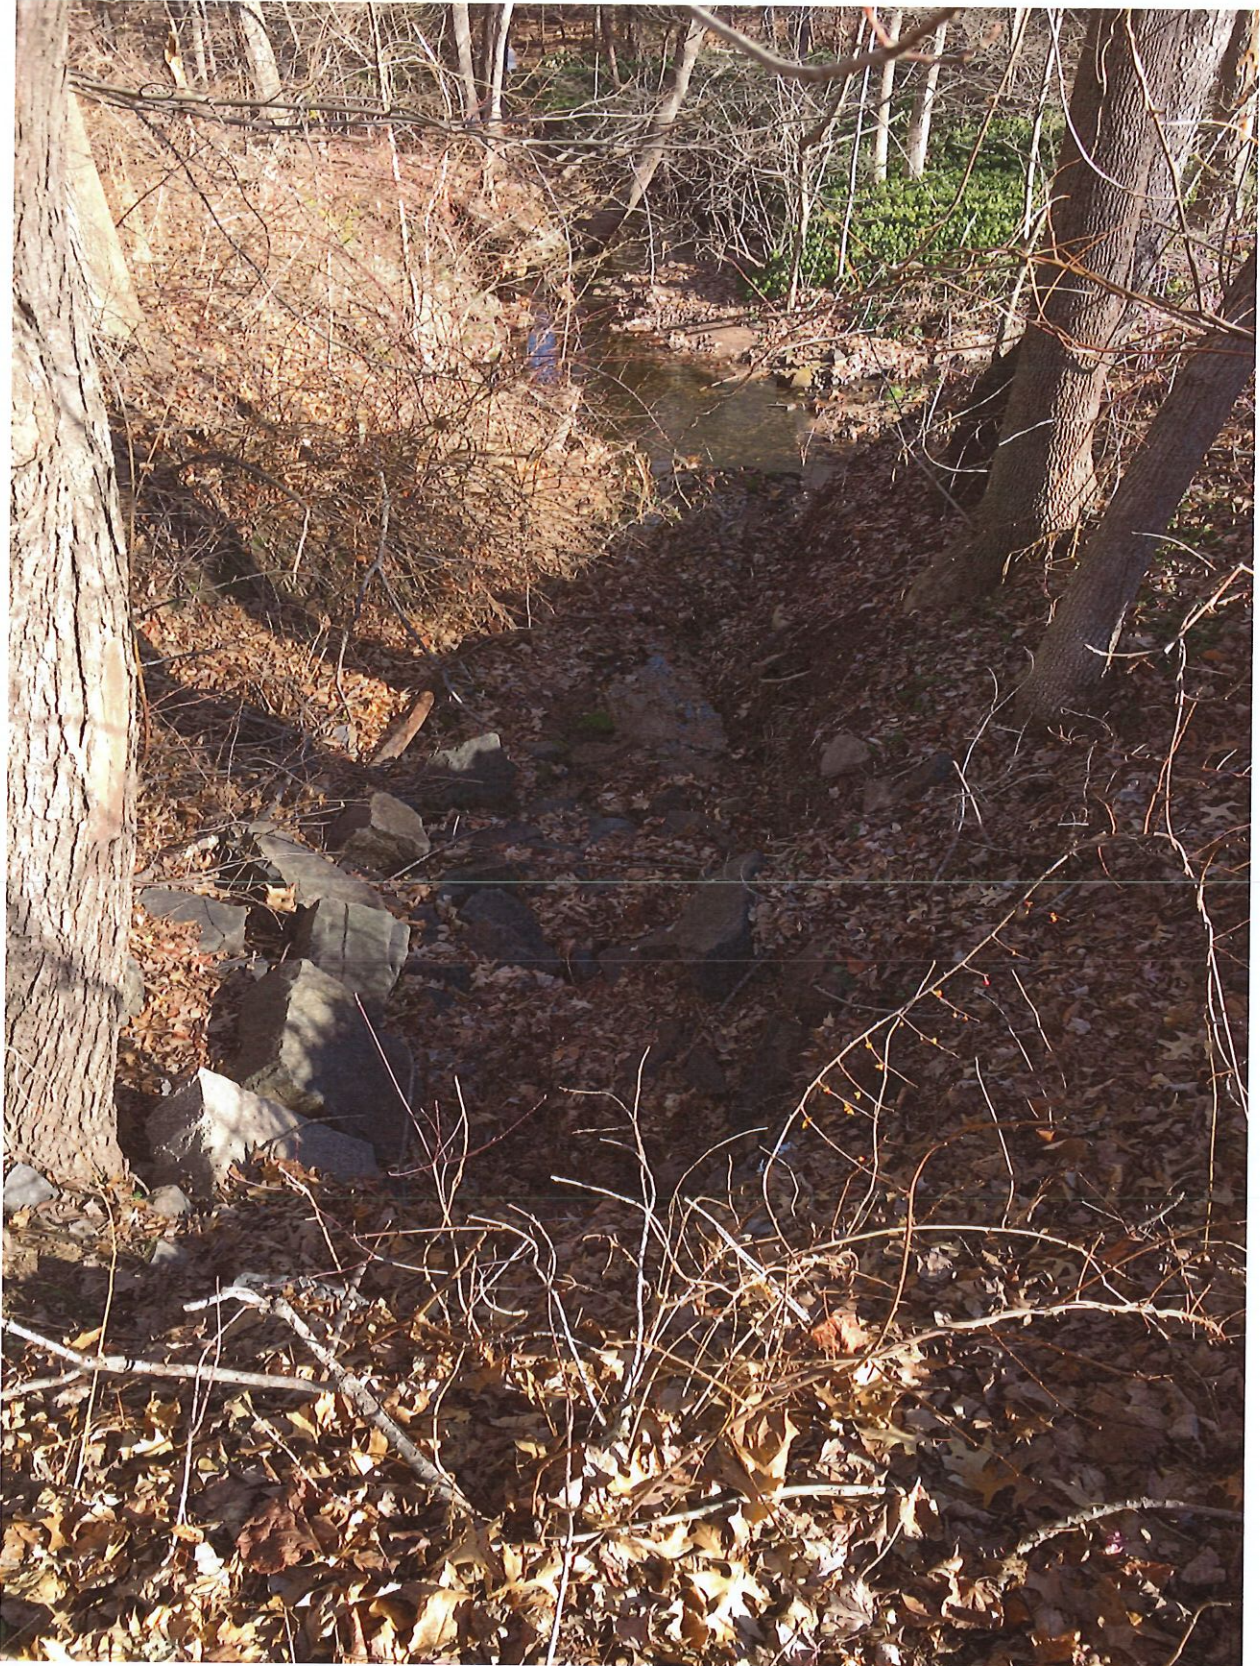
Large stone lining stream bank and channel in town drainage easement outlet in Wickham Brook.

The applicant designed the proposed plan in conjunction with a landscaping company. There is precedent for bank stabilization on this property with the town drainage easement occupying the western property boundary and outlet structure into Wickham Brook, shown on the attached map by the green line and red triangle in the blue lined area. The applicant indicates an interest in replicating that work to halt the erosion in the section of the bank not anchored by shrubbery. The approximate area of erosion is located in the area shown on the map with the blue lines coming off of the main drainage easement. Note that there is no drainage structure in the ground in this area. The applicant will provide further information on the size of the stone to be used in the project.

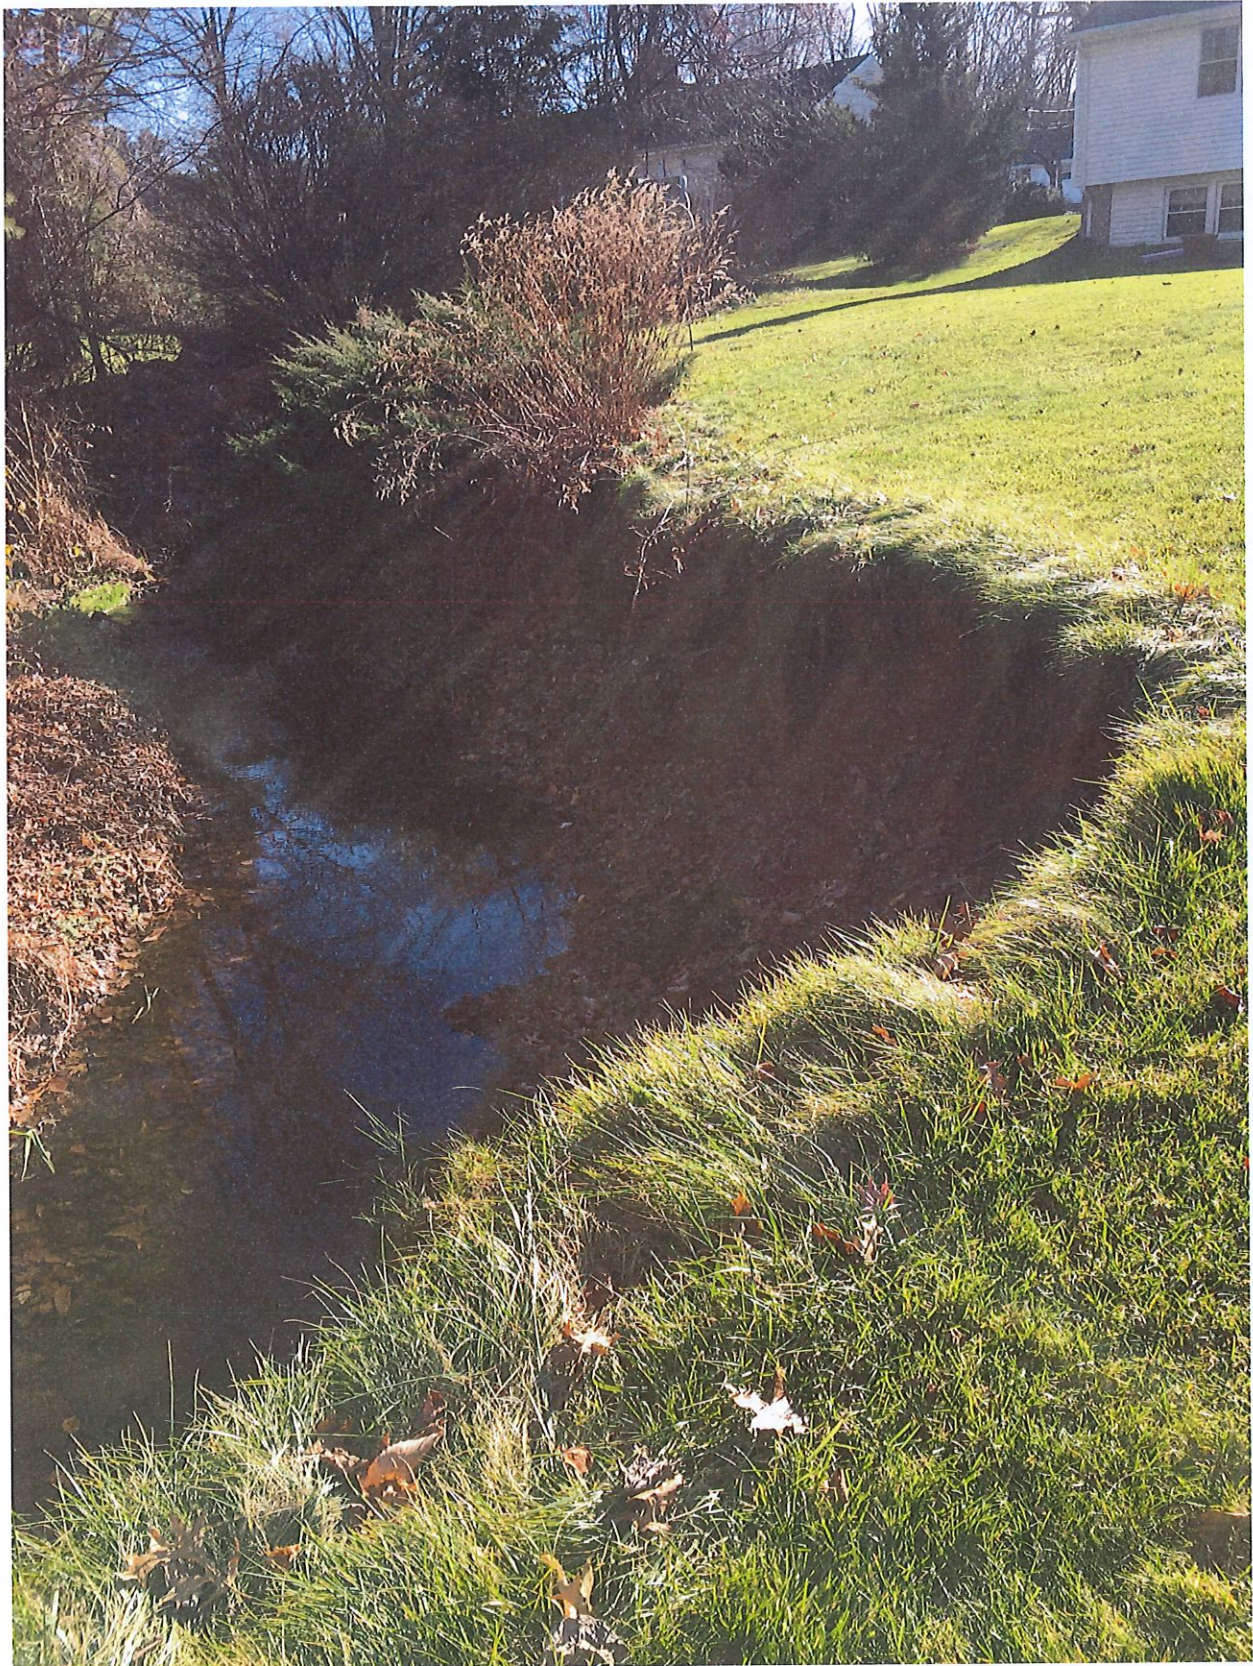
Picture taken facing the south along Wickham Brook. Erosion of soil at top of slope in lawn area.

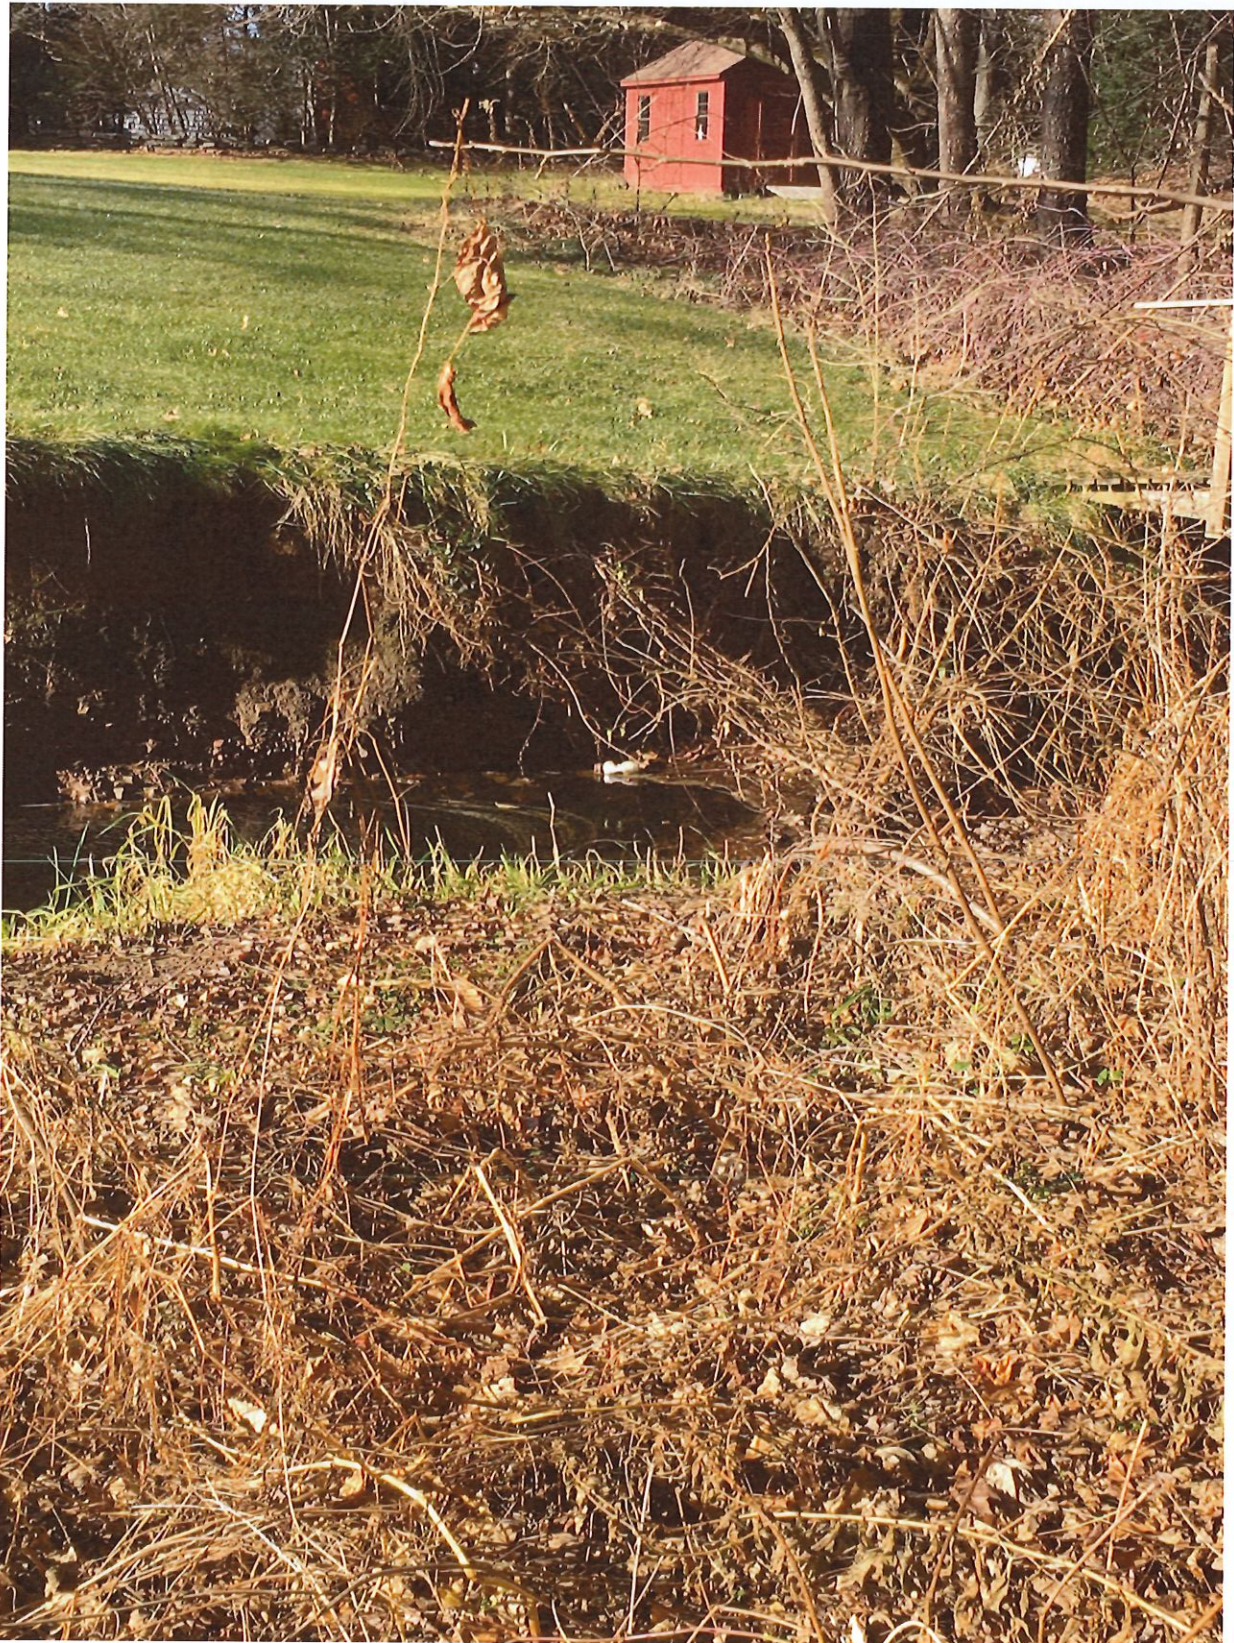
59 Olde Stage Road #4

Picture taken facing the western stream bank of Wickham Brook, approaching the town drainage pipe outlet.
