RE: Wetlands Delineation, Functions and Values and Impact Assessment
2333 Main Street
Glastonbury, Connecticut

Wetlands Report
Main Street – Glastonbury, Connecticut
July 25, 2024

Project:
 2333 Main Street

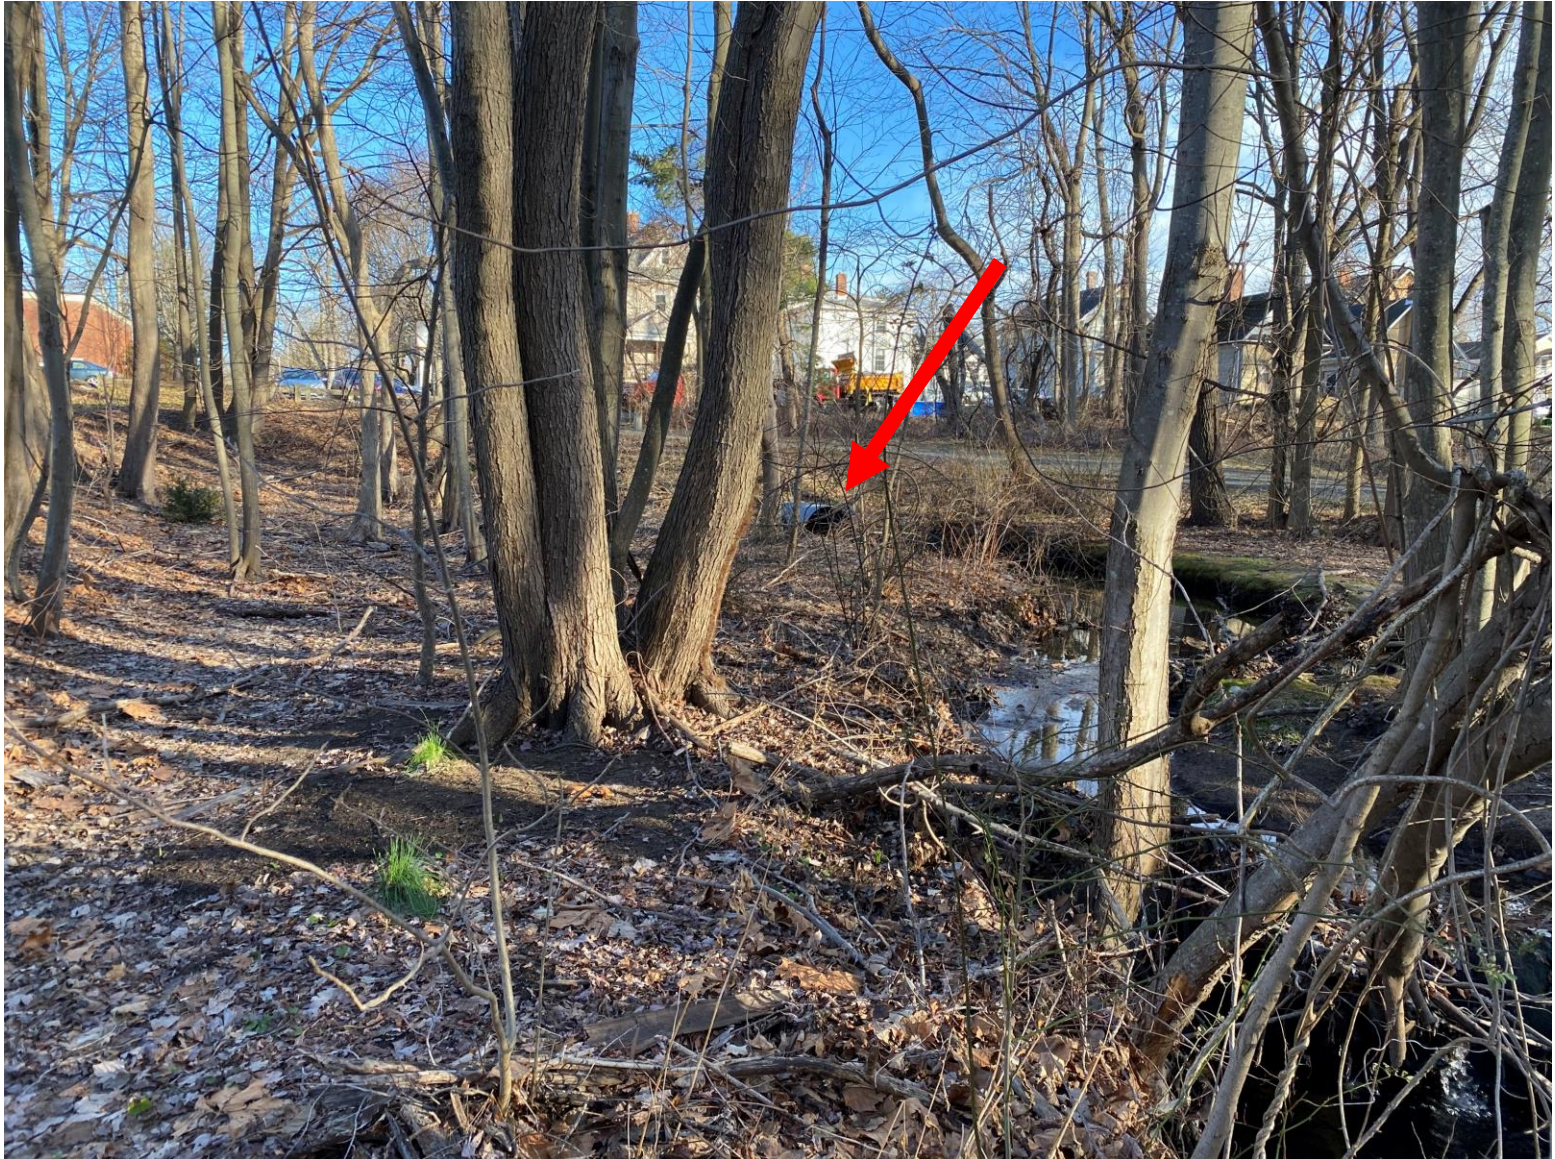
MBI accessed the property via the paved parking lot behind 2327-2333 Main Street and commenced the evaluation along the southern property boundary. A 48-inch, corrugated metal pipe discharges on to the southeastern portion of the property adjacent to a walking path that borders the property to the south. The watercourse associated with the discharge appears to exhibit perennial flows and bank floods during periods of heavy precipitation. Evidence of scour and rack lines were noted along the streambed. Subsurface exploration in this area using a hand auger exhibited soil generally consistent with the Scarborough Muck Soil Series. The adjacent non-wetland soil consisted of sandy, gravelly fill material along the edge of the paved parking area and extending along the eastern wetland boundary. Subsurface exploration west of the paved area, within the wooded wetland, exhibit similar soil as previously described with an apparent increase in organic matter. Wetland soils were generally characterized by 18-24 inches of black, mucky silt loam underlain with grey fine silty sand.

SOUTHERN PORTION OF SITE LOOKING EAST TOWARD CORRUGATED METAL PIPE OUTFALL (SEE ARROW) AND ASSOCIATED STREAMBED. NOTE FLOOD DEPOSITION IN FRONT OF MAPLE TREE CLUSTER IN LEFT CENTER OF PHOTOGRAPH.

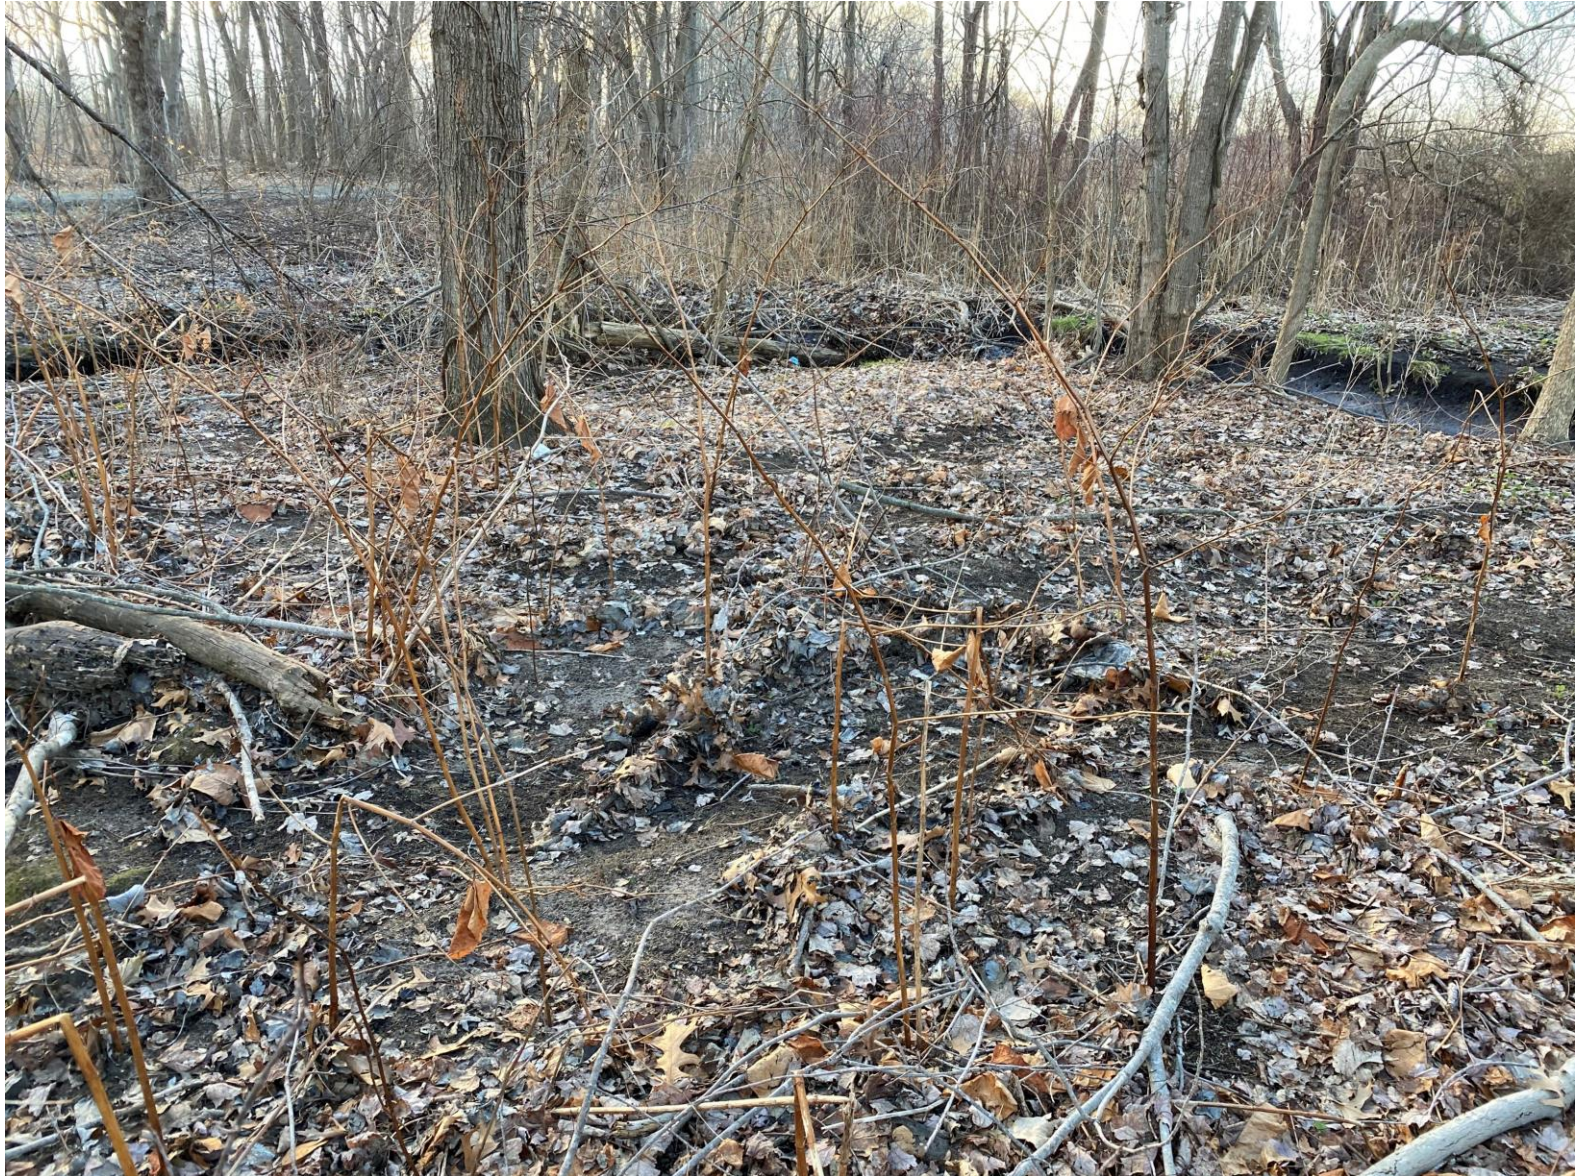
Sedimentation/Shoreline Stabilization – This function relates to the effectiveness of a wetland to stabilize streambanks and shorelines against erosion. Stream banks contain well-established woody vegetation offering soil stabilization on the whole. Some streamside erosion is evident as a result of flood flows and relatively erosive soil properties.

WETLAND AREA SOUTHWEST OF PAVED PARKING AREA WITH EVIDENCE OF FLOOD FLOWS ALONG BROOK

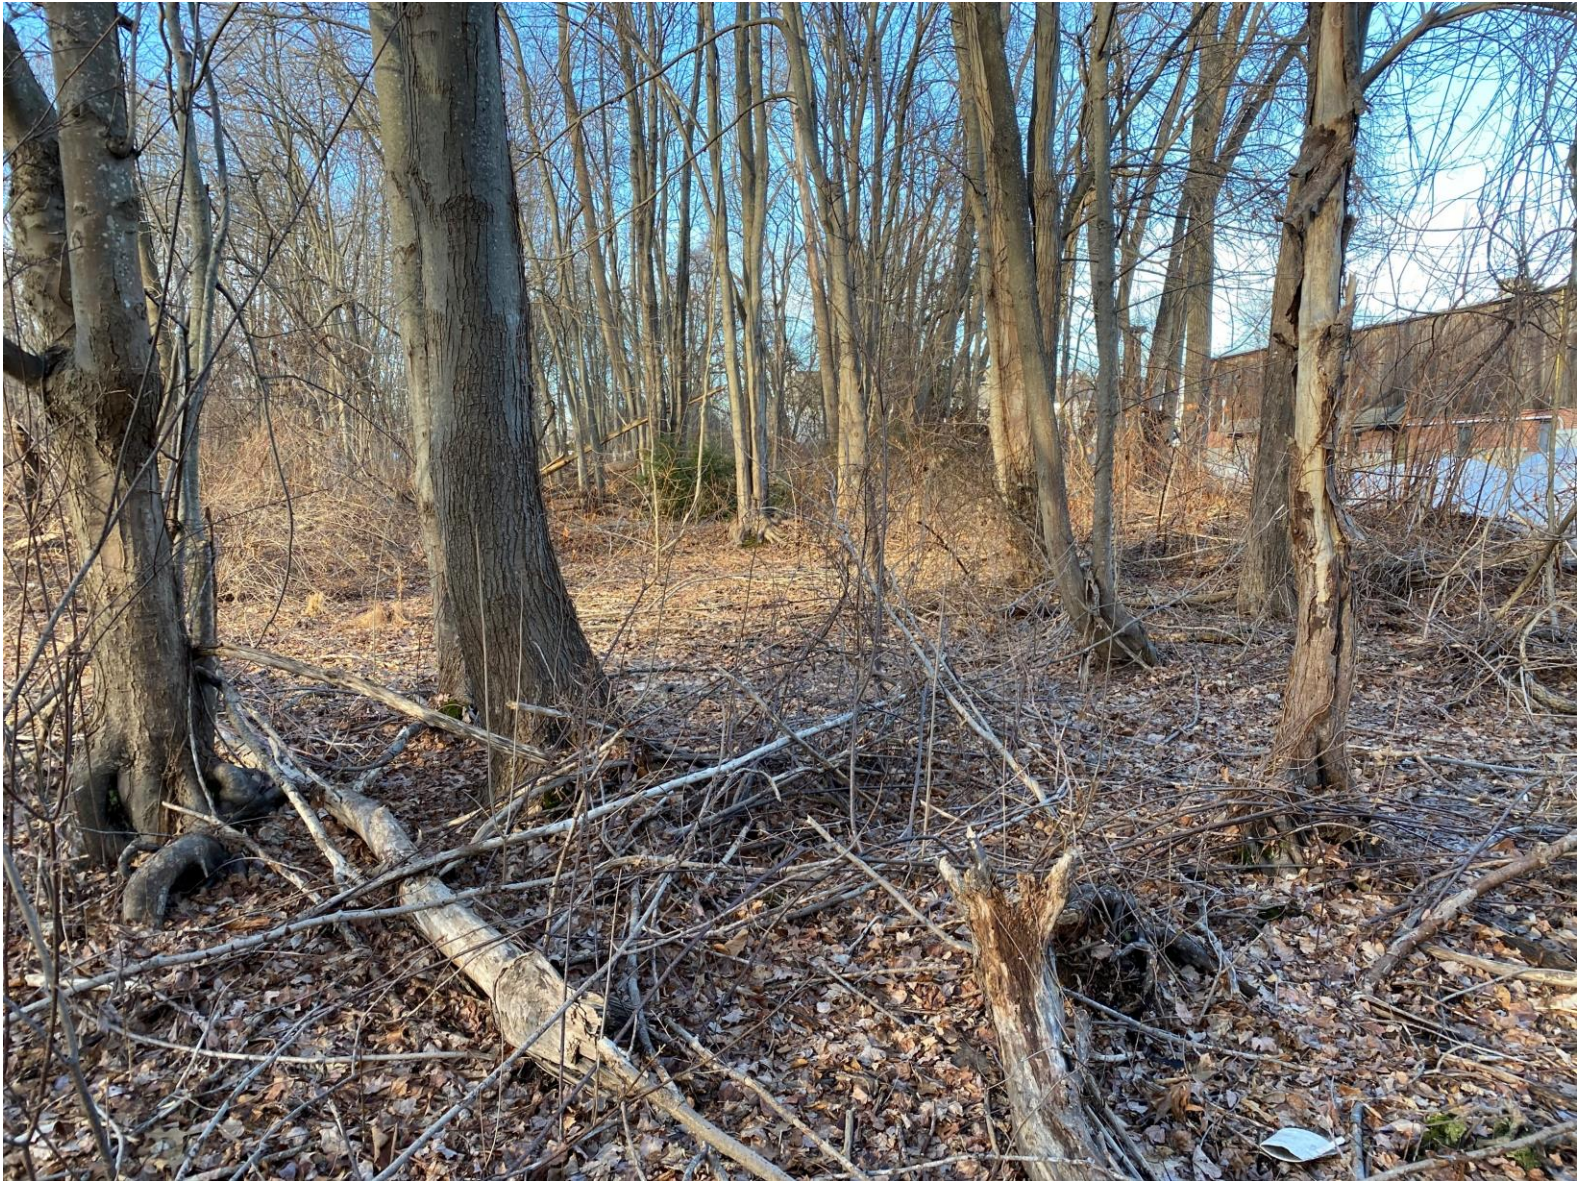
Woody vegetation observed within the Wetland area includes Red Maple (*Acer rubra*), Silver Maple (*Acer saccharinum*), Eastern Cottonwood (*Populus deltoides*), and Slippery Elm (*Ulmus rubra*). The shrub layer included Sweet Pepperbush (*Clethra alnifolia*), Silky Dogwood (*Cornus amomum*), Spice Bush (*Lindera benzoin*), Multiflora Rose (*Rosa multiflora*), and Asiatic Bittersweet (*Celastrus orbiculatus Thunb.*). Herbaceous species observed include Japanese Knotweed (*Polygonum cuspidatum*), Sensitive Fern (*Onoclea sensibilis*), Skunk Cabbage (*Symplocarpus foetidus*), and Evergreen Woodfern (*Dryopteris intermedia*). A large, dense stand of Japanese Knotweed occupies the northeastern portion of the wetland and extends along the majority of the wetland boundary where it abuts the paved areas. Abutting upland areas included Black Oak (*Quercus velutina*), Red Oak (*Quercus rubra*), Black Cherry (*Prunus serotina*) and Green Briar (*Smilax rotundifolia L.*).

TYPICAL WETLAND AREA CONTAINING BUTTRESSED RED MAPLES. NOTE SITE COMMERCIAL BUILDING IN BACKGROUND..

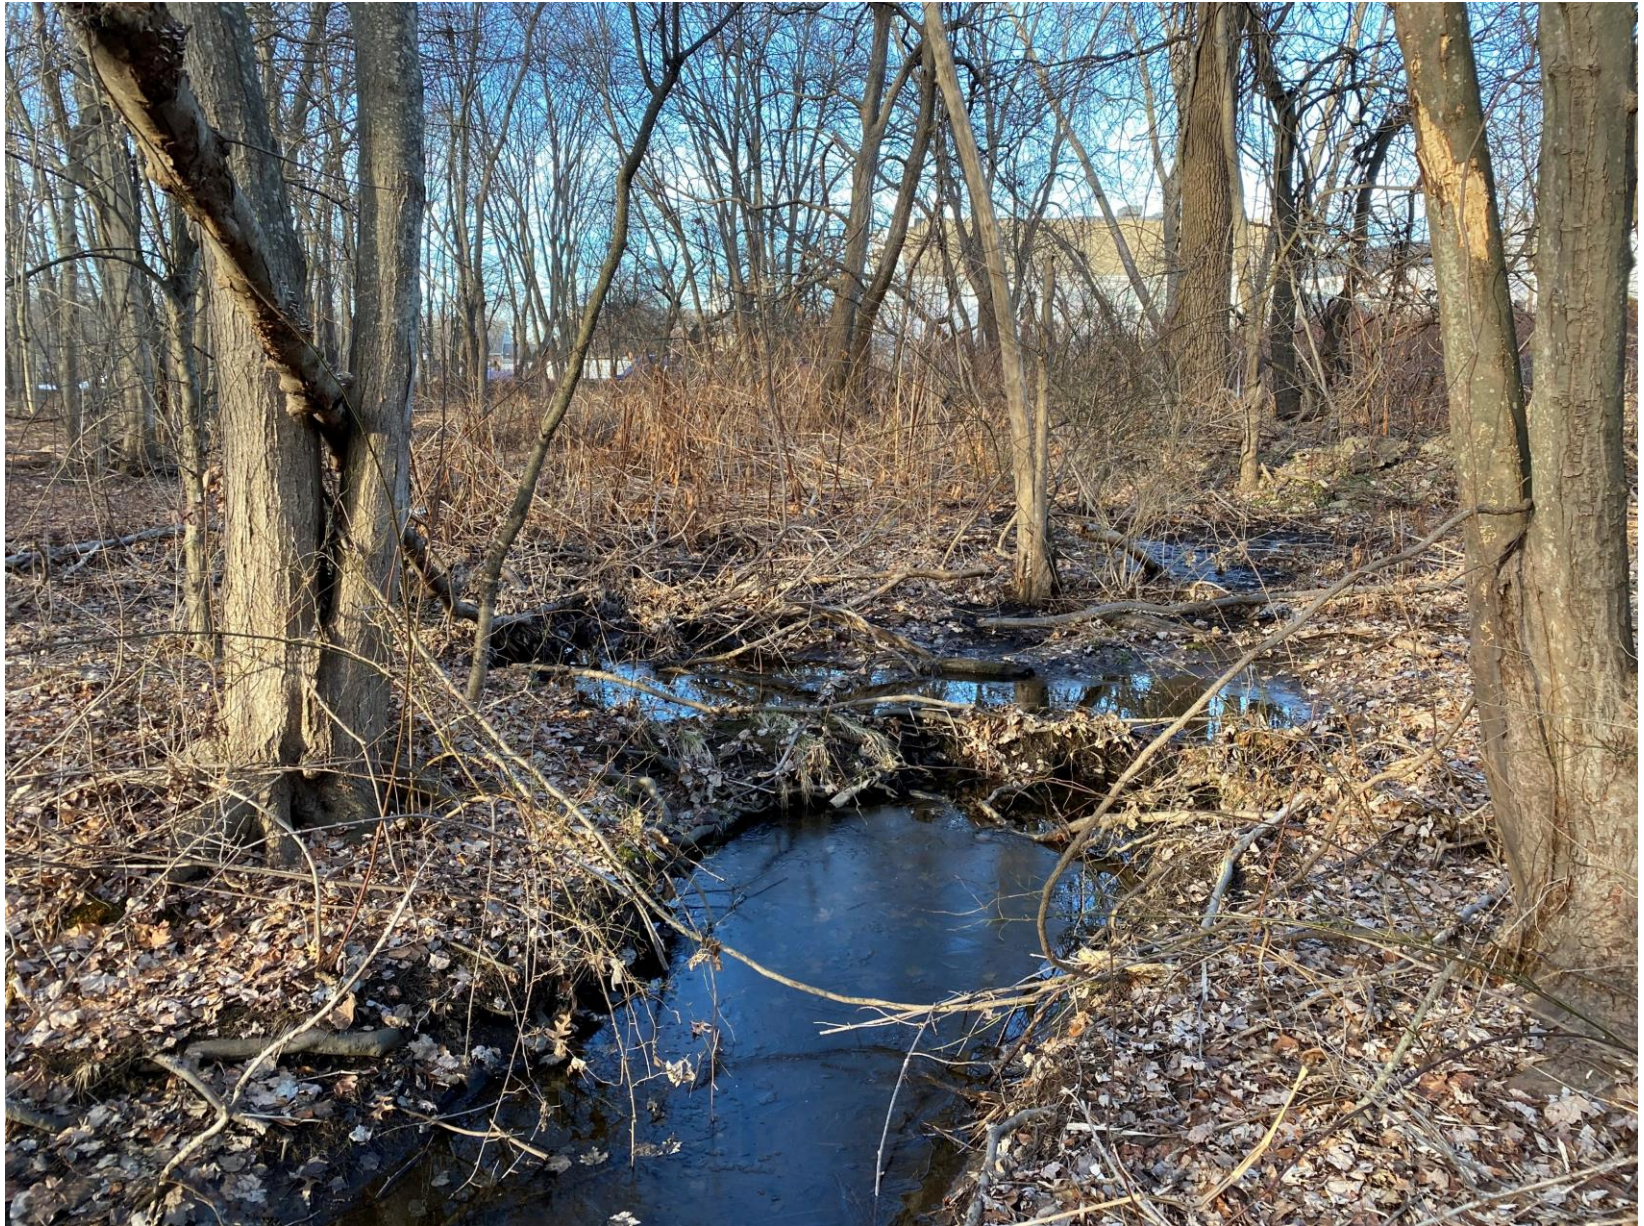
The northern outfalls ultimately deliver surface flows that follow the sewer easement southward. The leak-off from the paved parking area joins these surface flows from the east where they join and form a channel that turns westward and joins the channel from the southern watercourse near the western property boundary. The confluence flows west and southwest, eventually discharging into the Connecticut River approximately 1500 feet west of the property. No man-made stormwater renovation features are currently associated with the site.

SURFACE WATER FLOWS FROM NORTHEAST PORTION OF WETLAND FLOWING SOUTHWARD

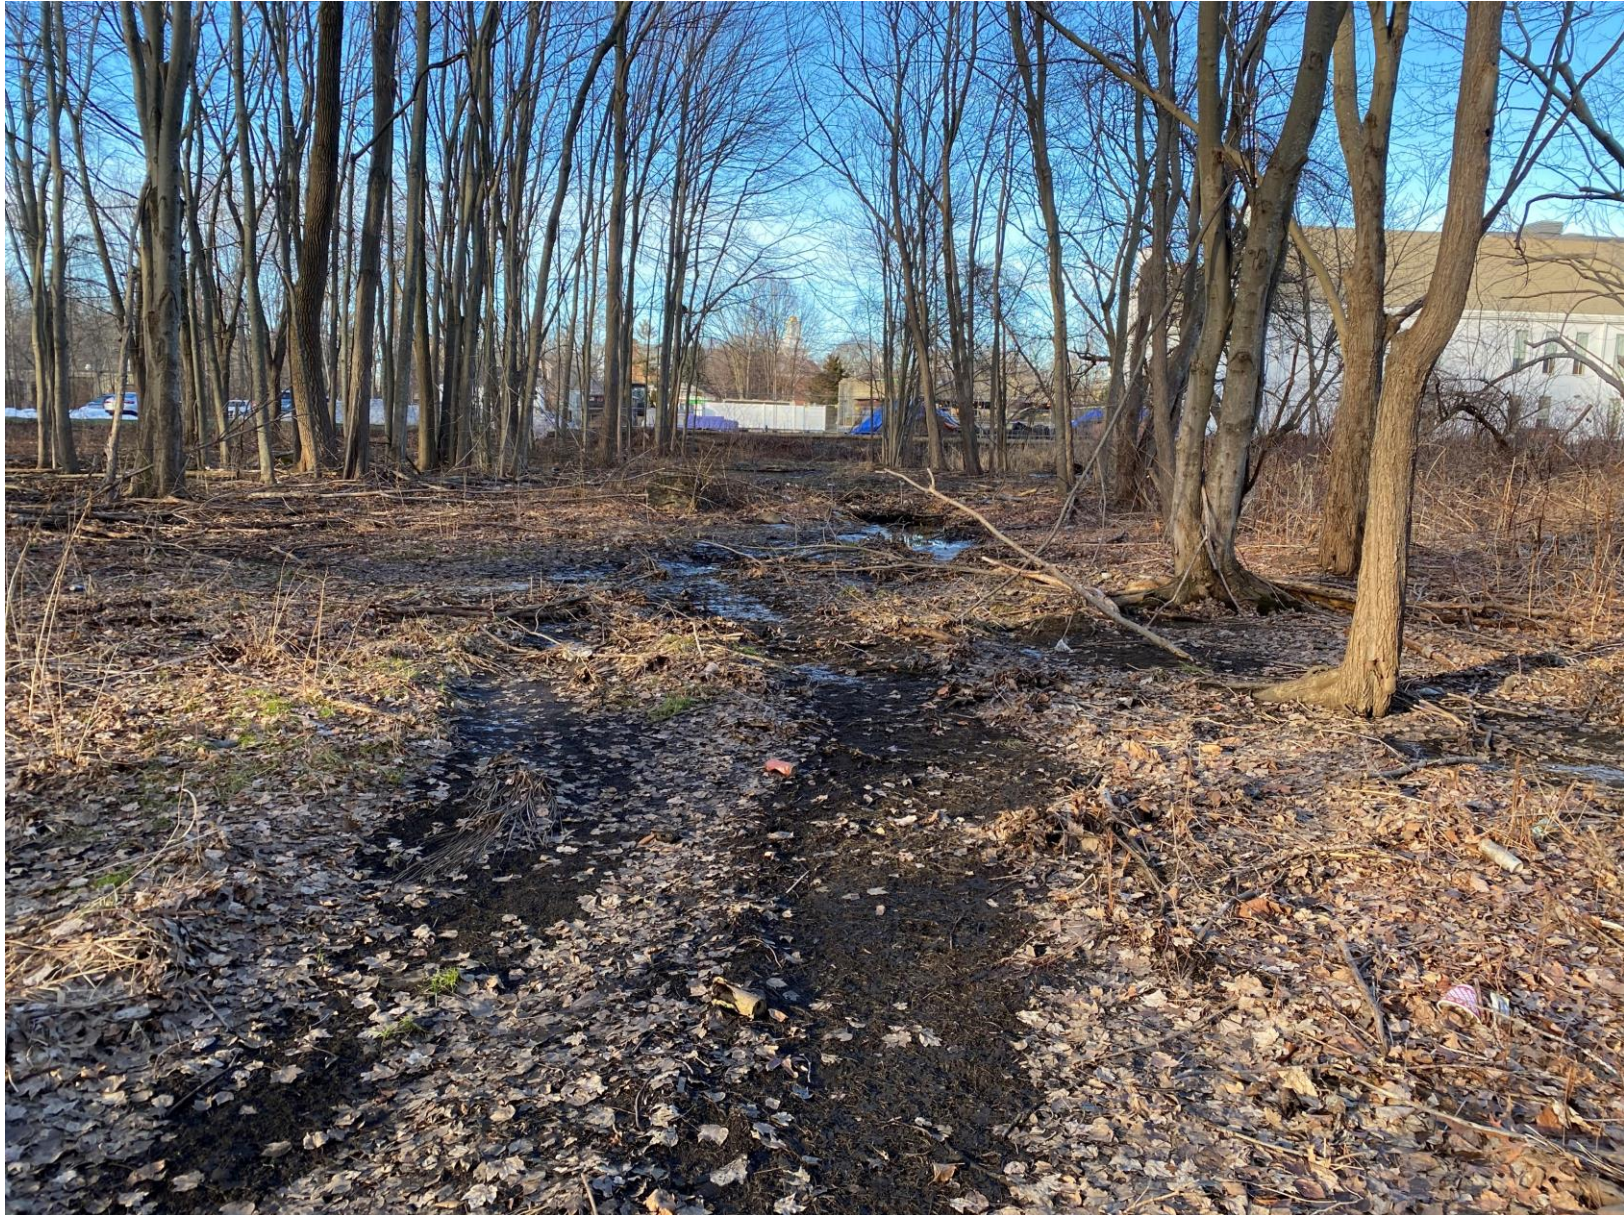
A sanitary sewer easement crosses the central portion of the wetland from north to south. The easement is generally cleared of trees and carries overland flows from the northeastern portion of the site resulting primarily from a 36" storm water outfall located to the rear of 2377 Main Street. Similar to the southerly outfall, some base flow, possibly resulting from groundwater exfiltration, is evident although the discharge could dry up in summer months. MBI observed the pipe outfall in March and January so no dry season data was collected.

VIEW LOOKING NORTH ALONG SEWER EASEMENT SHOWING THE CLEARED EASEMENT AREA AND SURFACE FLOWS.

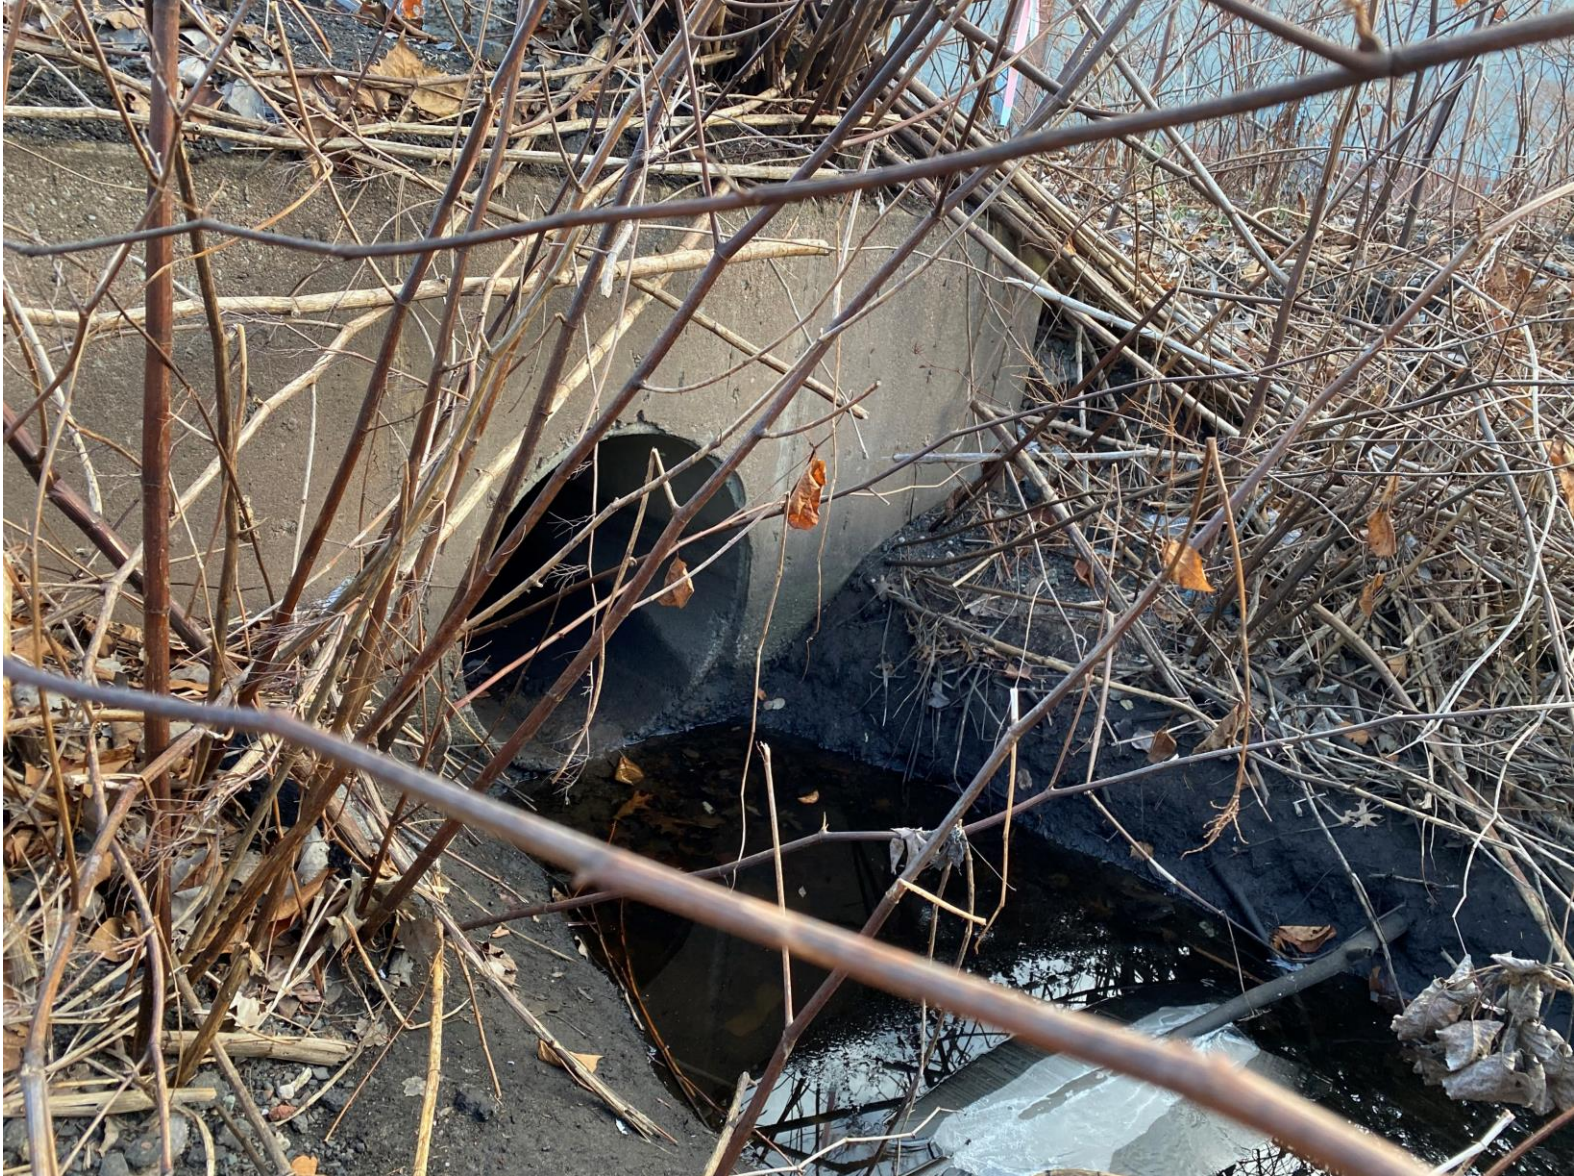
The northern portion of the wetland also receives intermittent stormwater discharges from a flared concrete pipe outfall located on the northern property boundary. This pipe appears to discharge stormwater generated by the adjacent paved parking area.

STORMWATER OUTFALL IN NORTHEASTERN PORTION OF WETLAND LOCATED WITHIN KNOTWEED STAND.

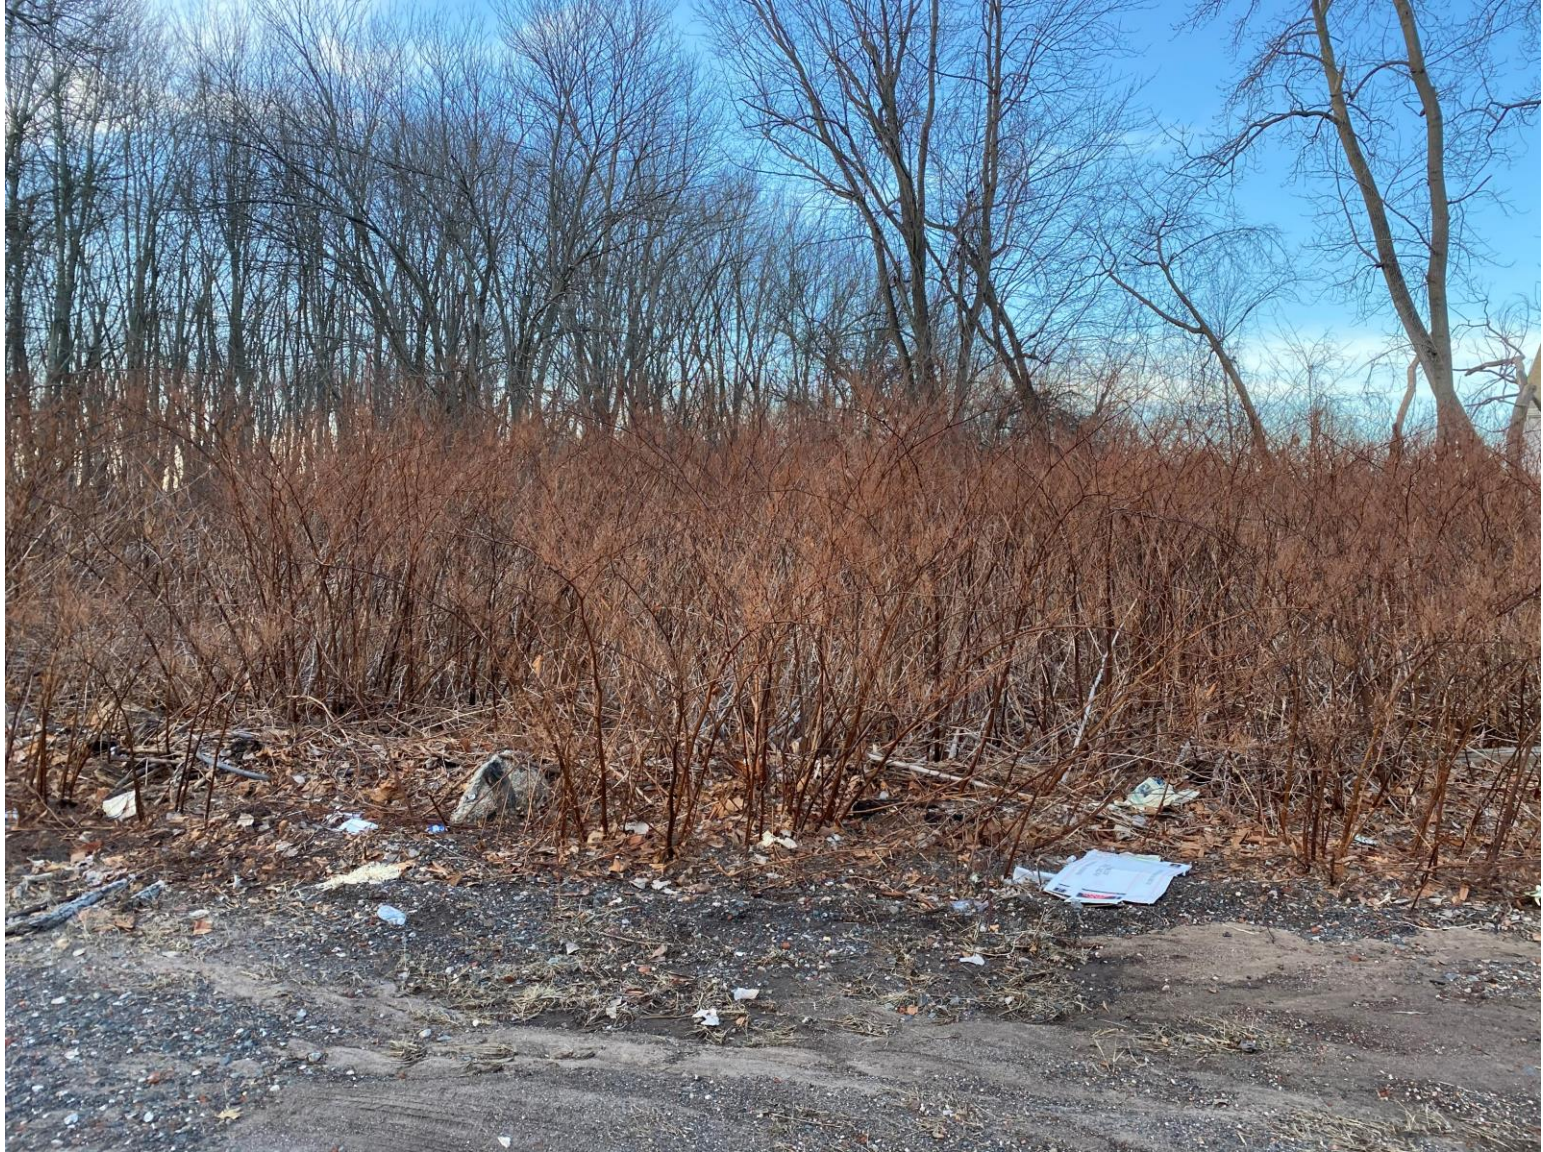
Visual Quality/Aesthetics – The wetland offers some visual qualities/aesthetics associated with the perennial stream entering the site although the disturbed eastern edge of the wetlands has resulted in the presence of significant invasives species.

KNOTWEED STAND IN NORTHEAST PORTION OF WETLAND. BEHIND 2341-2355 MAIN STREET BUILDING

- Project erosion control measures should be strictly enforced and monitored in accordance with CTDEEP's 2024 Manual to ensure that no sediment intrusion into the wetlands occurs;
- Install native wetland and upland (as appropriate) shrubs along the basins and other improvements that will be located along the wetland boundary.
- Ensure that Knotweed removed as part of the project installations is properly managed so that fill material containing plant material is not distributed to other areas of the site or offsite.

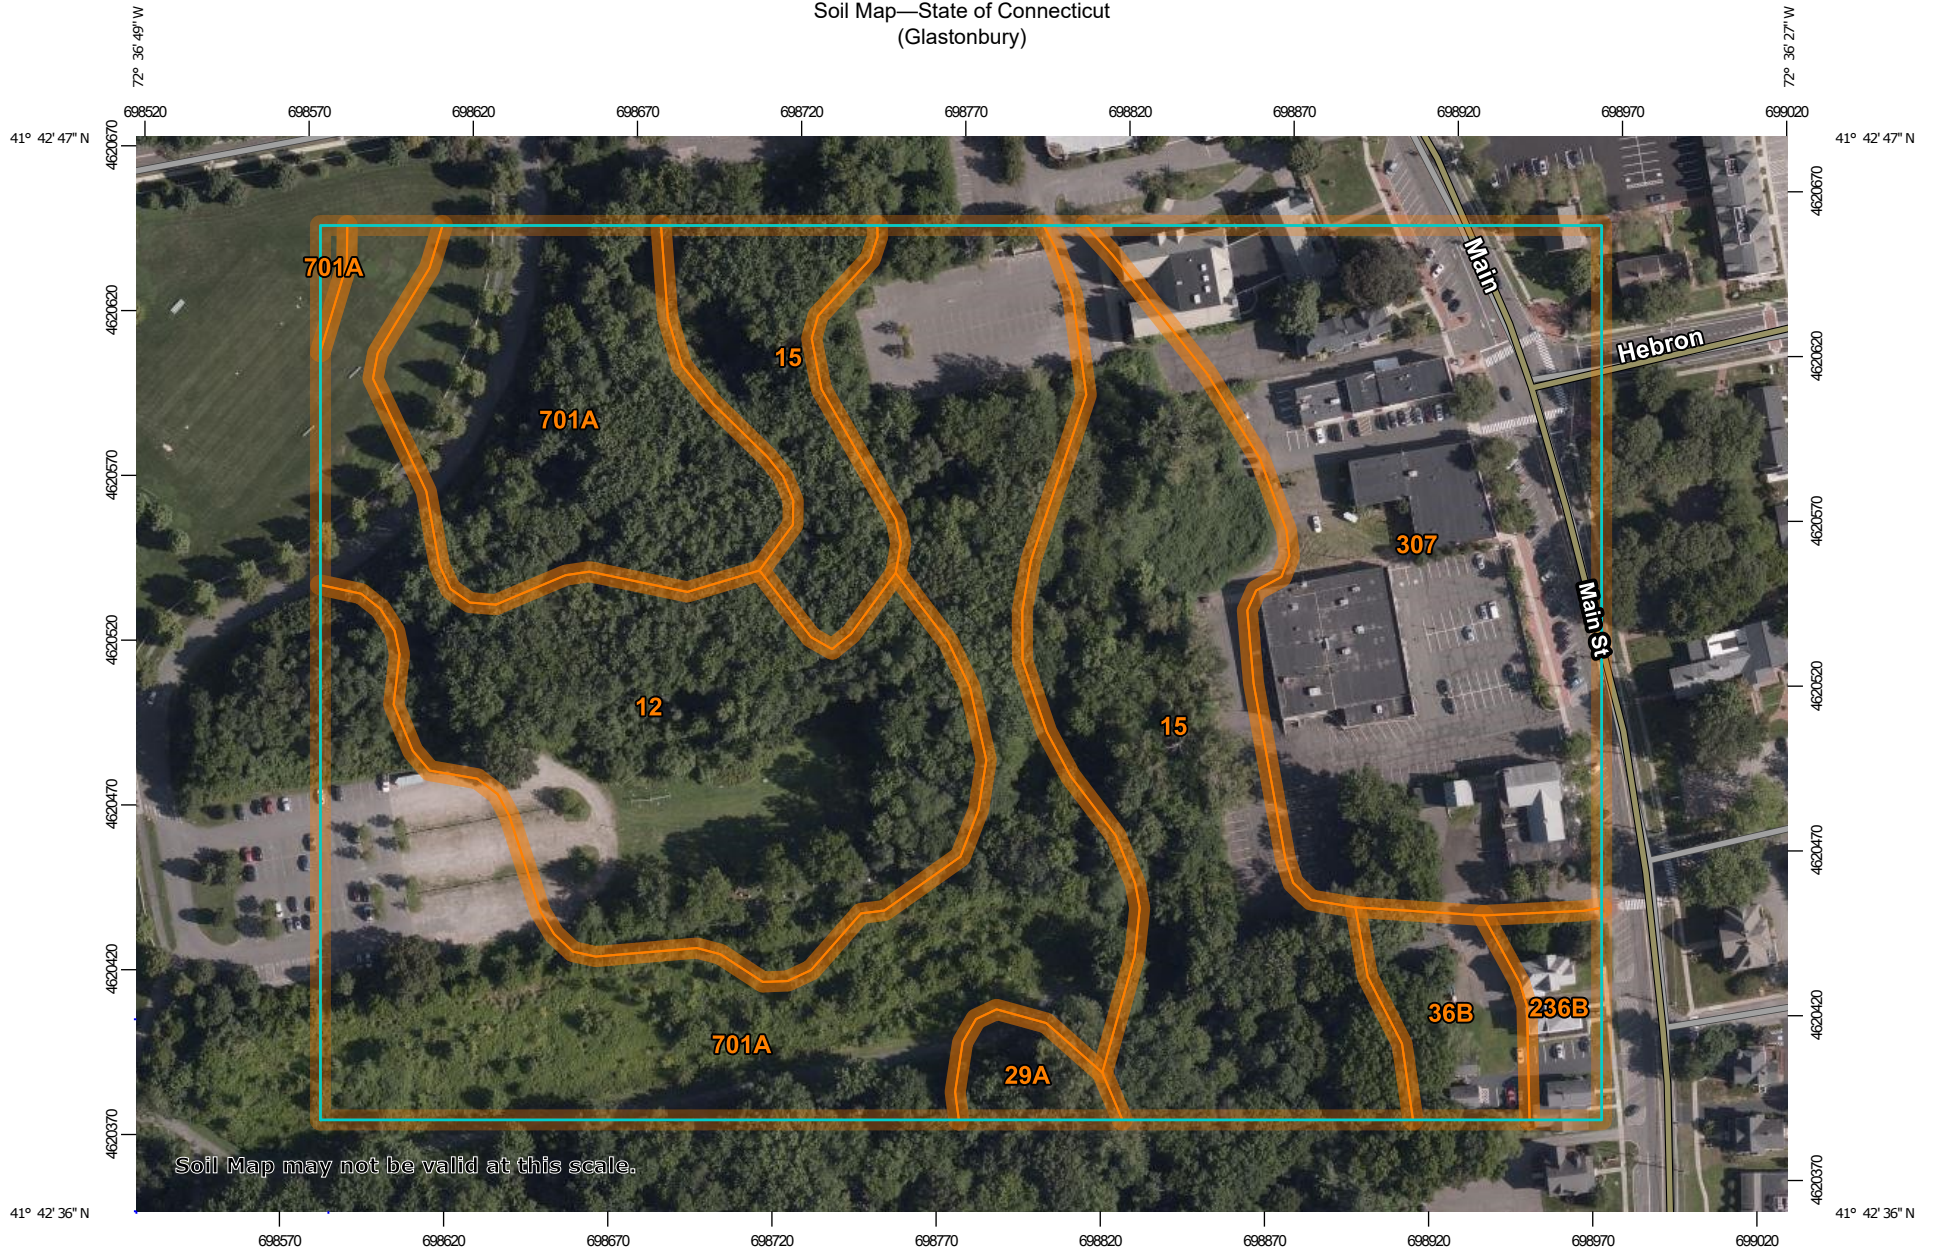
Soil Map—State of Connecticut
(Glastonbury)

The Natural Resource Conservation Service (NRCS) identifies Scarboro Muck as the wetland soil type in the delineated wetland area which is consistent with observed conditions. NRCS soil mapping and descriptions are provided as Attachment B.
