Pre-Demolition ACM and Lead Based Paint Survey
For 429 Marlborough Road
Prepared by Triton Environmental, LLC

Site Plan
429 Marlborough Road

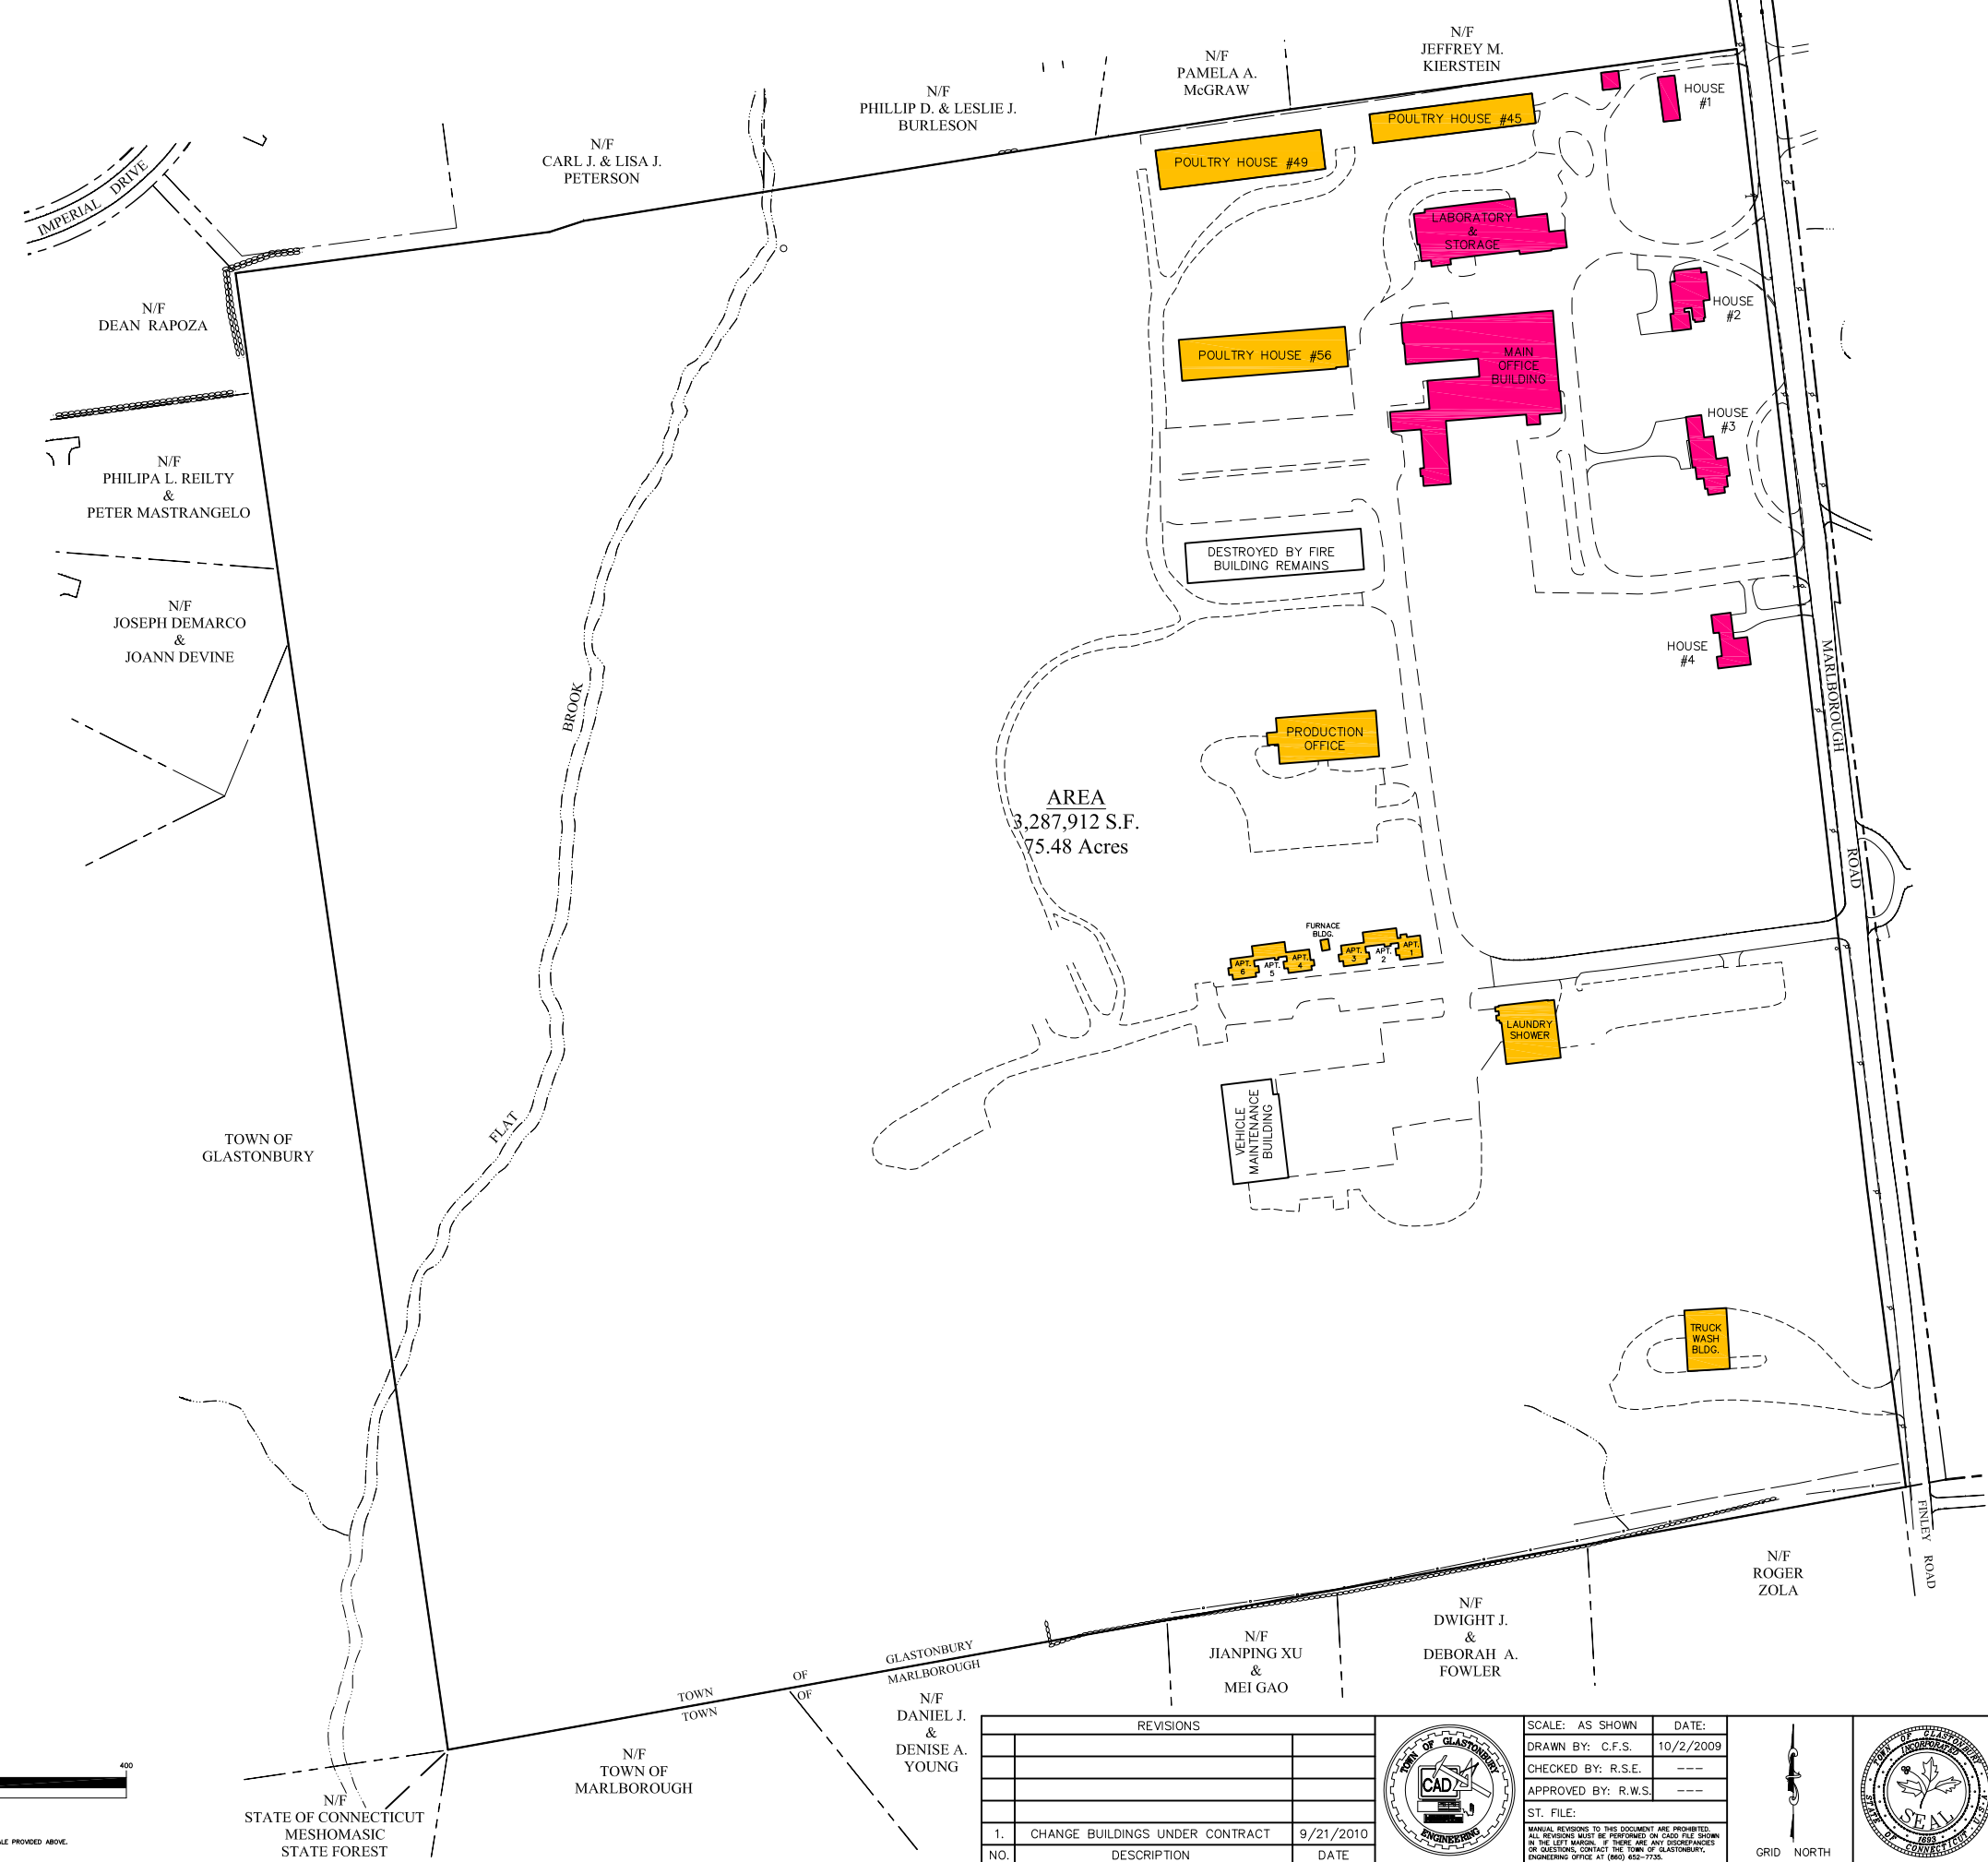
- Structures Previously Demolished
- Structures Included in Asbestos Removal Contract
