**TOWN OF GLASTONBURY  
BID NO. GL-2012-01**

**68 MATSON HILL ROAD DEMOLITION**

**ADDENDUM NO. 1  
JULY 29, 2011**

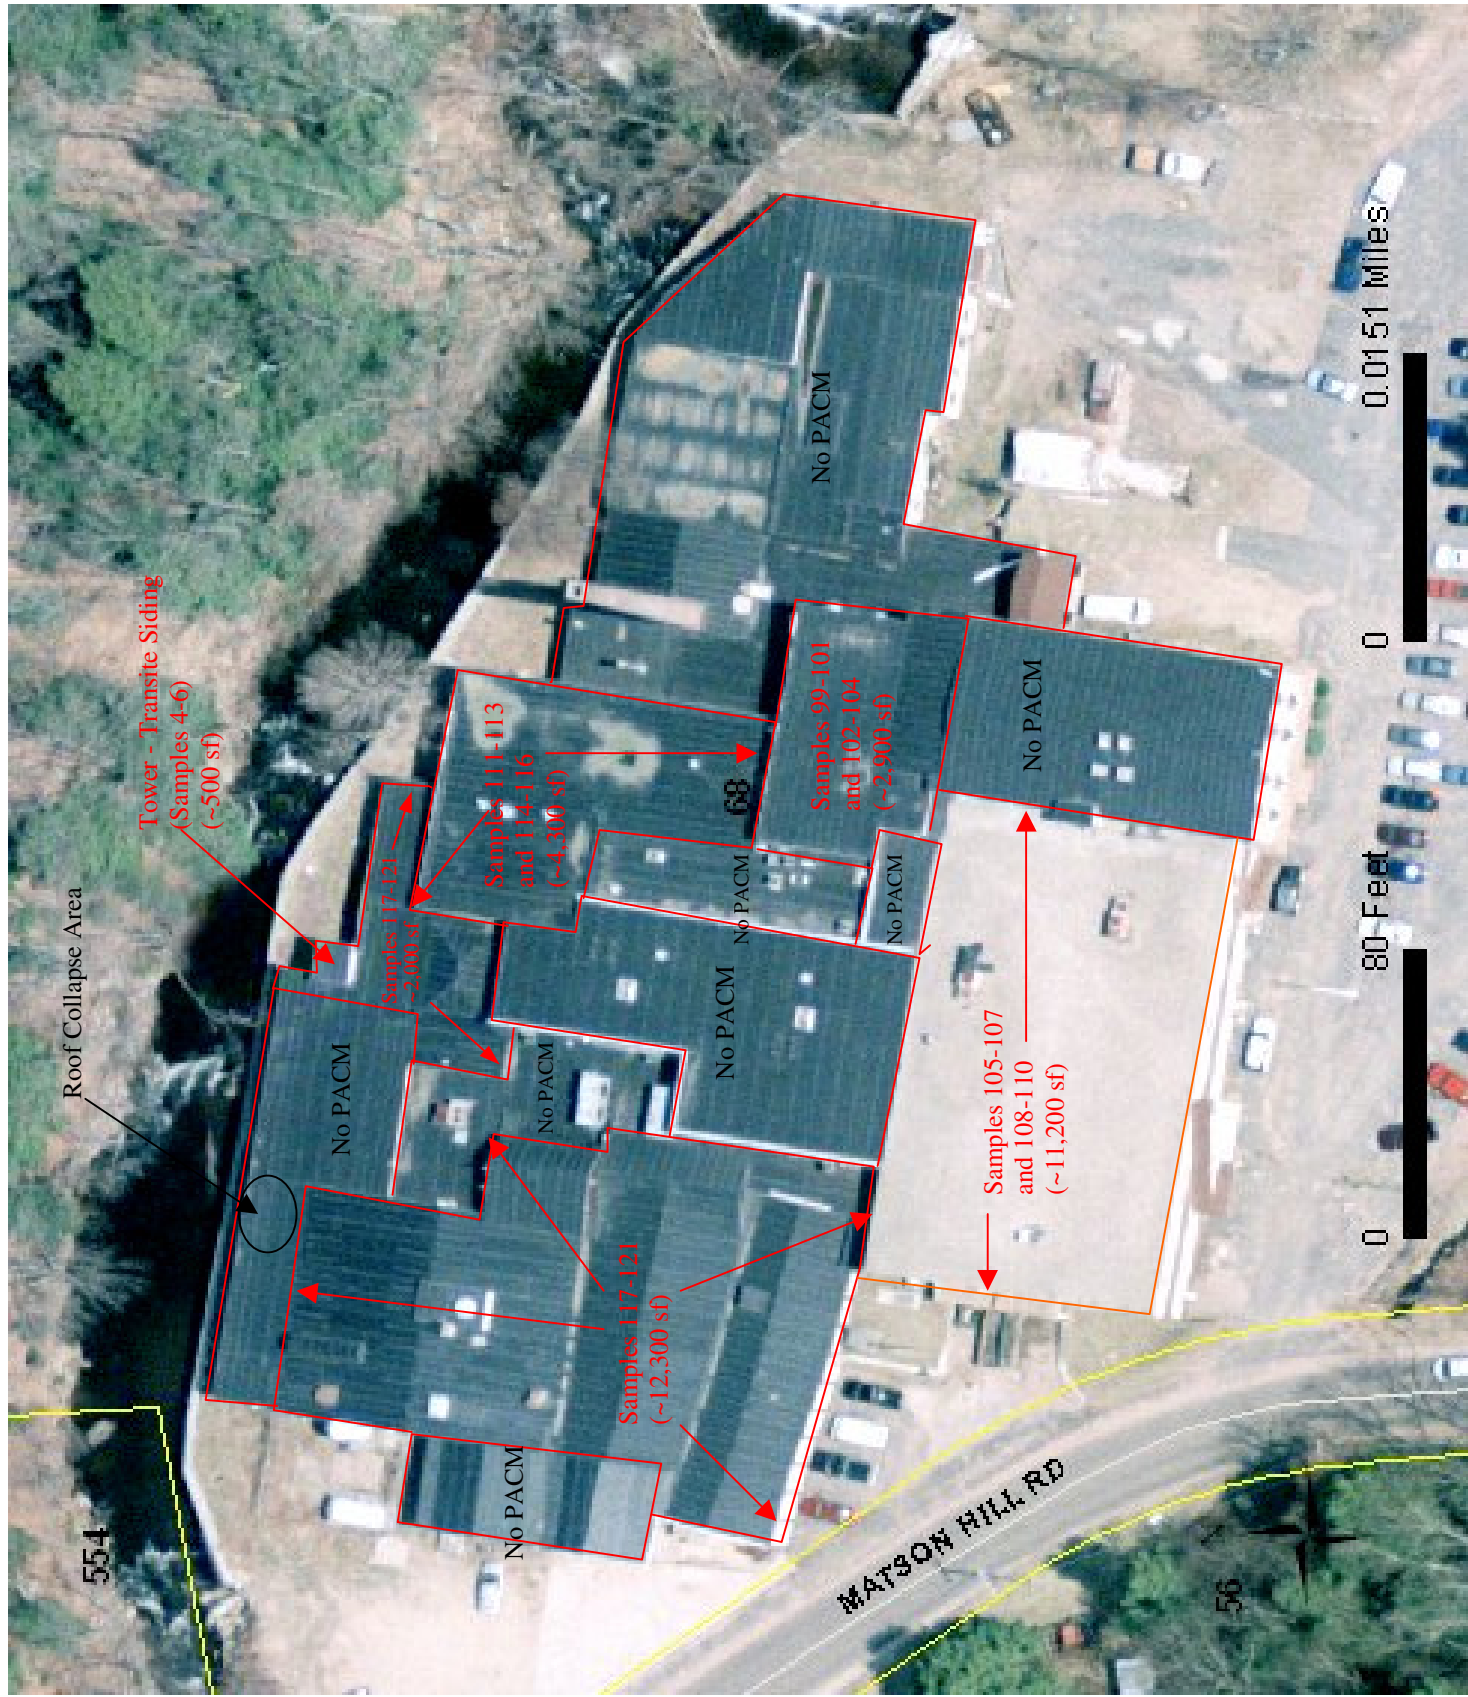
# Roof Diagram Indicating Areas of Identified Asbestos Containing Materials

Image and square footage of roof areas taken from Town of Glastonbury Geographic Information Systems

Section 1.3 Scope of Work, Table 1 Summary of Identified Asbestos Containing Materials: This Table is hereby replaced with an updated version of Table 1 that is attached to this addendum to address discrepancies in the quantities of asbestos roofing materials and to clarify the quantity of TSI-Aircell insulation. An updated roofing diagram is also attached to this addendum, which replaces the diagram included in Appendix A, Enclosure 4 of the Pre-Demolition Asbestos Survey prepared by Triton Environmental.
